# Condition Survey Report

Historic Environment Scotland

Holyrood Park Lodge,  
140 Holyrood Road,  
Edinburgh  
EH8 8DX

01/02/16

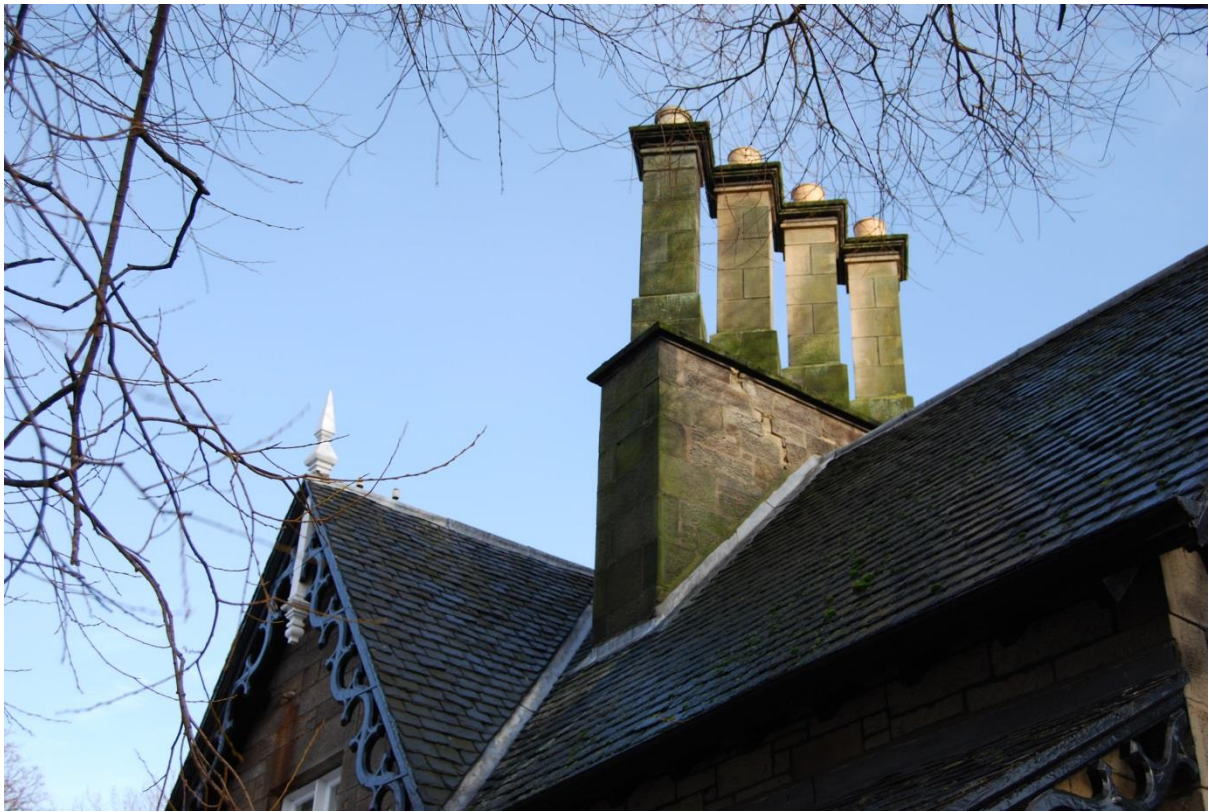
Element	Description	Condition	Photo
<b>External</b>			
Chimneys	Sandstone ashlar. Open or vented? Pots capped?	Inspected from ground. Crack in masonry, repointing required.	Figure 1
Roof	Slate roof with zinc ridge and flashing. Painted decorative barge boards.	Inspected from ground. A few loose slates. Moss needs to be cleared. Barge boards in good condition.	Figures 2, 3 and 4
Walls	Sandstone ashlar.	Some open joints, repointing required. Greening on masonry, signs of moisture.	Figures 5, 6, 7 and 8
Windows	Single glazed, timber, painted white.	Generally in good condition. Some soft mastic and peeling sealant. Some flacking of paint.	Figures 9 and 10
Doors	South door, timber plank, painted. West door, timber ledge and brace, painted.	Generally good, not draught proofed. Letter box in west door not sealed.	Figures 11, 12 and 13
Rainwater goods	Cast iron, painted.	Generally okay condition. Gutters need clearing. Missing downpipe on east elevation.	Figure 5

**Figure 1:** Diagonal crack in the masonry on the southern side of the chimney stack

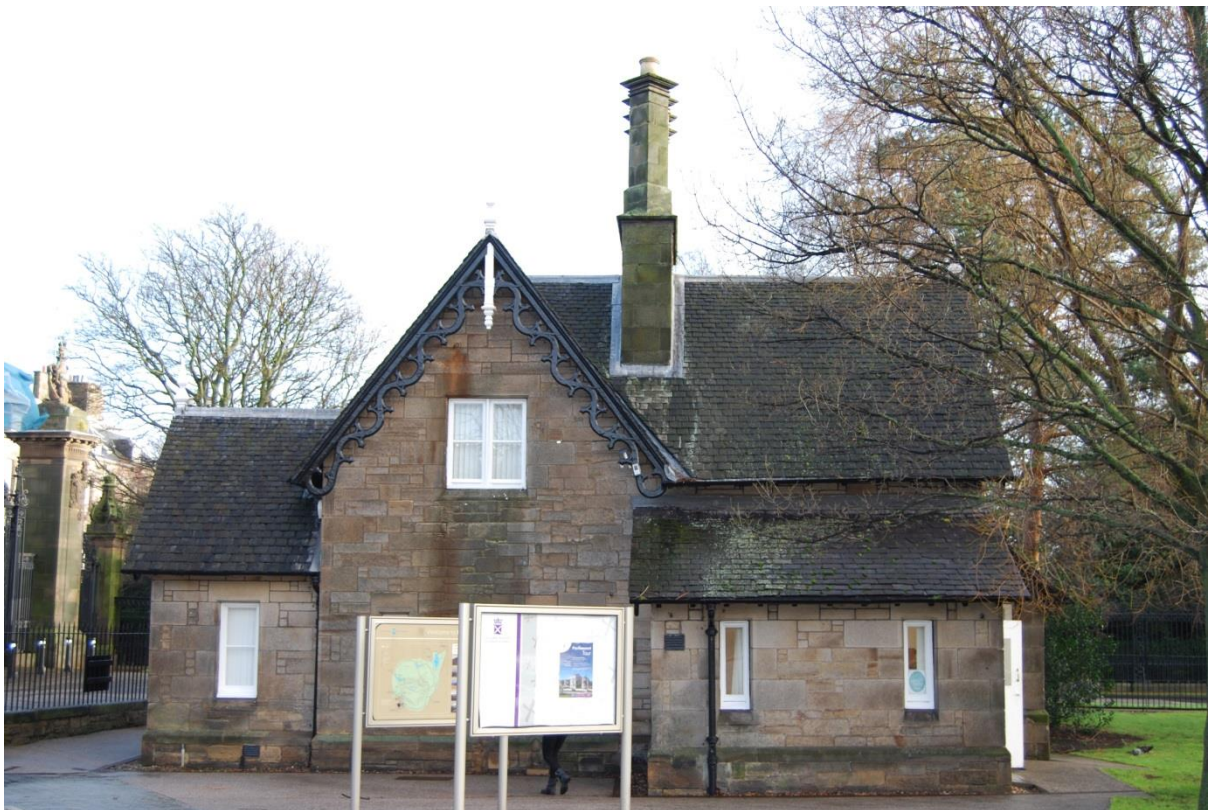
**Figure 2:** West elevation of the lodge showing the overall external condition

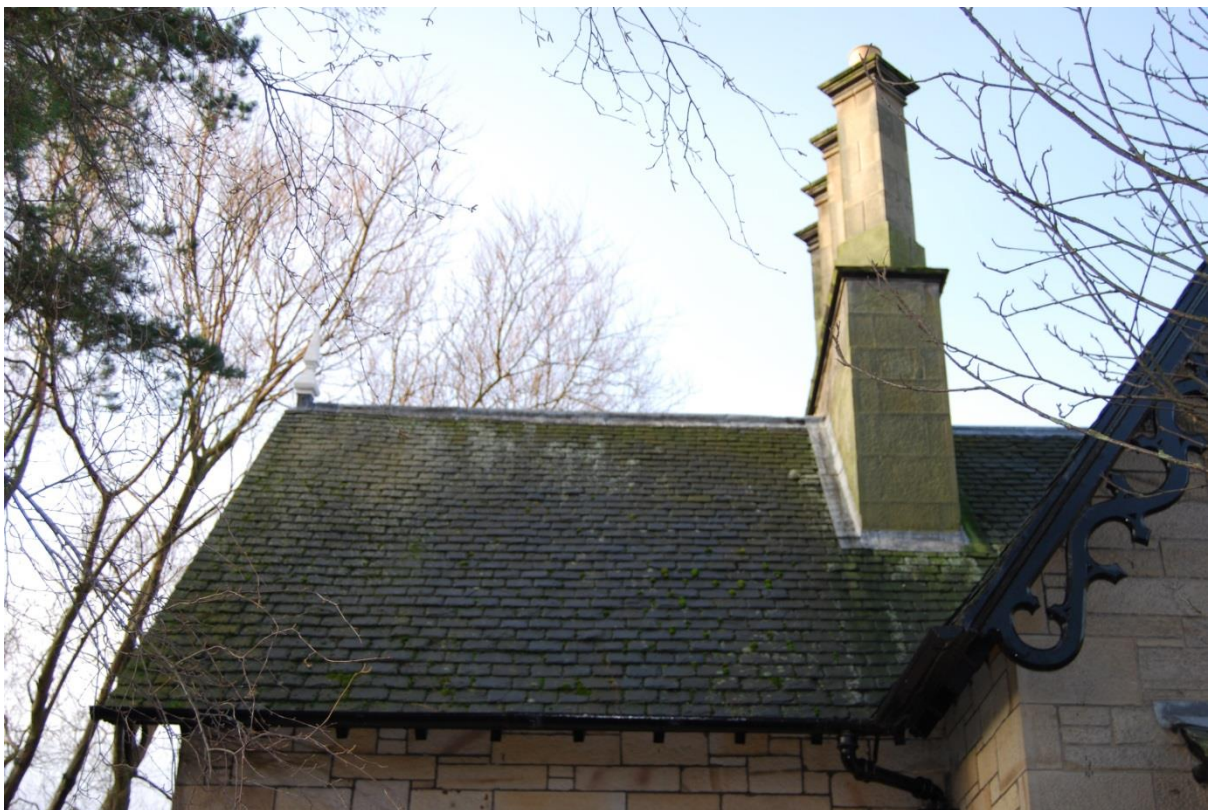
**Figure 4:** West elevation of the roof

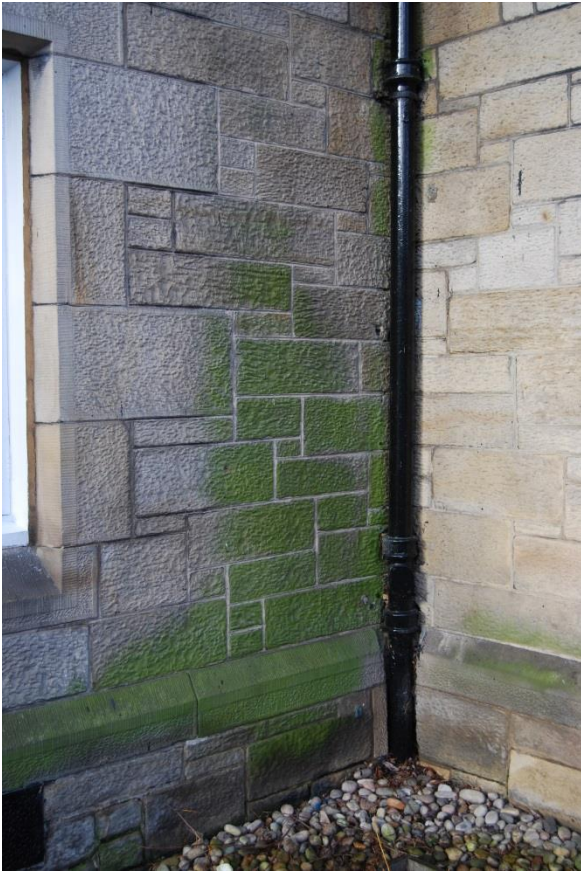
**Figure 5:** Greening on masonry due to excess moisture

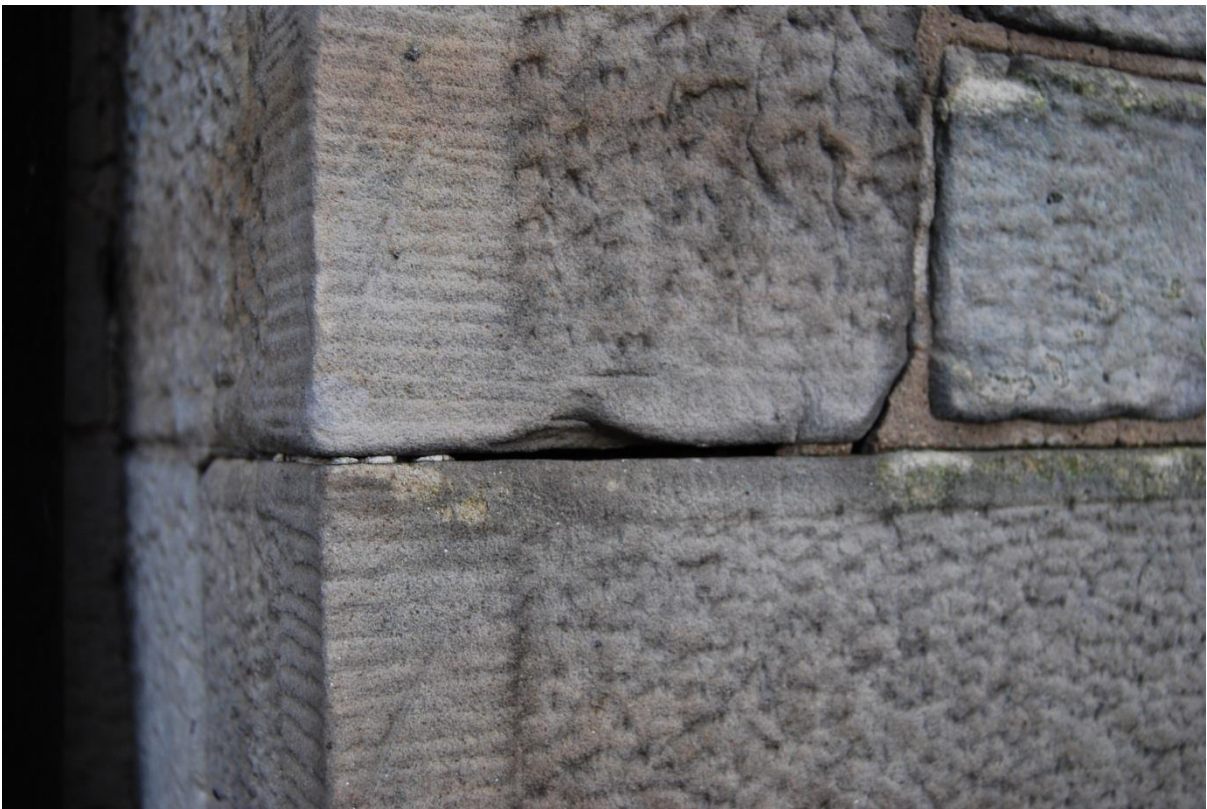
**Figure 6:** Loss of mortar in masonry joints could be allowing water ingress

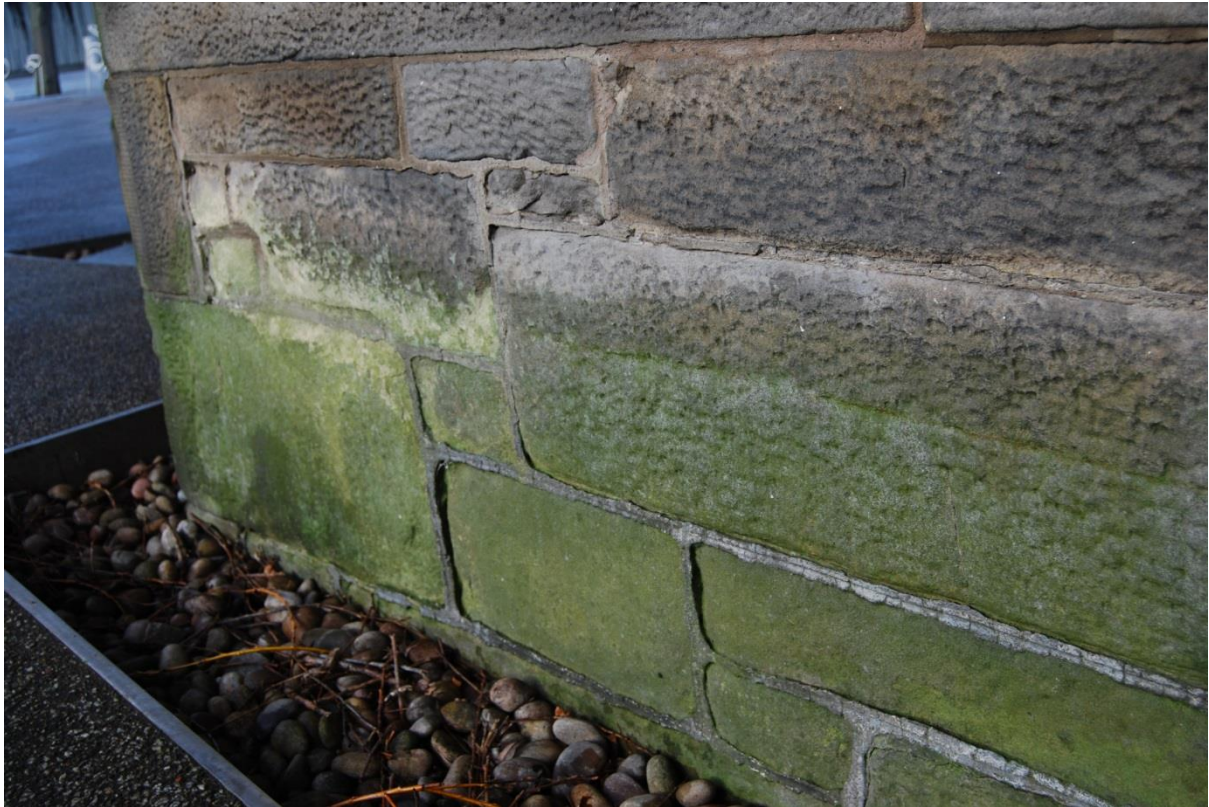
**Figure 7:** Cement pointing on the lower wall starting to fail.

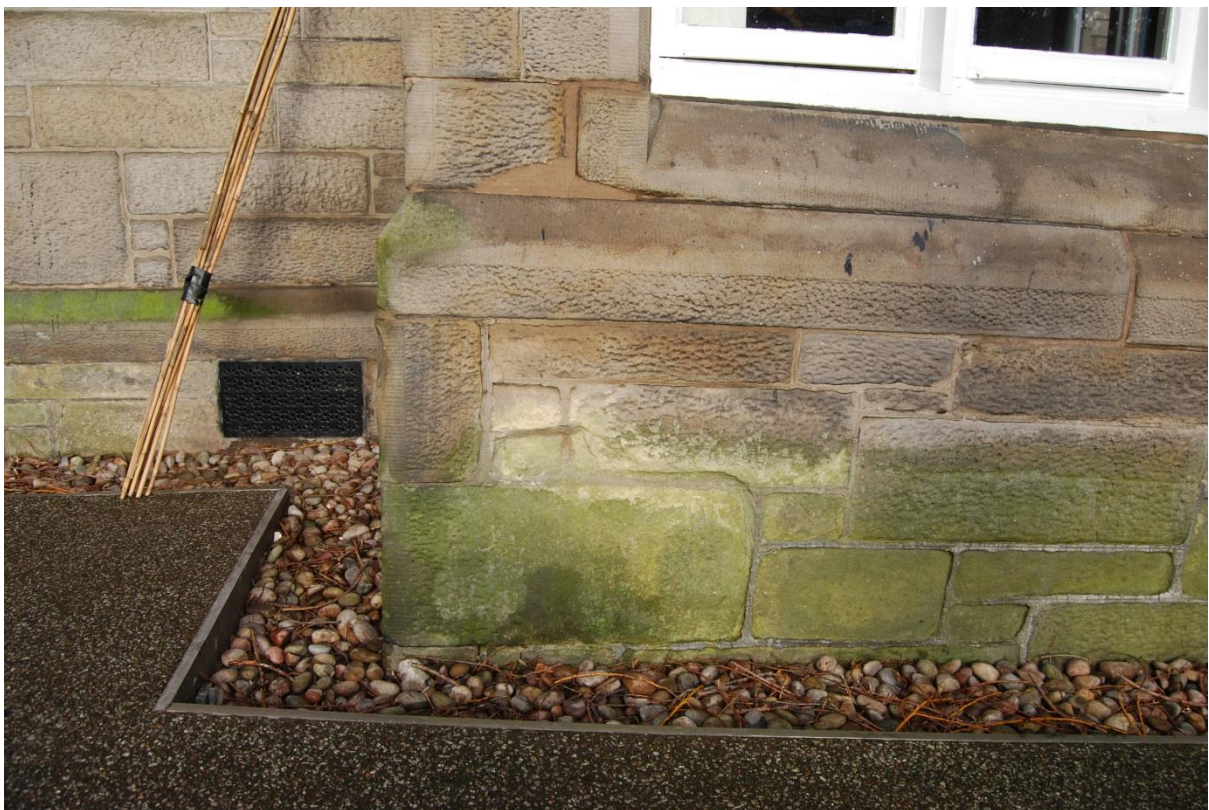
**Figure 8:** Greening of masonry caused by excess ground water.

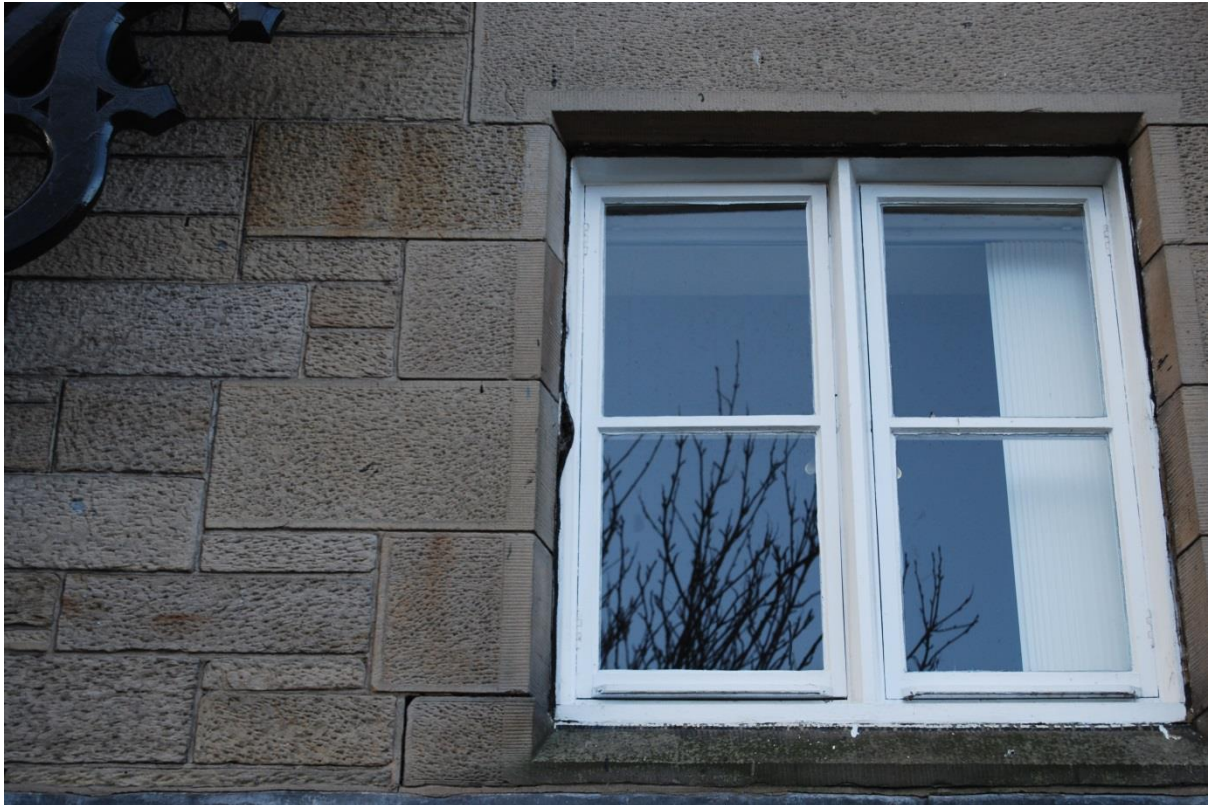
**Figure 9:** Warped mastic around the window which could be allowing water ingress.

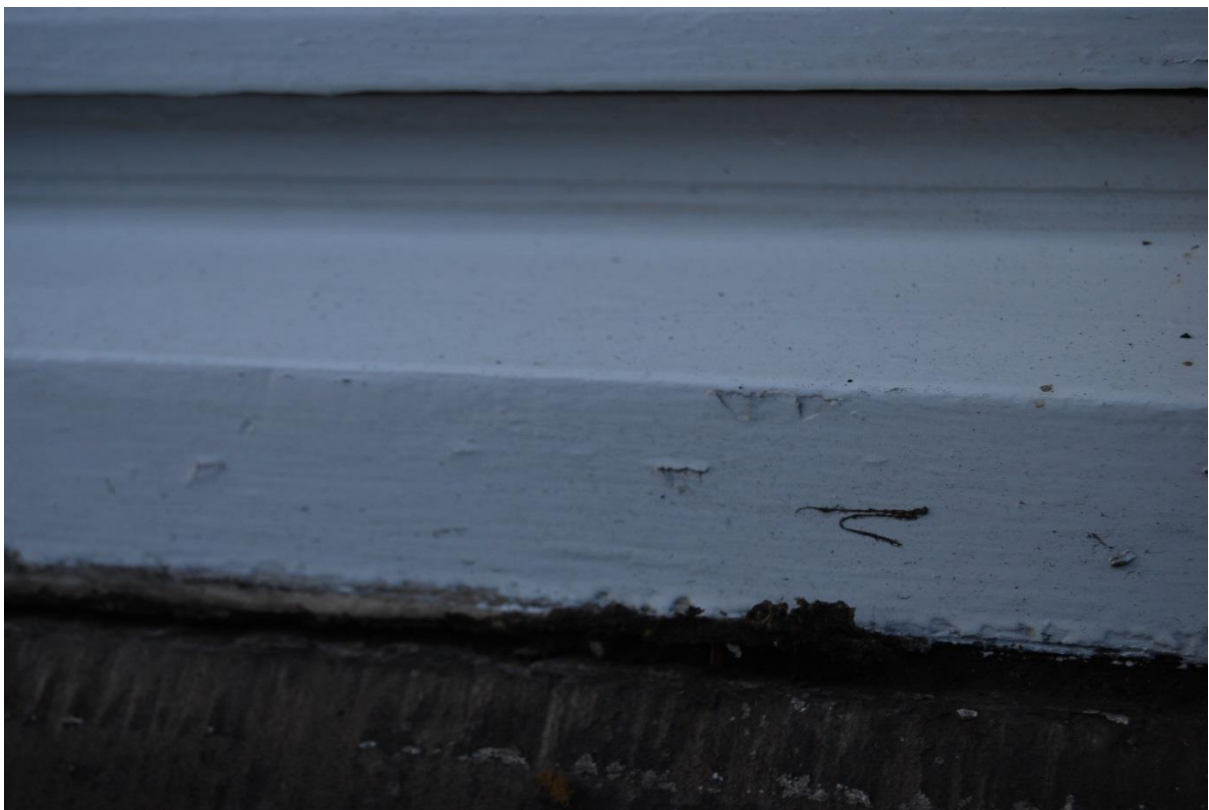
**Figure 10:** Mastic which has peeled off exposing the mortar joint below.

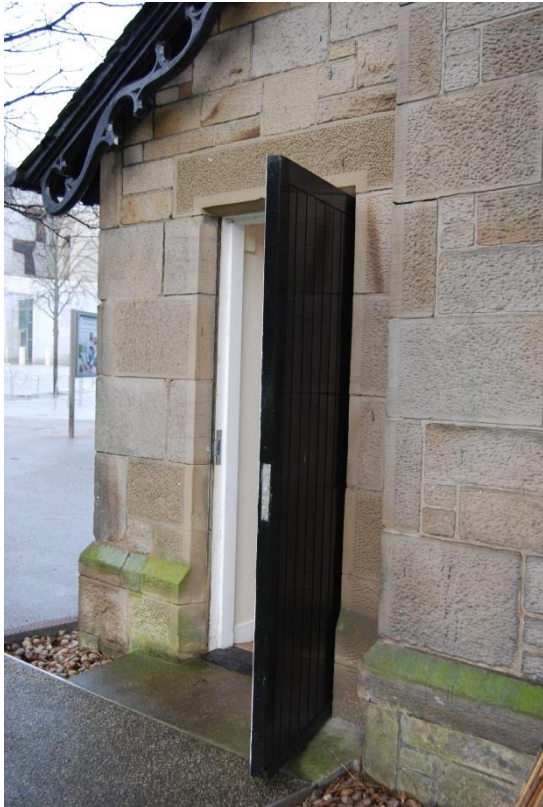
**Figure 11:** External timber panel door to exhibition space, usually left open.

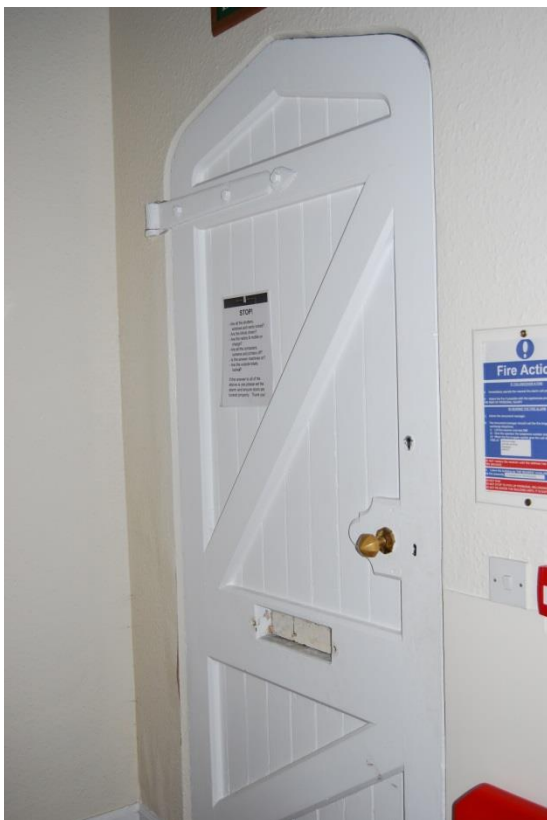
**Figure 12:** Timber ledge and braced external door fitted with no draught-proofing.

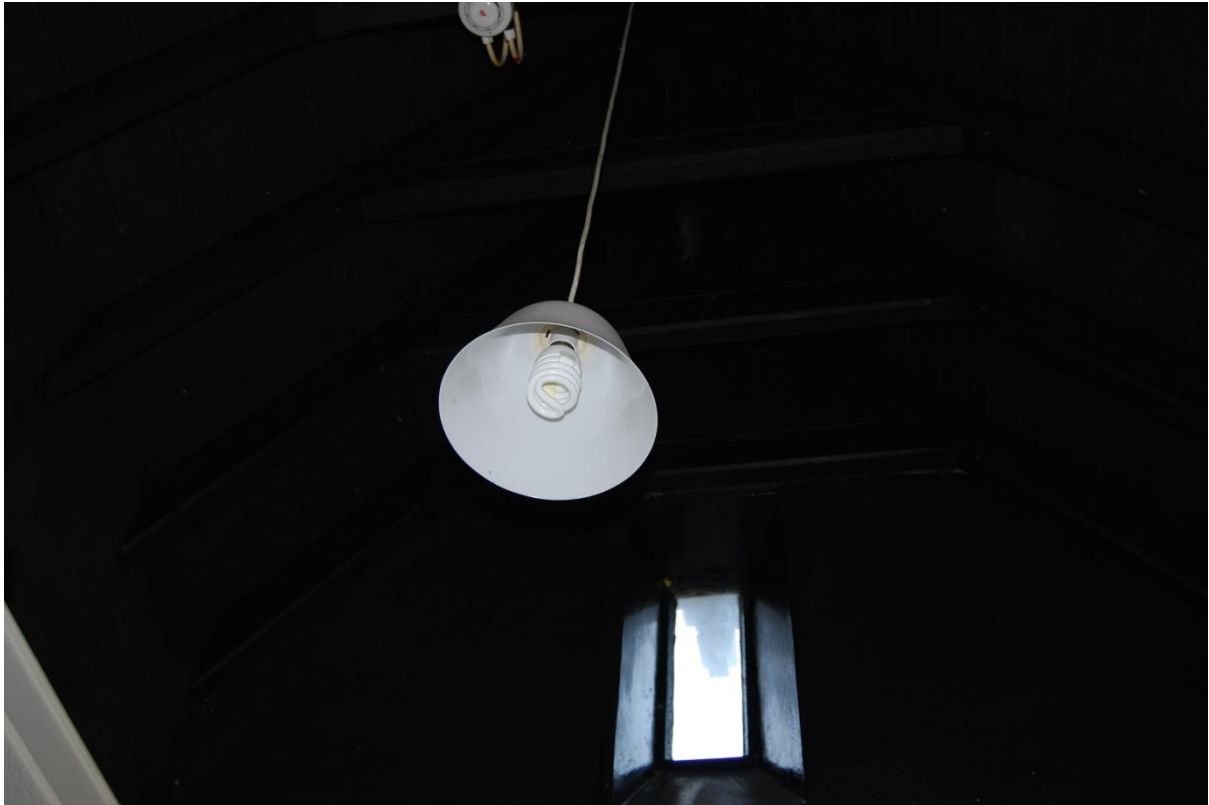
**Figure 13:** Exposed rafters in entrance lobby, uninsulated and painted black.

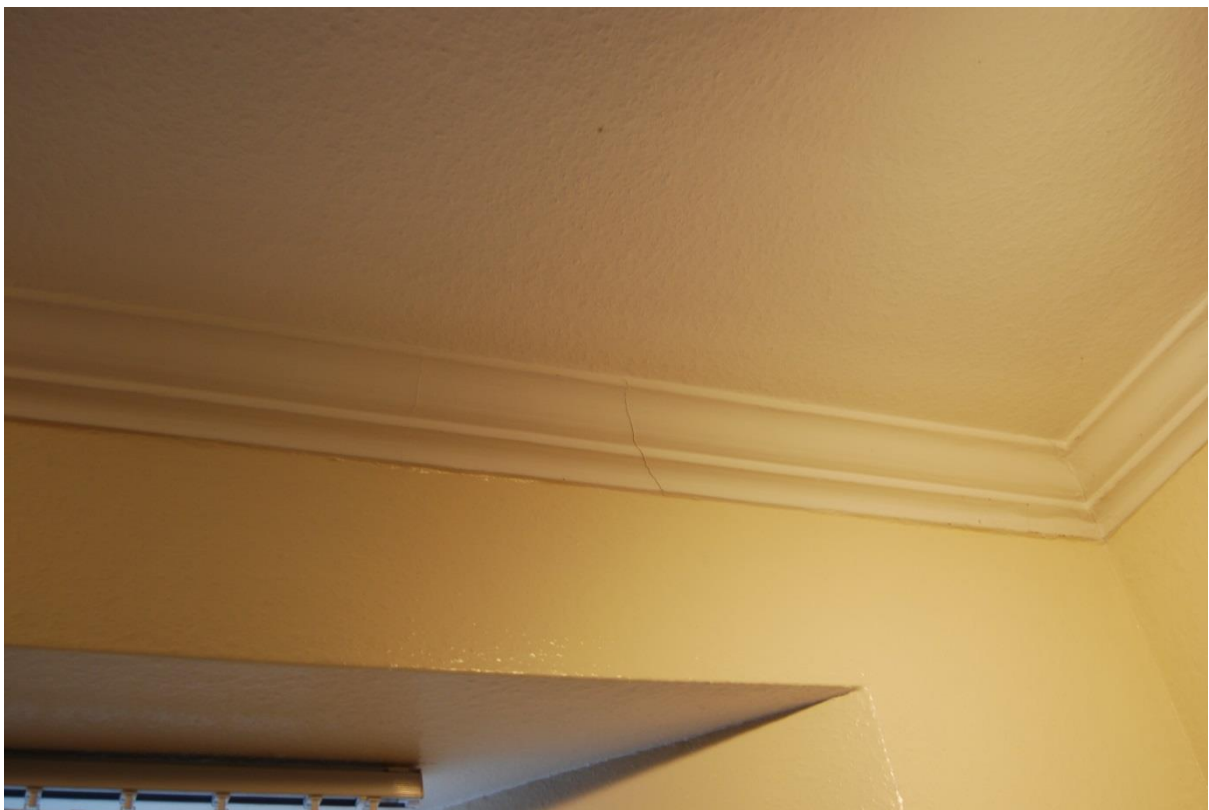
**Figure 14:** Cracks in cornicing in ground floor office due to settlement.

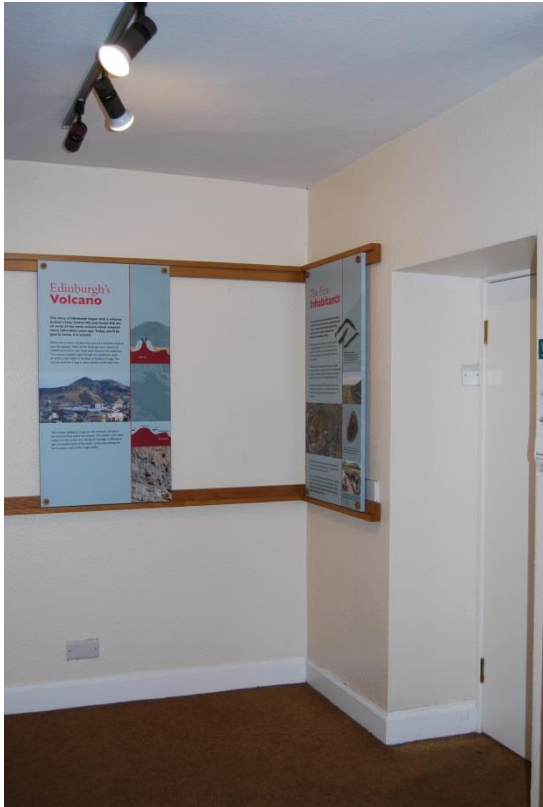
**Figure 15:** Carpeted, uninsulated floors.

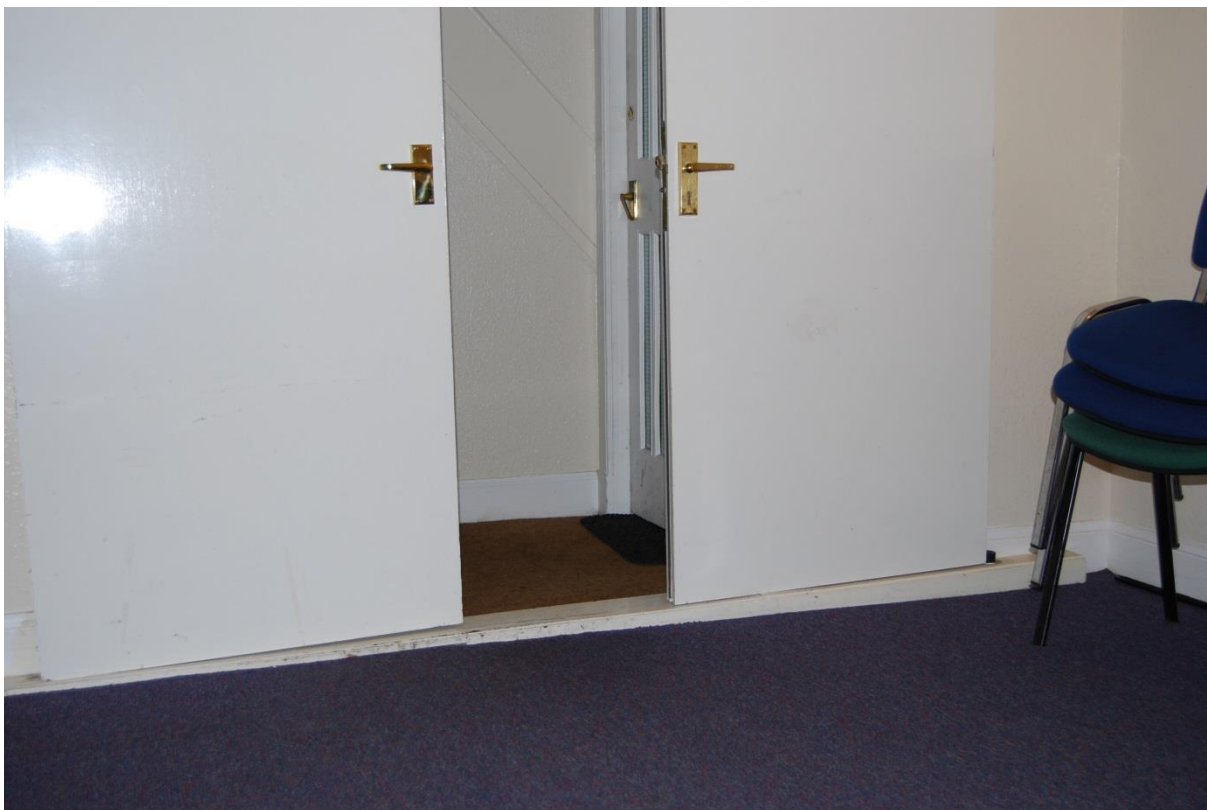
**Figure 16:** Uneven floors due to movement from settlement.

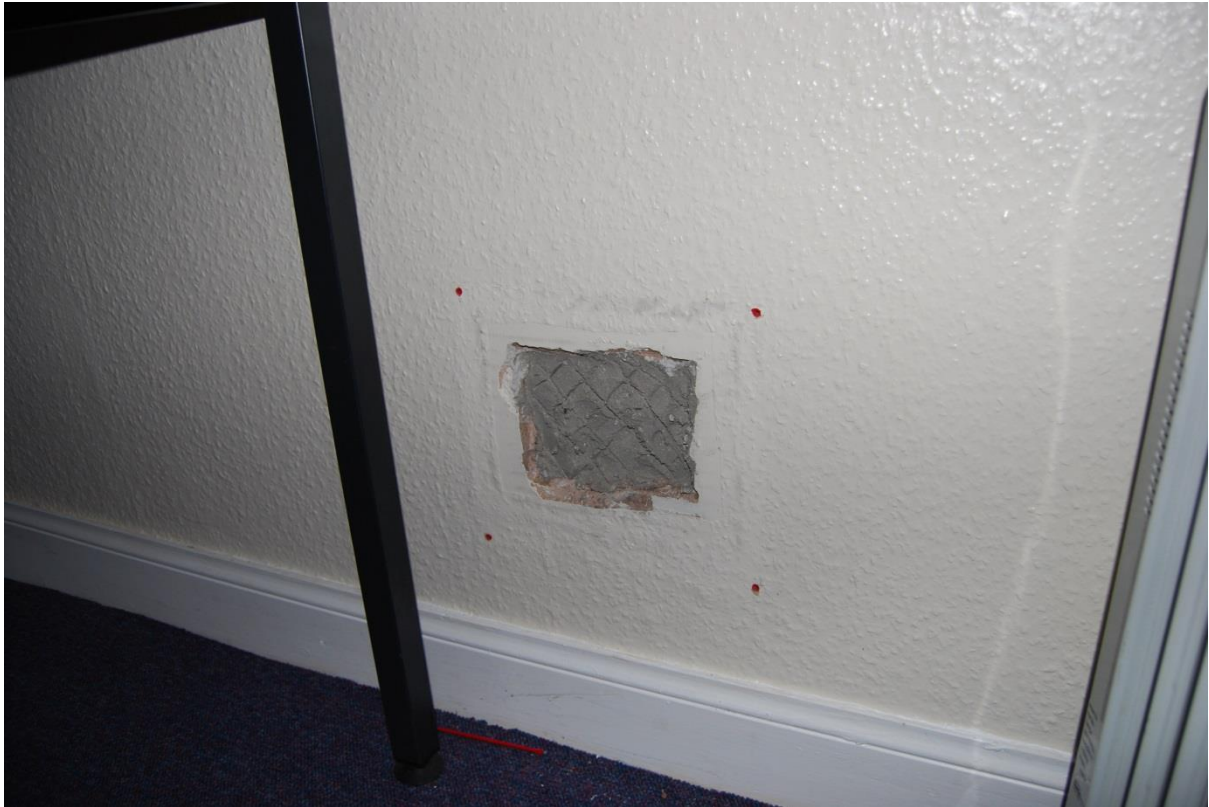
**Figure 17:** Blocked up vent in ground floor office, where original fireplace would have been.

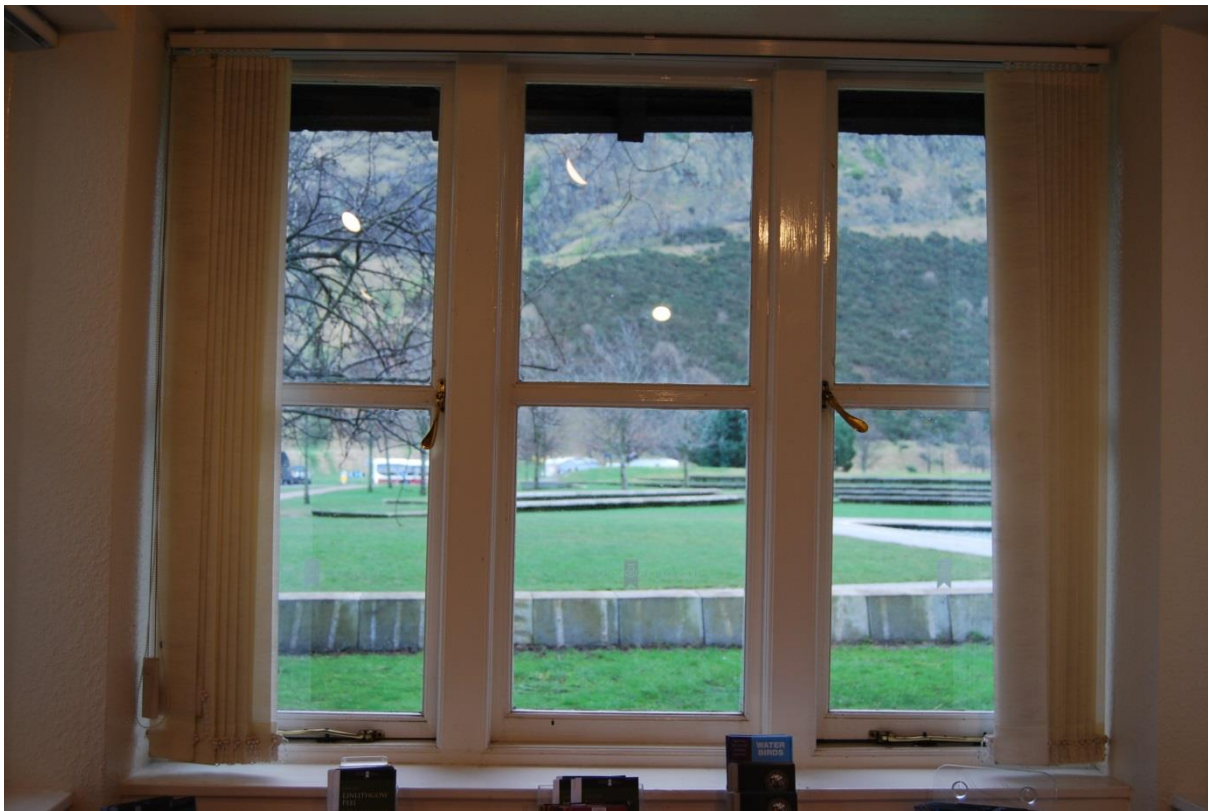
**Figure 18:** Openable windows on the south elevation with gaps appearing at the bottom due to settlement.

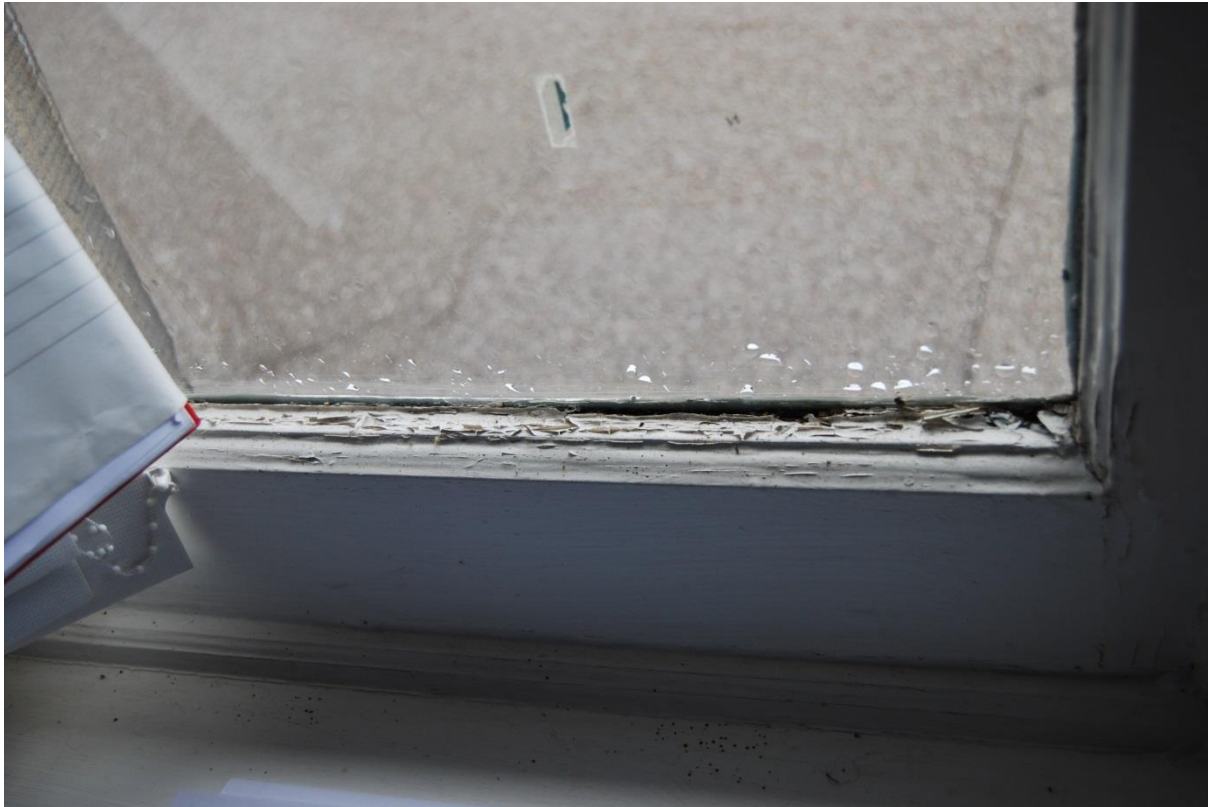
**Figure 19:** Early signs of rot on the interior of a window on the west elevation at ground floor level.

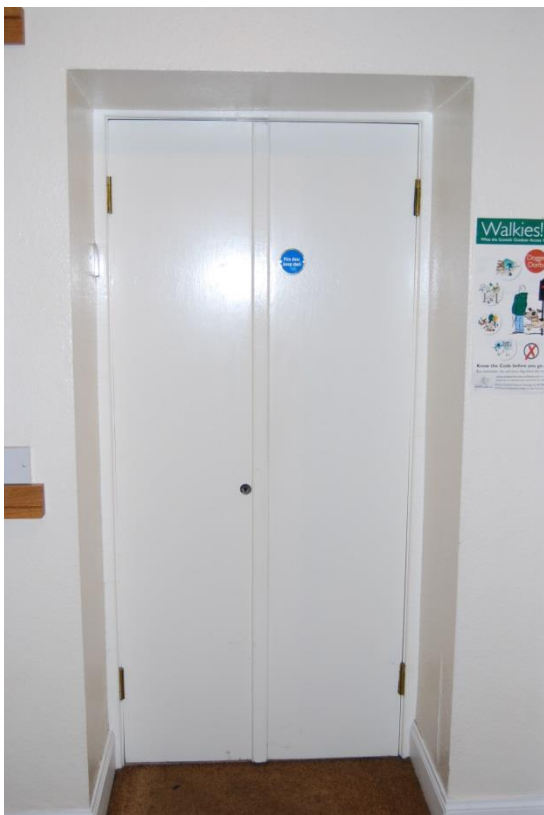
**Figure 20:** Internal fire door separating exhibition space from the rest of the building.

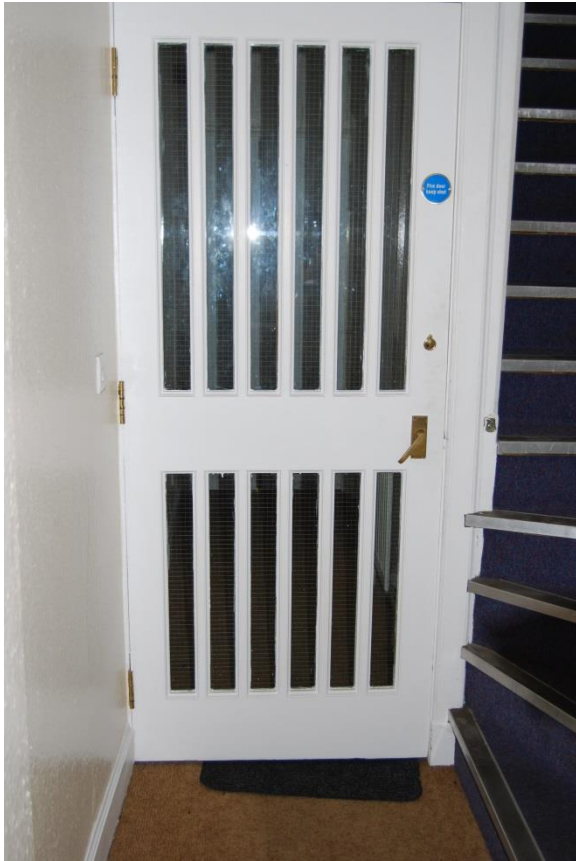
**Figure 21:** Internal glass and timber fire door separating the entrance hallway from the office space on the ground floor.

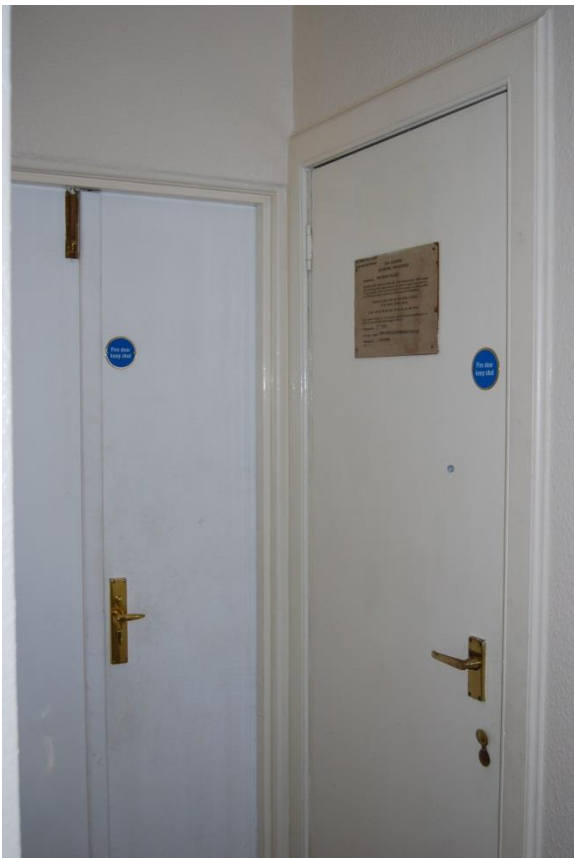
**Figure 22:** Fire door on boiler cupboard beneath the stairs.

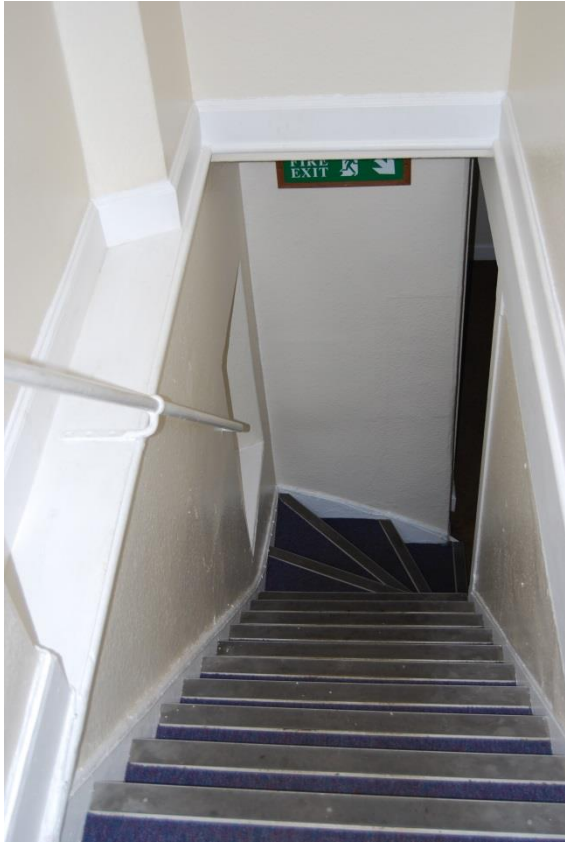
**Figure 23:** Carpeted, narrow stairway providing access to first floor.

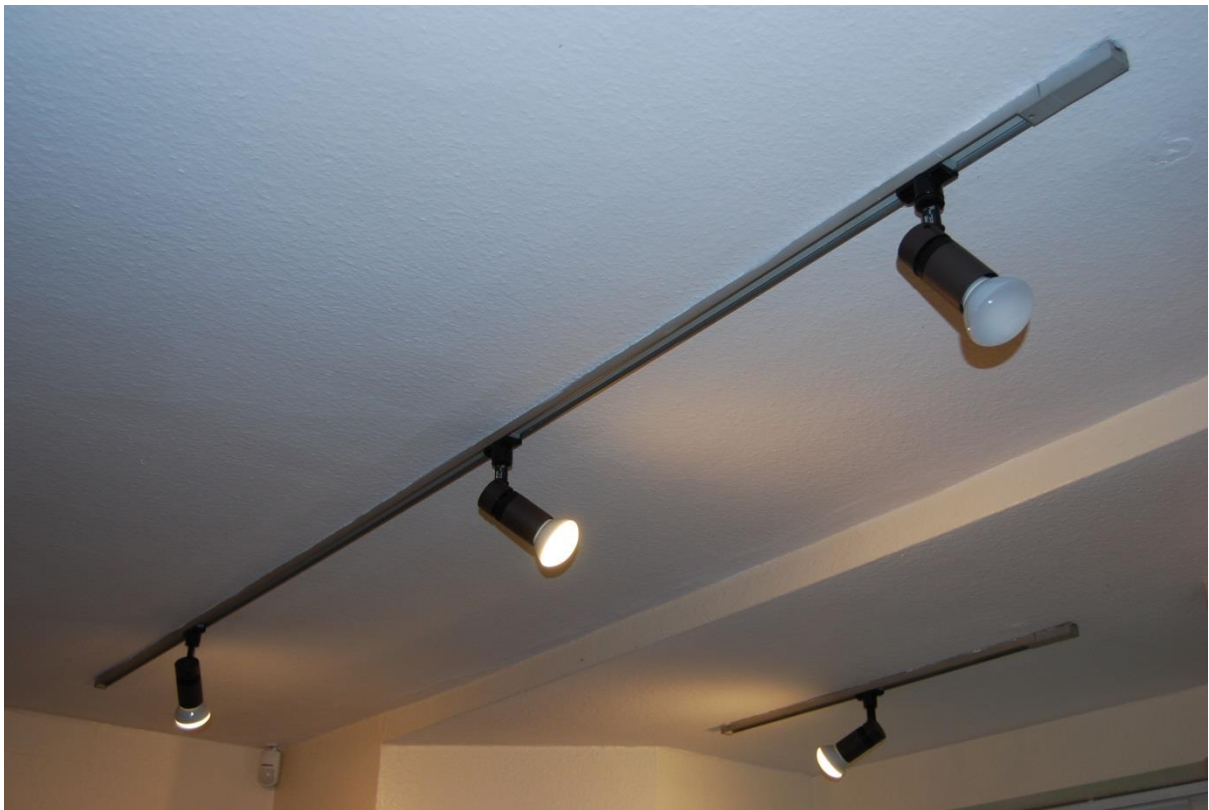
**Figure 24:** Existing spotlights in exhibition space and round floor office.

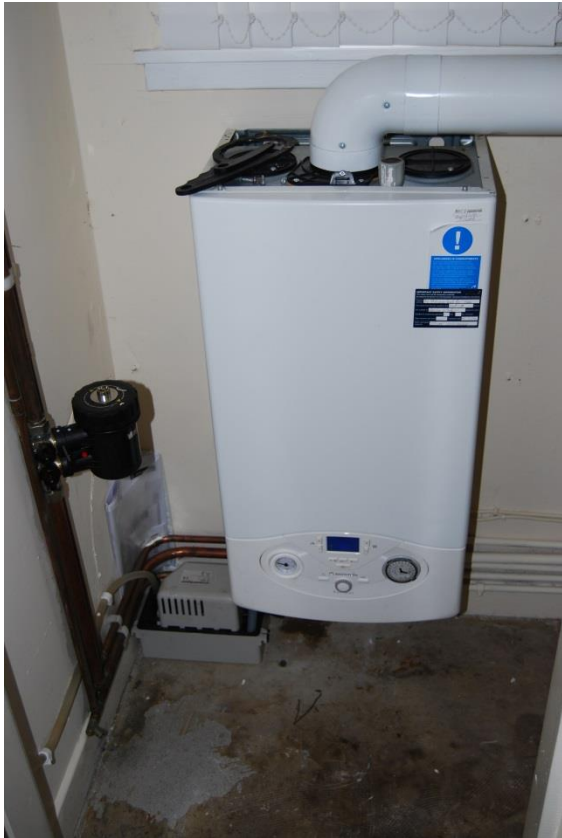
**Figure 25:** Existing gas boiler.

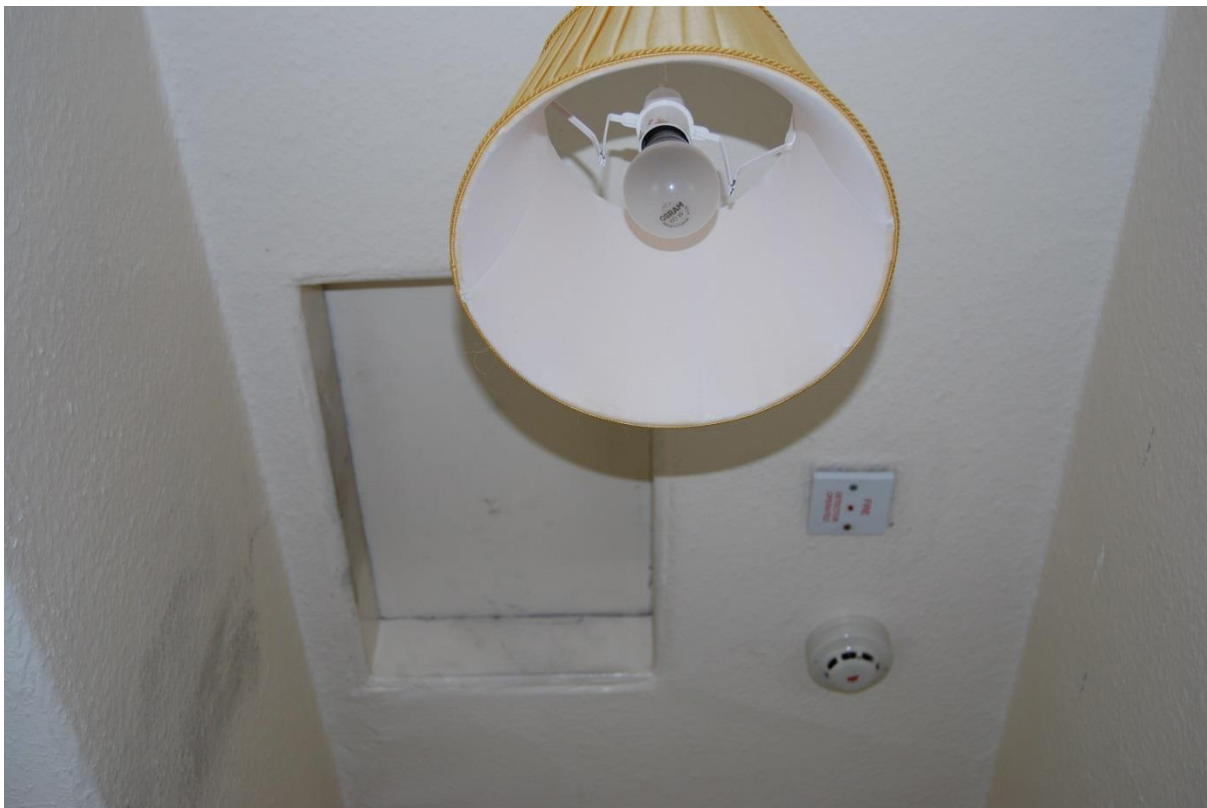
**Figure 26:** Small hatch above stairs offering access to the northern attic space.

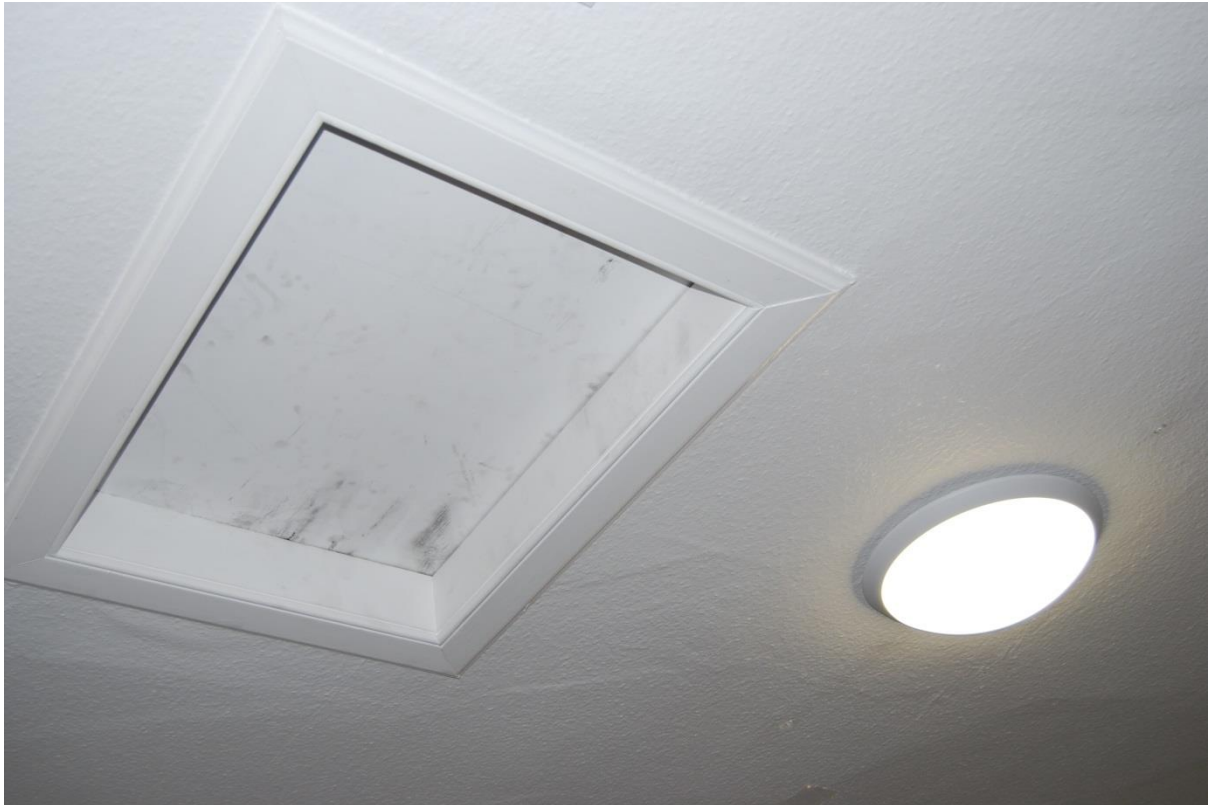
**Figure 27:** Slightly larger hatch in first floor storage room offering access to the southern attic space.

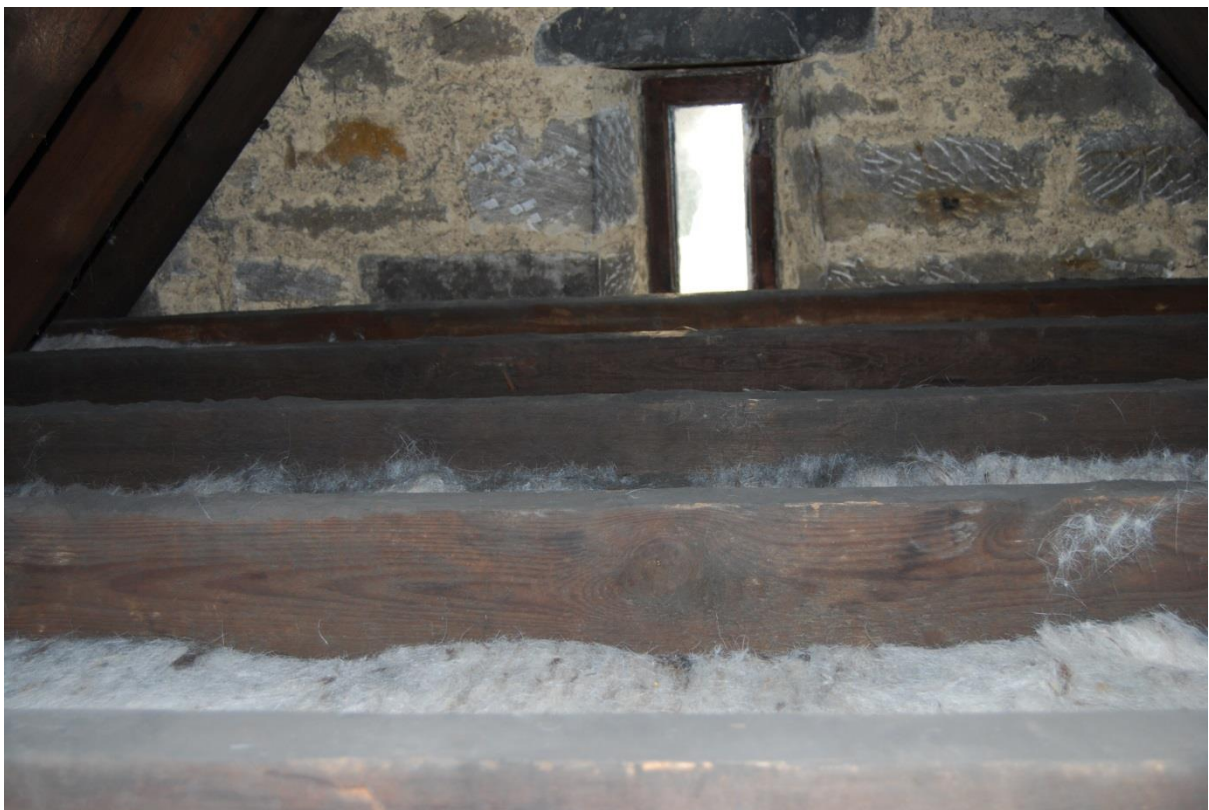
**Figure 28:** Southern attic space looking south showing small amounts of insulation and no mould.
