# Condition Survey Report

Historic Environment Scotland

Holyrood Park Lodge,  
140 Holyrood Road,  
Edinburgh  
EH8 8DX

01/02/16

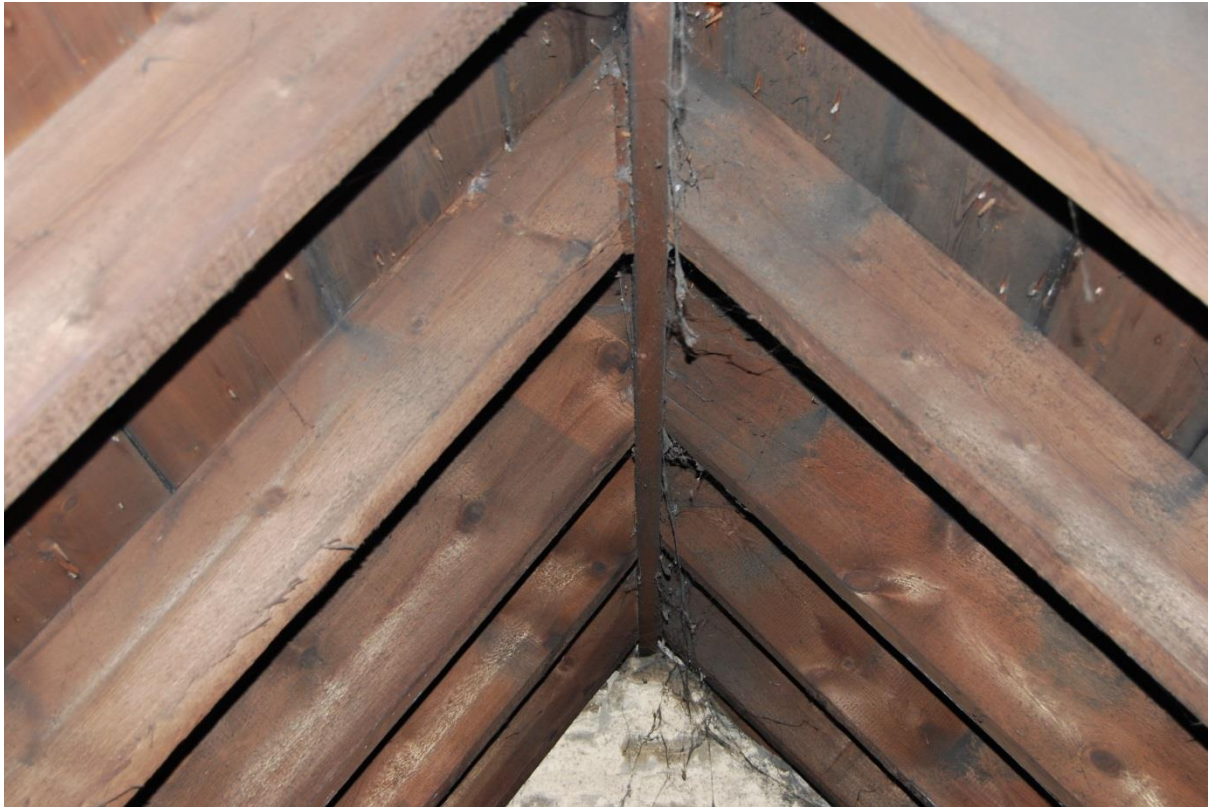
**Figure 29:** Rafters and ridge beam of southern part of the roof in good condition.

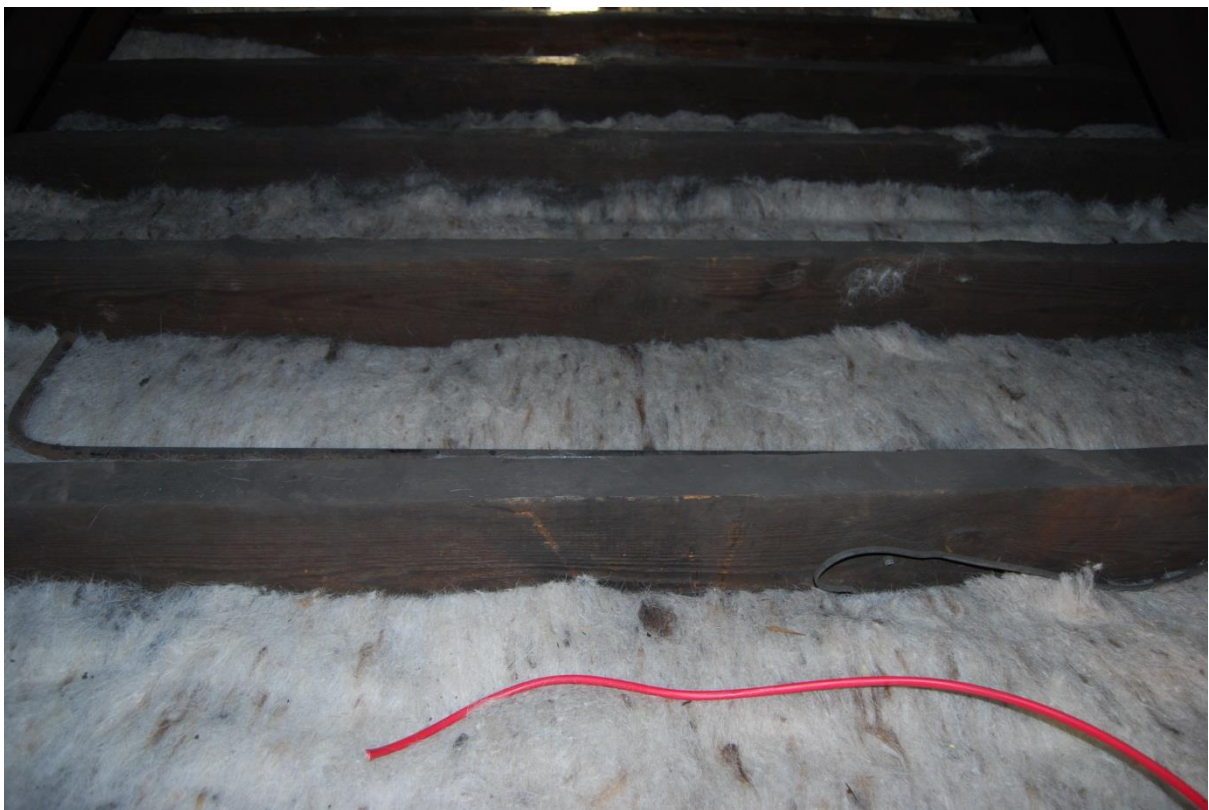
**Figure 30:** Sheep's wool insulation in between joists.

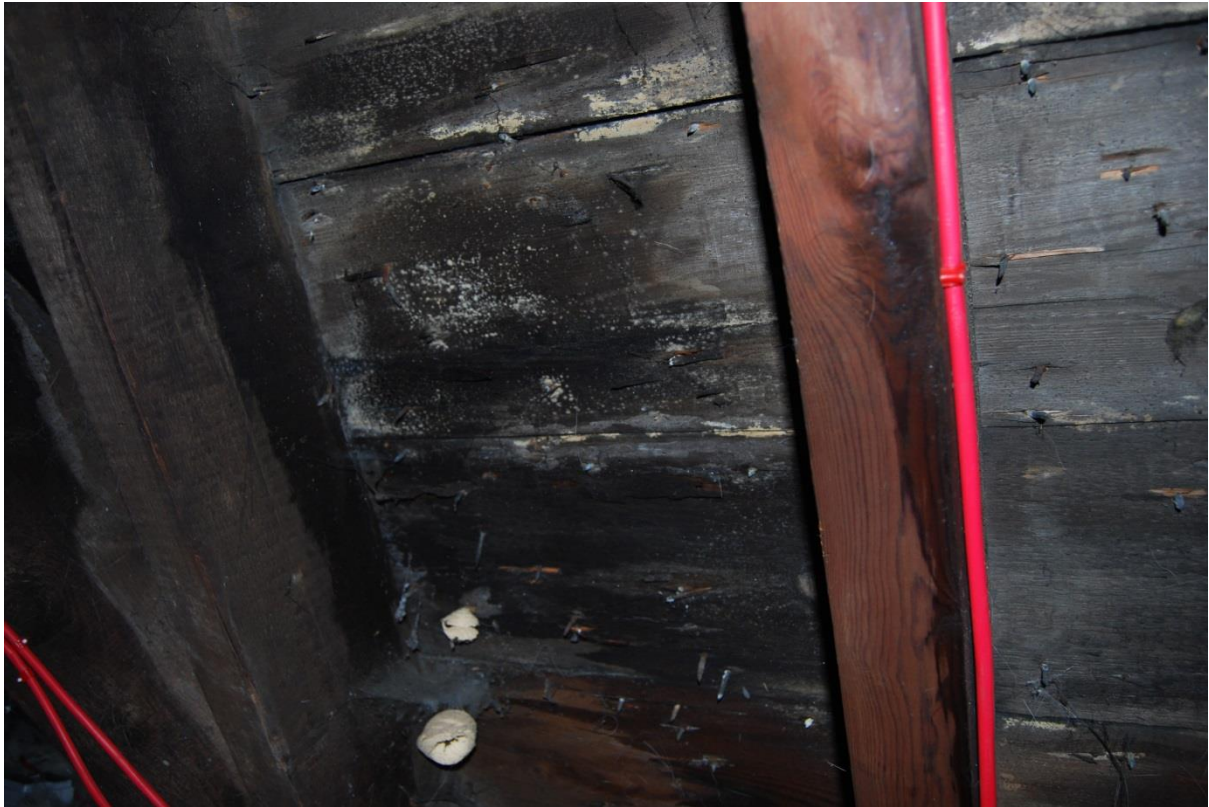
**Figure 31:** Underside of sarking in northern roof space showing signs of mould.

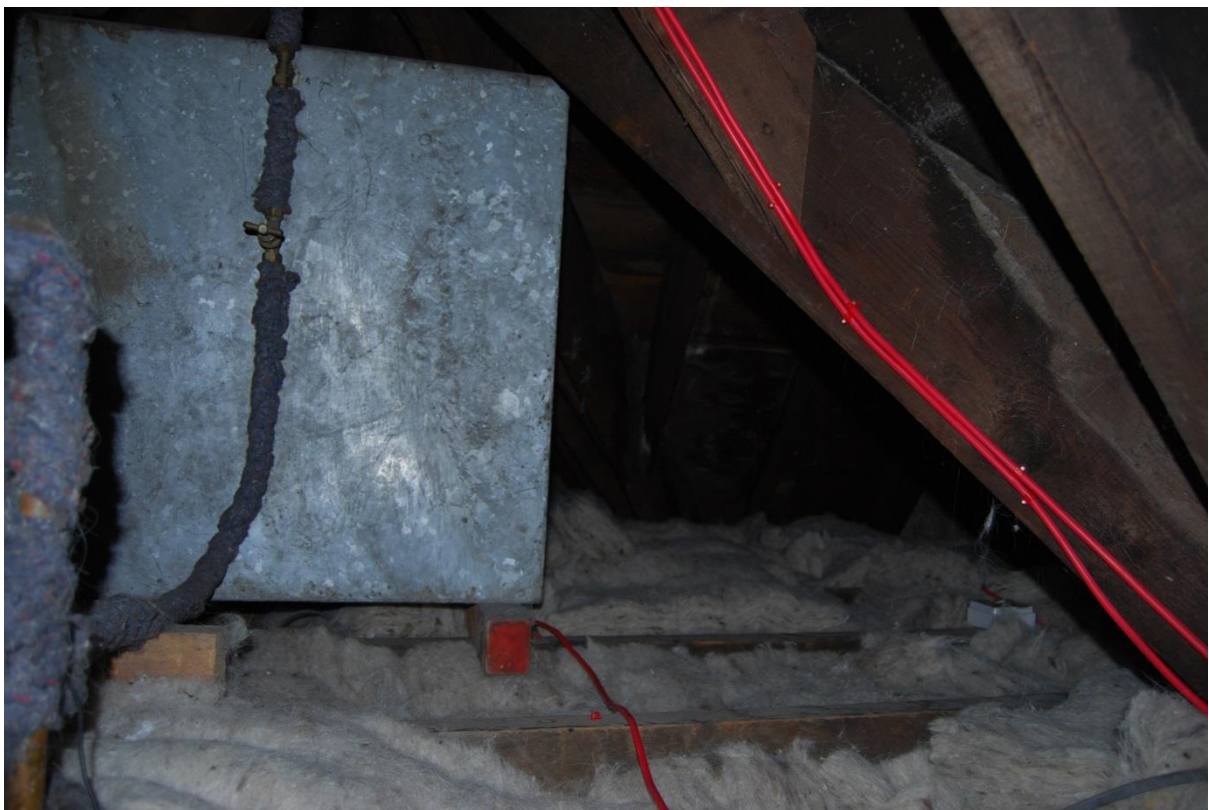
**Figure 32:** Old water tank in northern attic space which blocks access to far side of attic space.
