Historic Scotland Refurbishment Case Study 20

11 Anatt Road, Perthshire

Thermal improvements to a 1920's cottage.

Roger Curtis

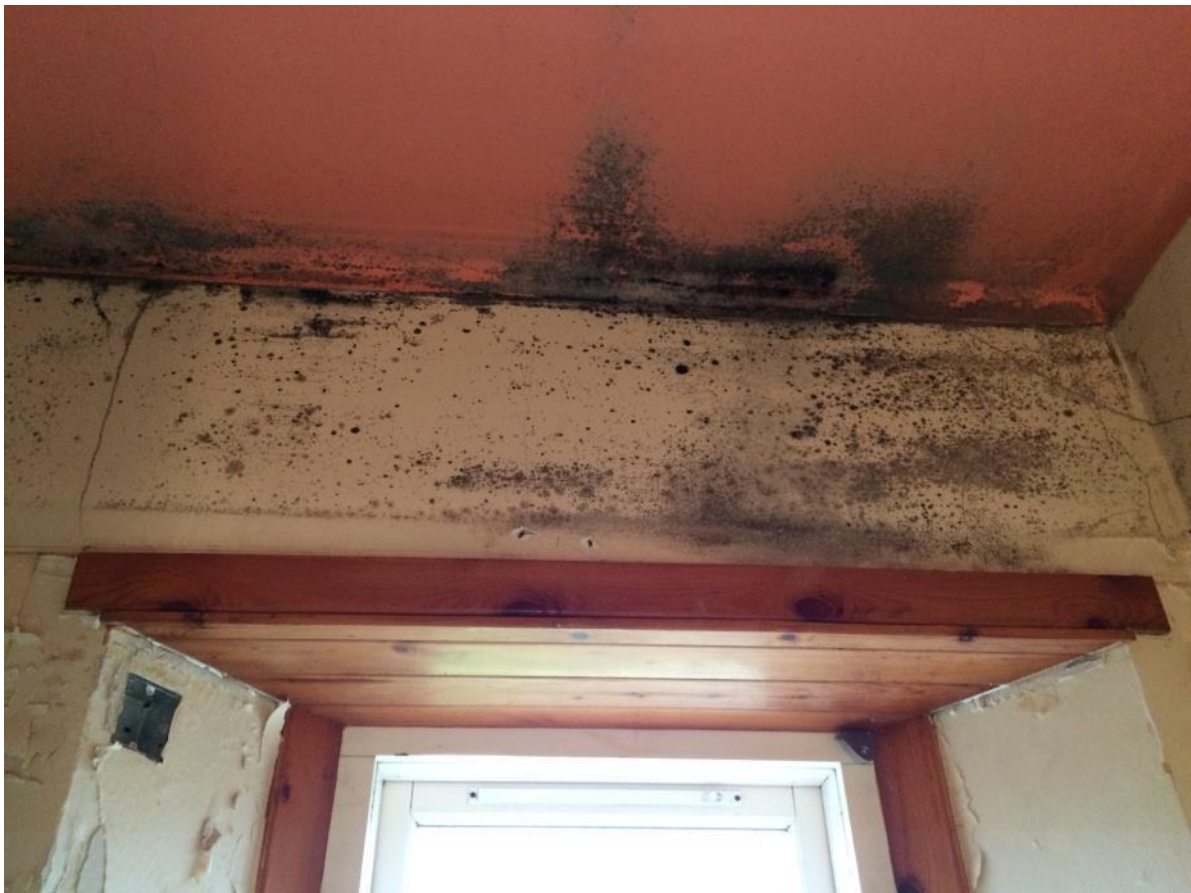
Figure 4: *Mould uncovered in the bathroom following the removal of the lowered ceiling*

Investigation of the bathroom ceiling had shown considerable areas of mould growth; improved ventilation would be required and the lowered ceiling would be removed. As with many properties, occasional condensation in the bathroom is common, but on occasion there had been excessive amounts in this and other properties. While poor ventilation will contribute to high internal relative humidity, the surface temperature of surface building elements is also important. To assist in managing condensation in this space a radiant panel heater was fitted above the wash hand basin (Figure 8). In this small room the arc of radiated heat easily covered the window reveals, the end wall and the wall on which part of the shower is located. By keeping these surfaces at a higher temperature water vapour is not able to condense.

While not part of the energy efficiency works, the Trust wished to re-configure the kitchen to modern expectations. To create more space a fitted larder and a cupboard accessed from the living room were removed to create space for a dining table. The new kitchen required routes for new wiring, there were to be chased into the brickwork partitions and plastered smooth. Under the previous scheme such routes were boxed in. To maximise the volume of the kitchen and improve amenity the lowered ceiling was removed.

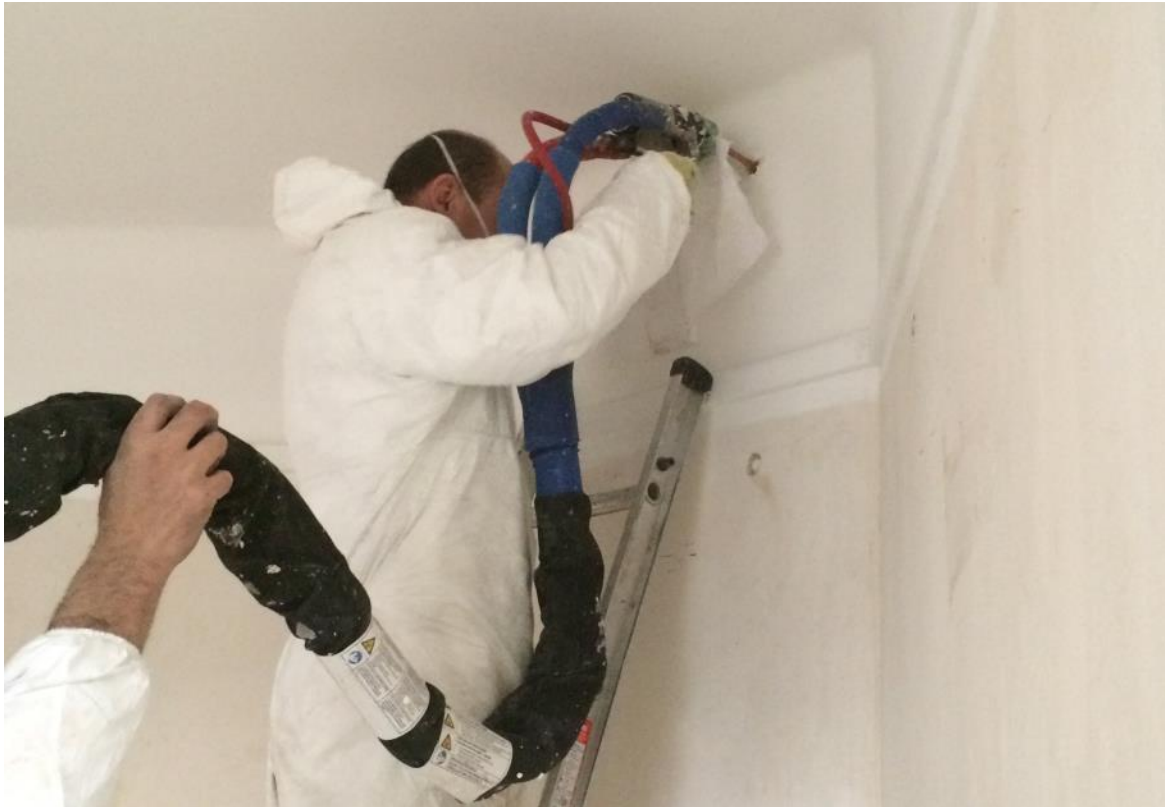
Figure 5: *Installing the foam insulation*

Due to the disruption and loss of space from the previous measures it was decided to retain the existing linings and apply blown materials behind the existing finishes. The suspended timber floor, in direct contact with the solum void, was an obvious area for improvement, and in order to minimise waste the existing floor would be lifted, the insulation, also wood fibre board, would be fitted between the floor joists and the floor put back. Initially blown cellulose was to be used, but contractor availability prevented this, and another contractor had to be found. The alternative contractor proposed a relatively new product; a water based expanding foam, that was injected into the cavity behind the lath and plaster. While this approach is considered unusual, tests by Glasgow Caledonian University had shown it was very vapour open and therefore would allow the dissipation of any wall humidity or liquid water through evaporation and diffusion³. Table 1 shows the performance of the material against other common product types.

A condensation risk assessment was carried out following BS 5250, although it should be noted that this methodology, while common in planning solid wall insulation retrofit in all types of buildings in Scotland, is not suitable for mass stone walls; however, this procedure was followed to see what it showed. To inject the material required the drilling of many holes, approximately 25mm in diameter normally at 1m centres. Preparation for the installation of this product was extensive; it involved the removal of existing wall coverings and skirting boards, plugging of the junction between the timber ground for the plaster and the masonry (to keep the material out of the solum) and sleeving of the mains electrical cable from plug boxes on the wall. However, with these preparations complete, the actual installation was relatively straightforward (Figure 5). As with many types of blown or injected material, often it is the handling of the equipment and the parking of the required equipment that can be problematic. An infra-red camera was used to check that the foam had spread evenly into the void. Once the material had set holes were patched over and skirting boards fitted.

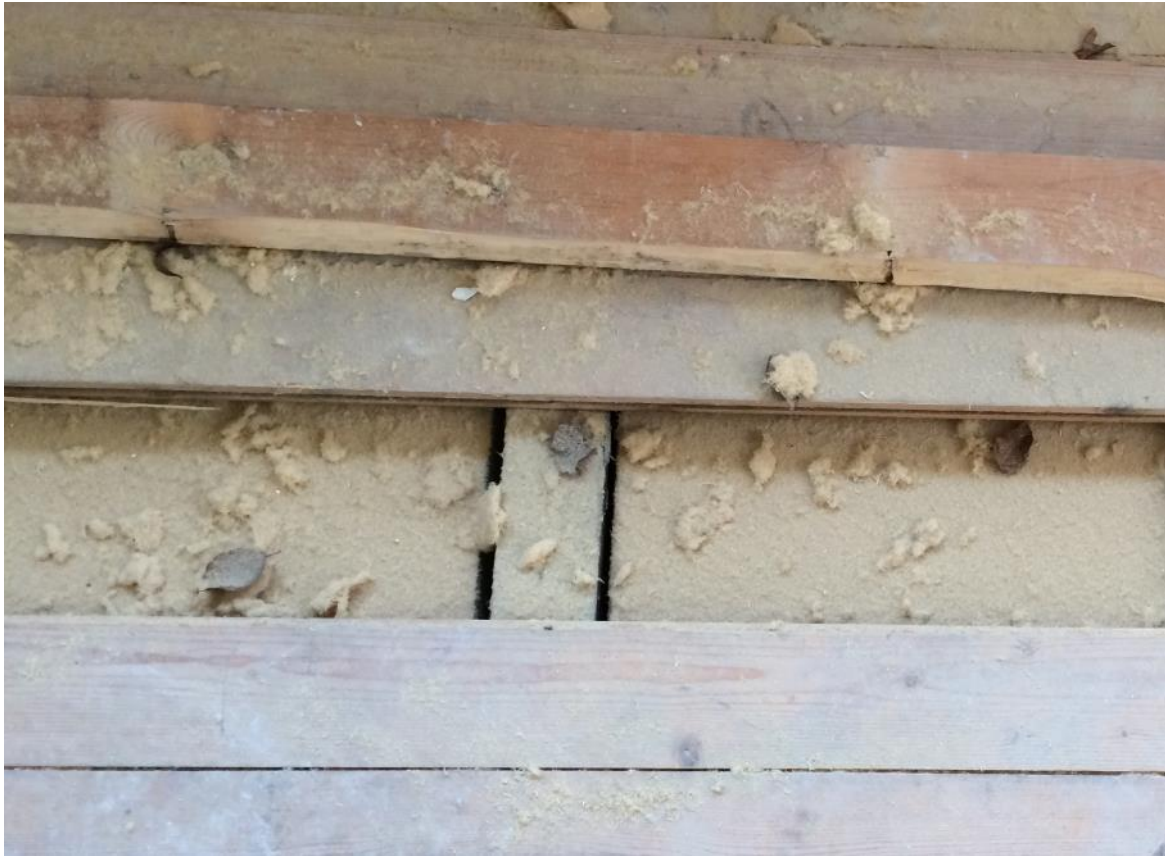
Figure 6: *Wood fibre board insulation installed between the floor joists.*

Initially there was caution as to if the floor could be lifted, upgraded, and replaced. However, a short trial lifting quickly showed that this was entirely possible. Most boards can be taken up easily once the laying sequence and the nailing pattern had been established. Careful use of a claw hammer and a pry bar resulted in limited breakages. Due to the generous solum void below, only two areas of floor were lifted, and most of the floor remained in situ. To secure the insulation batts between the joists, light timber runners were fastened to the bottom of each floor joist; a nail gun was used due to the joist spacing restricting the swing of a hammer. The insulation material was 100mm of wood fibre material. This was cut outside to the joist separation width, giving a snug, but not overly tight fit (Figure 6).

This gave considerable improvement in air control, but allowed modest air movement between the solum and the room above. The floorboards set aside were de-nailed and refastened. About 15% new floorboards were required to make good breakages and account for legacy interventions and cuts in the floor from previous works. An access panel was formed in each room for subsequent inspection of the solum void and access to services. As ventilation was being considerably reduced, especially from the solum void up the back of the wall, the proper functioning of the air bricks at the base of the external walls was checked, and any blockages removed. In some places the ground levels were lowered. Previous works included a plastic sheet, laid against the wall and covered in gravel to restrict weed growth. This was preventing the earth adjacent to the wall footing to dry out and it was removed.

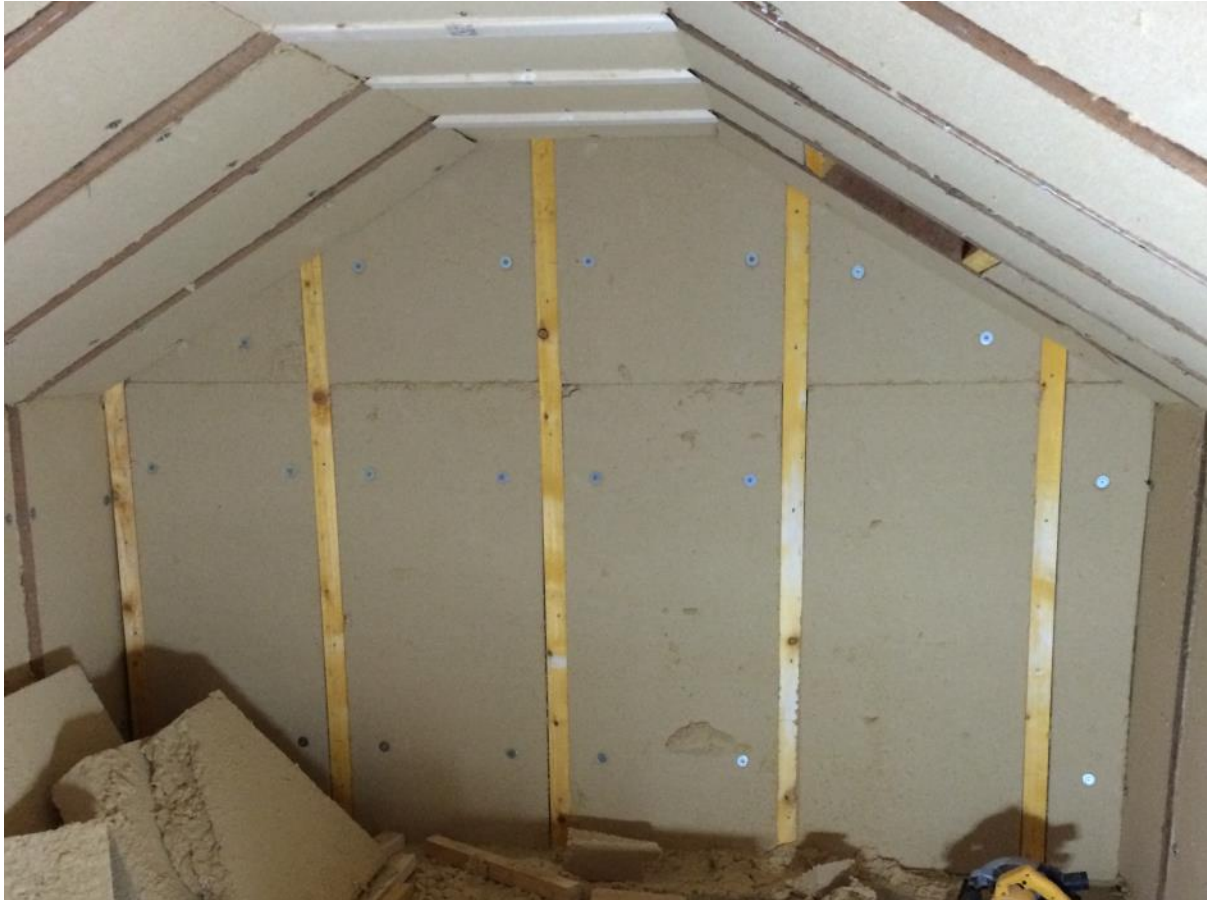
Figure 7: *The wood fibre insulation installed in the roof space*

As the Gannochy Trust cottages have no cooms, and the roof pitch is approx 45 degrees, there is ample space in the roof void. In order to provide a warm storage area for tenants spare possessions, wood fibre insulation was fitted between the vertical hangars on the sides, and to the underside of the rafters. As with the floor work, this was 100mm thick boards, mounted with timber runners fastened to the cheeks of the rafters and between the hangars (Figure 7). This geometry of

The space behind the hangars was already insulated with mineral wool; this was left in place but checked and any gaps filled. Due to the fibrous and dusty nature of the wood fibre boards they were painted with a coat of vapour permeable paint to bind the fibres and thus consolidate the surface of the material. Roof ventilation has always been an issue in many of the Trusts cottages, and the roof vent disposition was modified to allow four of the existing fittings to ventilate the cold roof space behind the insulation, and two others at the upper level to give modest ventilation to the 'warm roof' space. The success of this approach will be monitored.

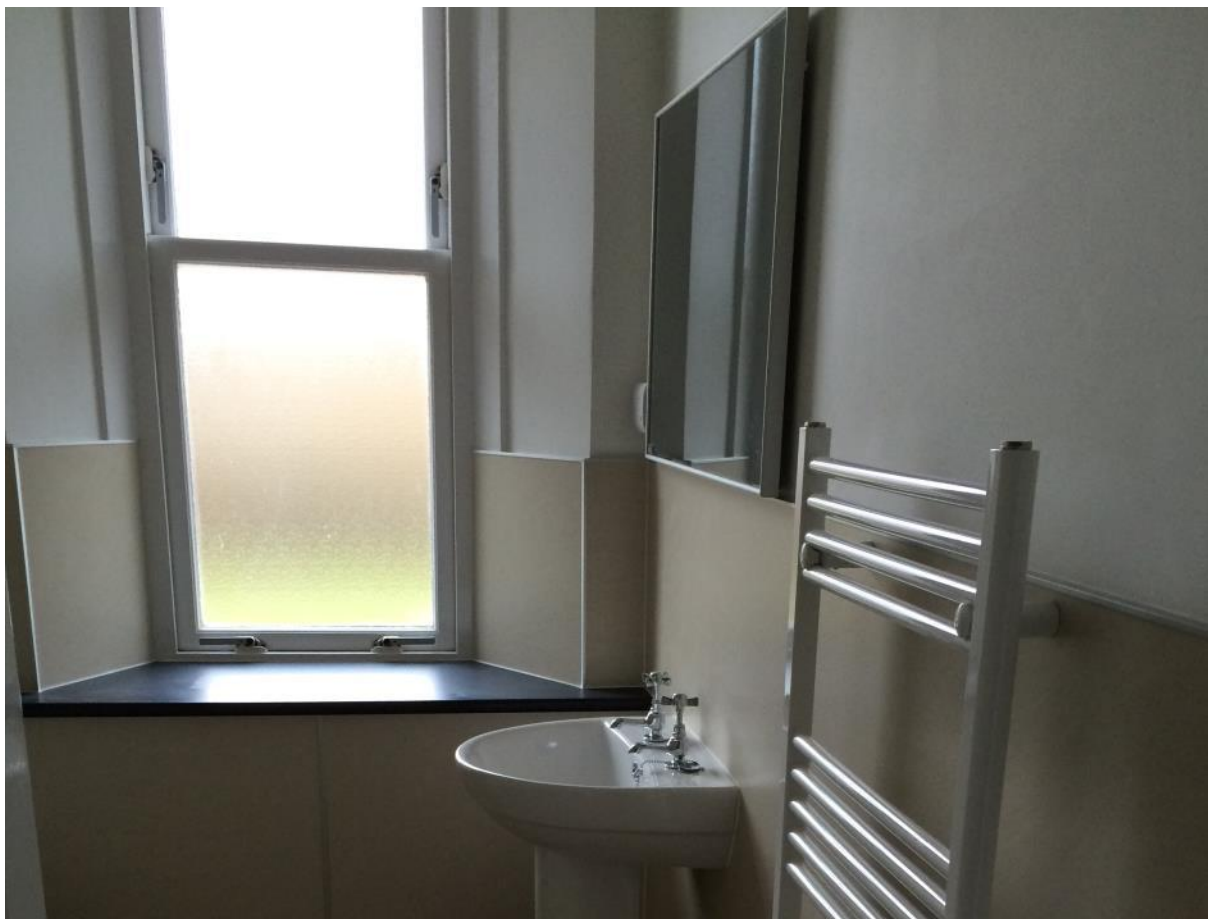
Figure 8: *The mirrored radiant panel in the bathroom.*

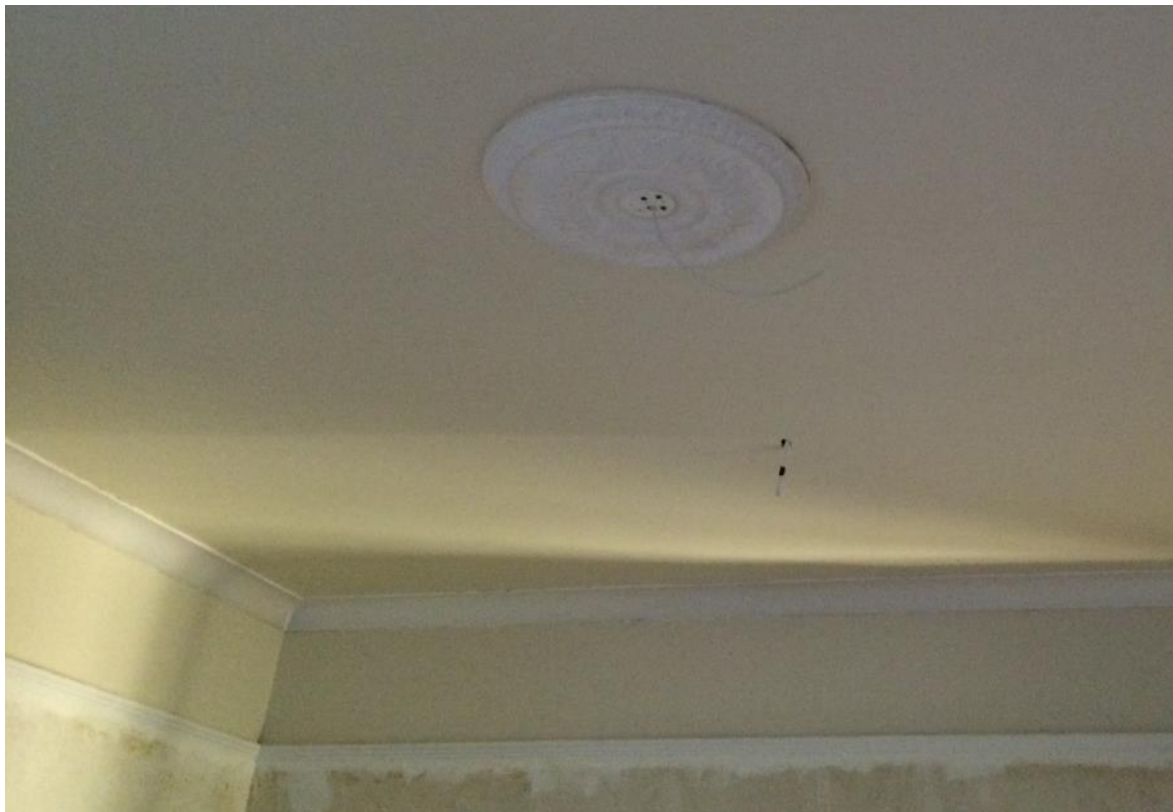
Figure 9: *Areas of completed clay paint*

With work completed on the walls and floors, redecoration was required. The walls were in a cleaned state, with all coatings removed down to bare plaster. Small holes were covered with filler. Lining paper was then applied to all walls below the picture rail to improve the wall surface and give a vapour open base for the new paint. While the exact nature of the decoration was considered a matter for the new tenants, they were consulted on colours. The cracks in some of the plaster ceilings that had caused concern were stopped with fine filler. Clay paint was used for all ceilings (Figure 9).

This type of paint is able to absorb and release the water vapour produced by occupants and other domestic activity; this is sometimes referred to as ‘humidity buffering’. While the use of such clay paint cannot replace adequate ventilation, it can assist in managing times of peak loading such as the use of showers or cooking. The picture rails were left in place, and formed a natural junction between the off

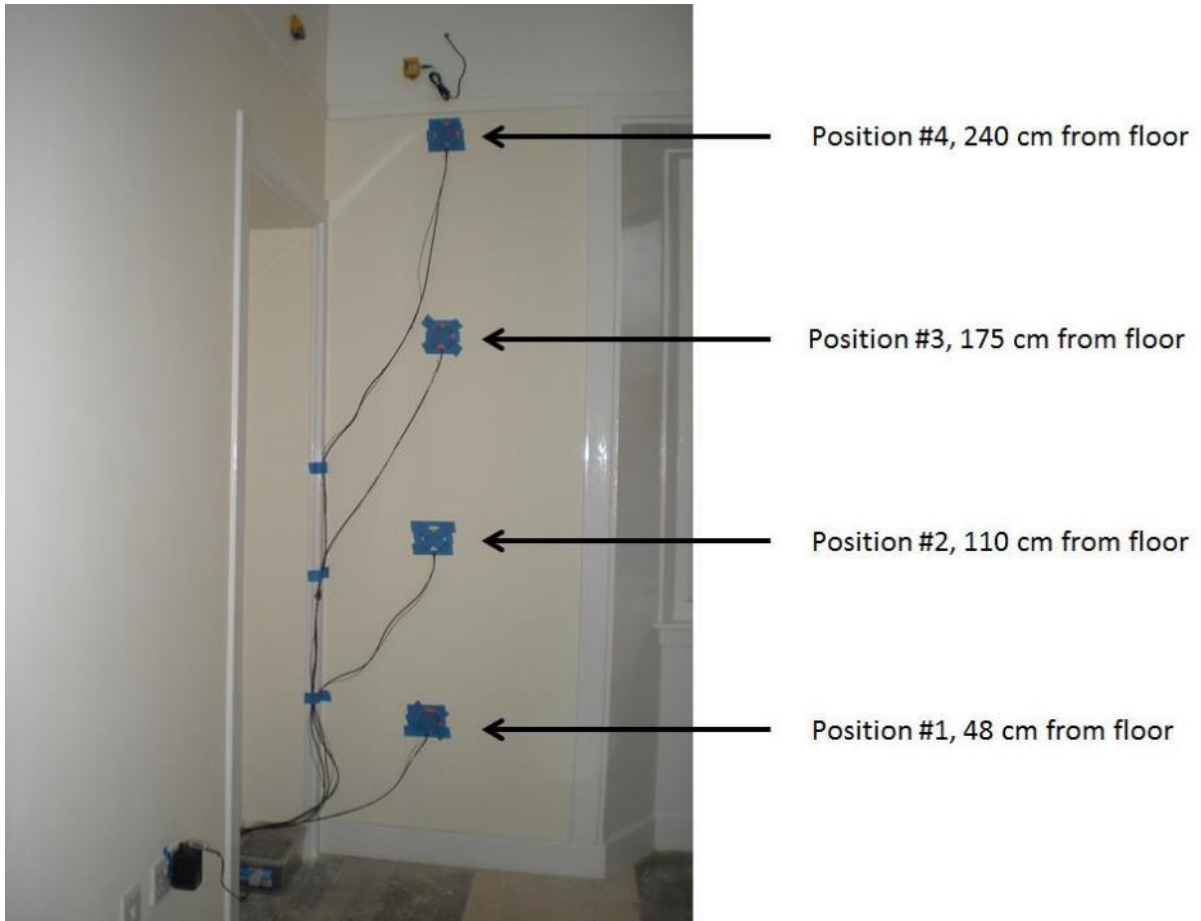
With the work complete in February 2015, there was time to conduct limited heat flux measurements in the finished building. To reach an average value 4 heat flux plates were mounted on the wall in the ground floor bedroom (Figure 10). The measurements were then compared with those taken in the autumn, and also from a similar property close by. The U-values showed good improvement in all areas and the early indications from the wall relative humidity measurements show that the foam insulation is drying out. This monitoring will have to be conducted over a 3 year period to fully assess the effects of the wall insulation. Table 2 shows these initial results.

Figure 10: The heat flux plates used to assess *u*-values in position

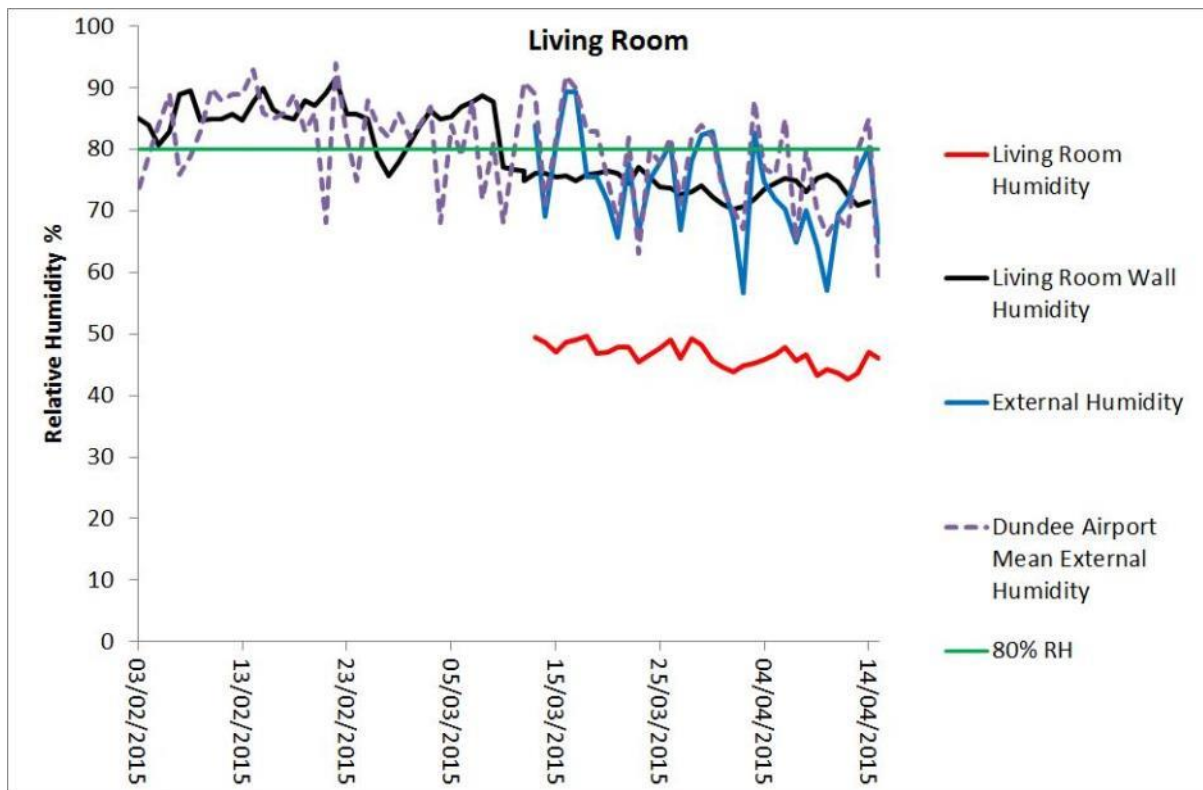
The humidity in the filled cavity behind the lath and plaster was also monitored to assess how quickly the foam insulation was drying out, and to ensure that the hygrothermal conditions in the wall were safe; while the measuring period was quite short the trend was downwards in the living room (Figure 11) and the bedroom. Longer term monitoring in this and other properties on the same estate will confirm this.

Figure 11: *The relative humidity within the living room wall after the works*

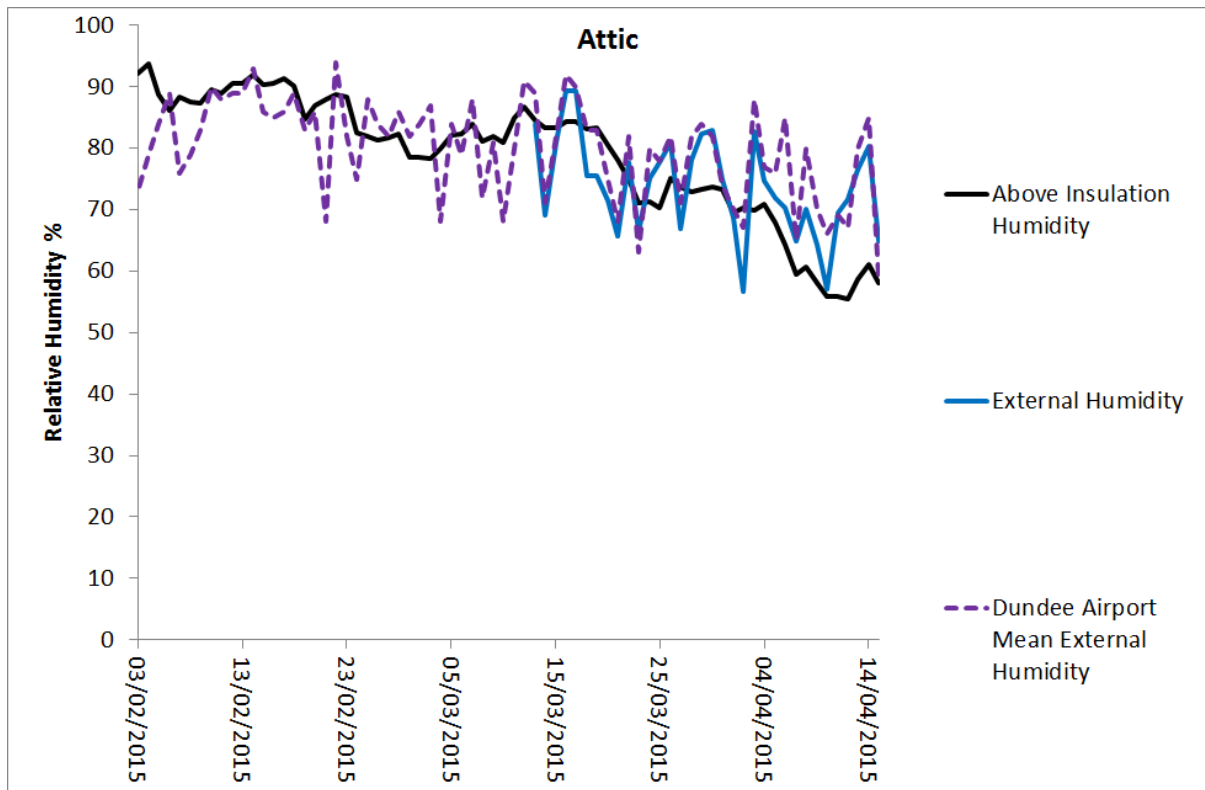
The roof space insulation was also monitored and across the woodfibre board, the air gap and through the sarking and the roof material to give a total U-value of $0.13 \text{ W/m}^2 \text{ K}$. In contrast to the walls, relative humidities remained high in the roof space in the winter months, and only reduced later in the spring of 2015 (Figure 12). This is likely to increased higher relative humidities due to a lower dew point, in turn resulting from the cooler conditions due to the insulation, and occupant driven moisture entering the roof space from a room hatch. These high humidity levels echo conditions experienced in other similar properties with partial refurbishments, and issues of defective slates cannot be entirely dismissed; a review of roof space air management will be progressed by the Trust over the next year.

Figure 12: *The relative humidity within the roof space following insulation work.*
