Tomintoul Croft, Braemar, Aberdeenshire

Inventory of Internal Elements

Version 2
August 2013

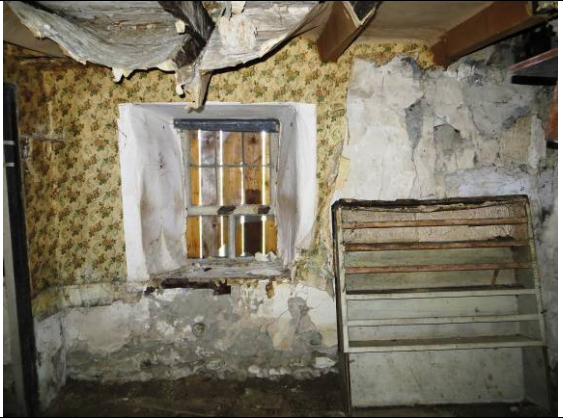
Location	Item	Retain?	Repair/adapt	Images
East room former sitting room / kitchen (Proposed Sitting Room)	Wall – North – Finishes Multiple patterned wallpaper layers on plaster on hard. Only part of the wall retains paper.	No	All finishes to be removed to allow wall consolidation and new plaster finish. Wallpaper removed after recording and sample retained.

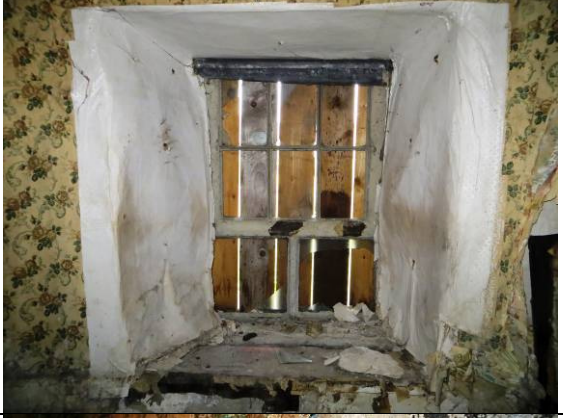
Window (W3): fixed 8-pane window; window ingoe lined in layers of wallpaper painted white; roller blind; window overpainted including layer of newspaper. Glass missing. No existing ironmongery.	Yes with adaptation	Wallpaper removed after recording; ingo masonry consolidated and plastered – consider cill detail /timber; remove roller blind; strip paint from window to access repair. Make necessary repair and adapt upper 6 panes to form side hung opening casement. Refer Window Schedule and drg no. TTL 410.

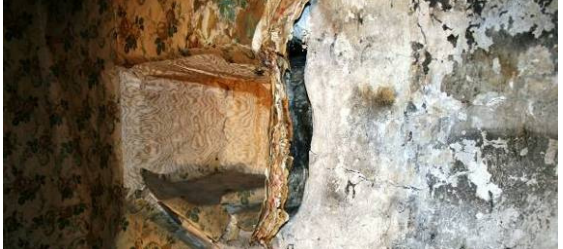
Wall - South – Finishes Multiple patterned wallpaper layers on plaster on hard. Only part of the wall retains paper.	No	As north wall.

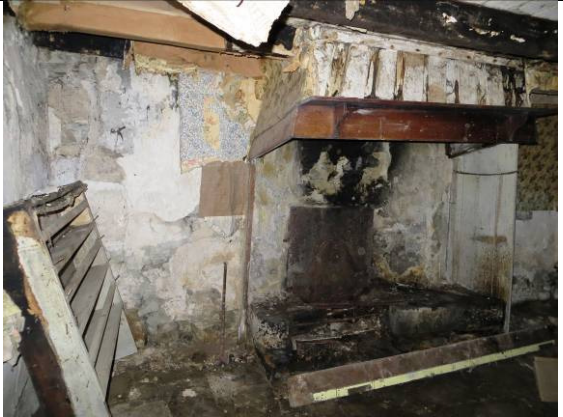
Location	Item	Retain?	Repair/adapt	Images
East room former sitting room / kitchen (cont)	Wall – South - Element small timber shelves	No	Record only	
	Wall - East – Finishes Multiple patterned wallpaper layers on plaster on hard. Only part of the wall retains paper.	No	As north wall.	Refer hanging lum image below
	Wall - East – Hanging lum Timber hanging lum flue and hood; Refer drg nos. TTL 407-8	Yes	Repair timber structure; wallpaper to exposed section above shelf to be recorded and removed.

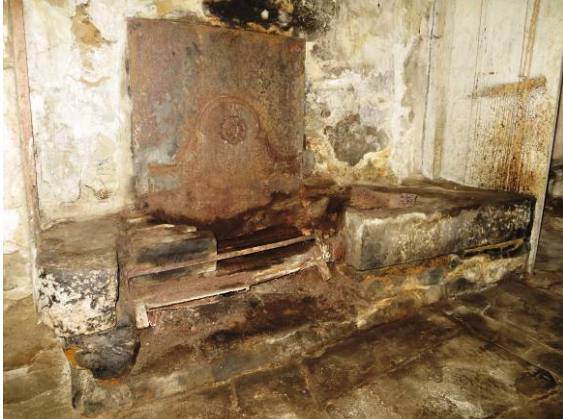
Wall - East – Hanging lum Timber shelf on 2 timber brackets and timber board trim to flue hood.	Yes	Repair	
	Wall - East – Hanging lum Timber side wall to hearth.	Yes	Repair	
	Wall - East – Hearth Cast iron wall plate with rose motif	Yes	Remove, wire brush, treat for rust and repaint; refix centred on retained granite hearth.

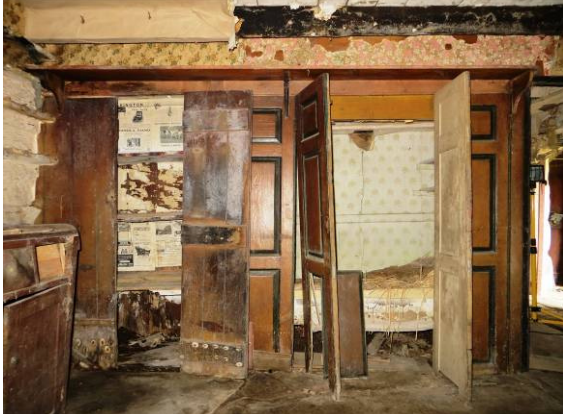
Location	Item	Retain?	Repair/adapt	Images
East room former sitting room / kitchen (cont)	Wall - West – Finishes Only exposed wall finishes above boxbed/ doors; decorative wallpaper.	TBC	Take samples presume wallpaper on timber boarding – possibly remove for repair with doors.

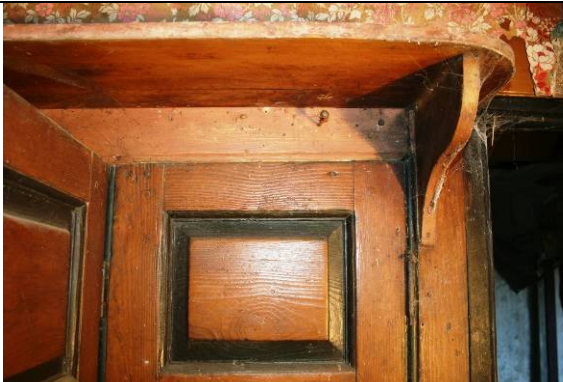
Wall - West – Box Bed Doors 2 x double fielded panelled doors (D8a-d). Finishes: dark timber stain with black detail to panels externally; white painted internally.	Yes	Repair and refinish to match existing. Bottom rail on D8b-d require to be renewed.	
	Wall - West – Cupboard 2 ledged & boarded doors (D7a & b). Finishes: dark timber stain both sides.	Yes	Repair and refinish to match existing.	Refer above image
	Wall - West – Shelf Above box bed: long timber shelf on 2 timber brackets and 1 modern metal bracket.	Yes	Refit without metal bracket and new timber support. Refer drg. nos. TTL 401-404.

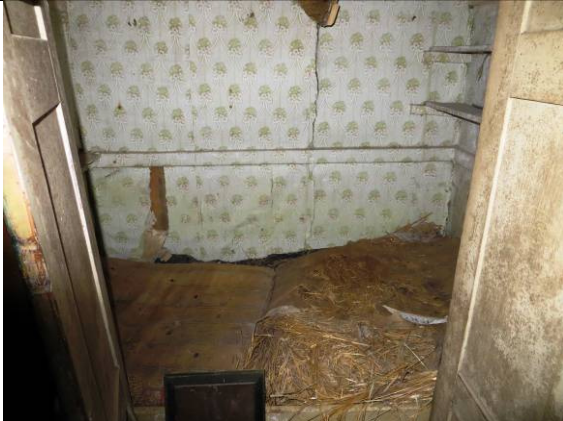
Location	Item	Retain?	Repair/adapt	Images
East room former sitting room / kitchen (cont)	Elements – Box bed Existing box bed enclosure constructed from boarded timber. Patterned wall paper finish.	Yes	Timber enclosure repaired; wallpaper removed after sample retained. New painted finish internally.

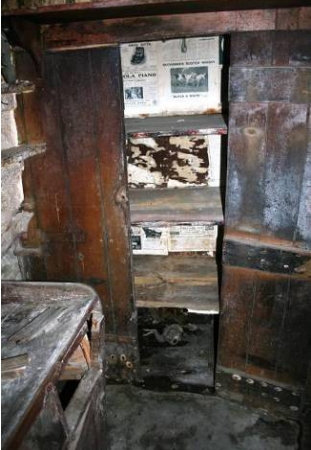
Elements – Box bed Straw mattress on rough sawn timber frame, earth floor below.	No (except timber base if possible)	New mattress; new timber floor below. Refer drg. nos. TTL 401-404.	
	Elements – Cupboard Built in store enclosure constructed from boarded timber with partial newspaper/magazine wall lining and soffit.	Yes	Paper to be recorded; poss keep sample for reuse.

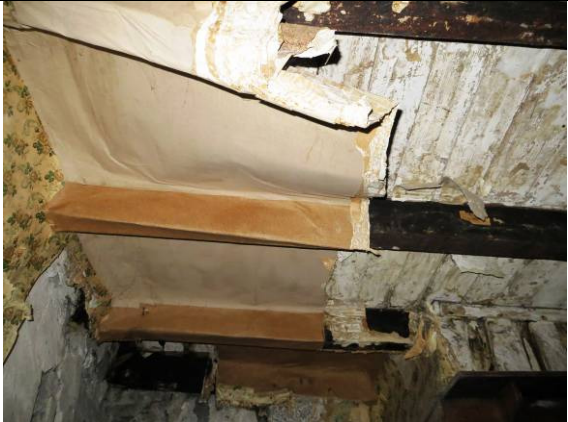
Location	Item	Retain?	Repair/adapt	Images
East room former sitting room / kitchen (cont)	Ceiling Timber joists with multiple layers of wallpaper / exposed area painted white with black timbers.	Yes	Wallpaper removed after recording; off white paint finish.

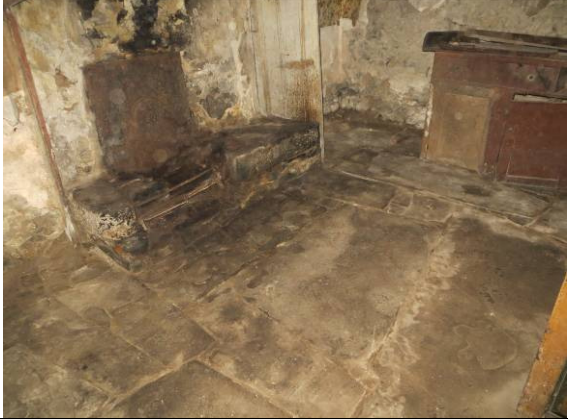
Floor Flagstone floor	Yes	Record/number prior to lifting to allow new floor construction. Reinstate flags on completion.

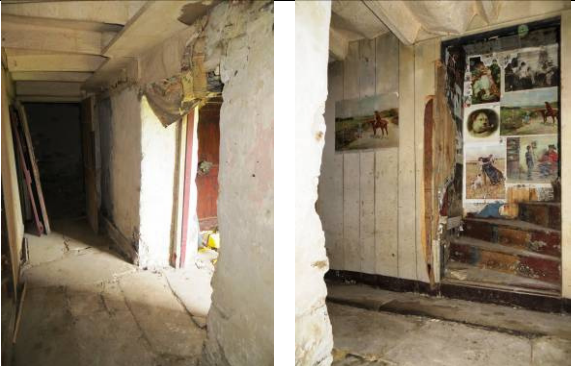
Location	Item	Retain?	Repair/adapt	Images
Hallway	Wall – North – Finishes Plaster on hard; area of patterned wallpaper above internal doors.	No	All finishes to be removed to allow wall consolidation and new plaster finish. Wallpaper removed after recording and sample retained.

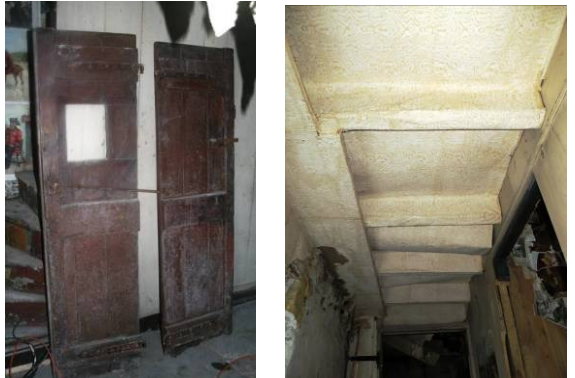
Wall – North - Door (D2a/b) Double timber ledged and boarded doors, 1 with small glazed panel (glass missing). original ironmongery including fixing brackets, door handle and lock (tbc).	Yes	Refit double doors in doorway to porch. Painted finish, colour tbc.	
	Wall – South – Element Long timber shelf	Yes?	Check condition further.

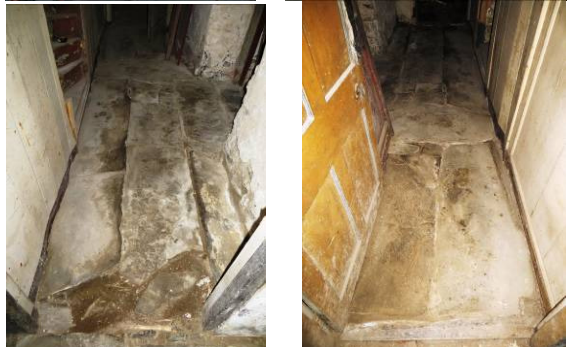
Wall – South – Doorway (D5) Original door to foot of stair (previously removed)	n/a	Reinstate with new door to match original design(details tbc after investigation). check jamb condition	
	Floor Flagstone floor	Yes	Record/number prior to lifting to allow new floor construction. Reinstate flags on completion.

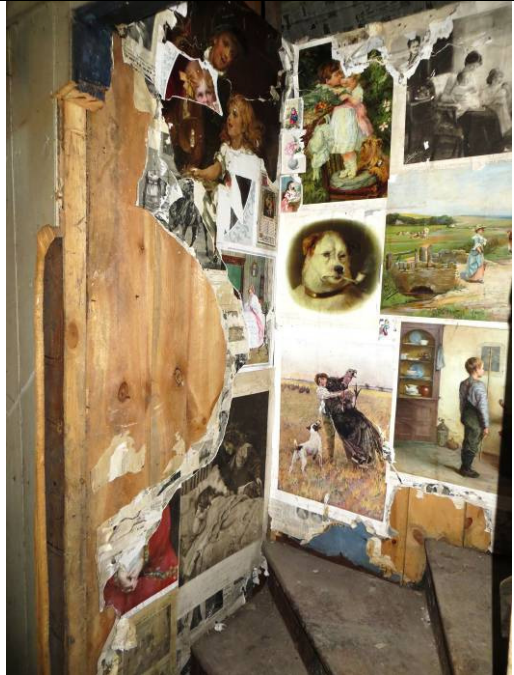
Location	Item	Retain?	Repair/adapt	Images
Staircase	Walls Historic magazine papers on timber stair enclosure.	Yes	Record and preserve insitu.

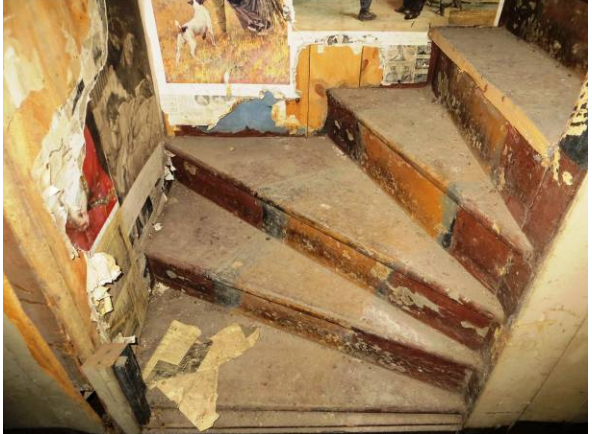
Element - Staircase Timber staircase	Yes	Retain insitu and make localised repairs.

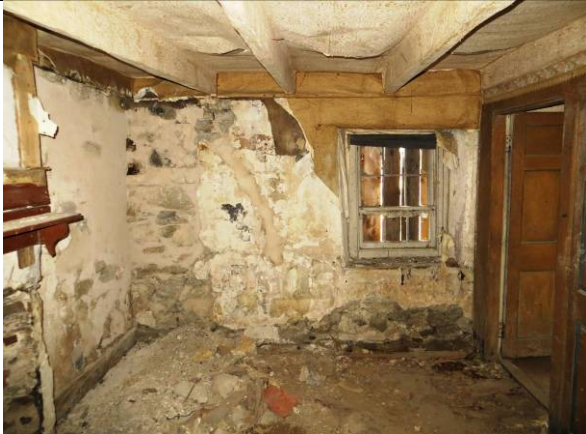
Location	Item	Retain?	Repair/adapt	Images
West room former parlour (Proposed Bedroom)	Wall – North – Finishes Multiple patterned wallpaper layers on plaster on hard. Only part on the wall retains paper.	No	All finishes to be removed to allow wall consolidation and new plaster finish. Wallpaper removed after recording and sample retained.

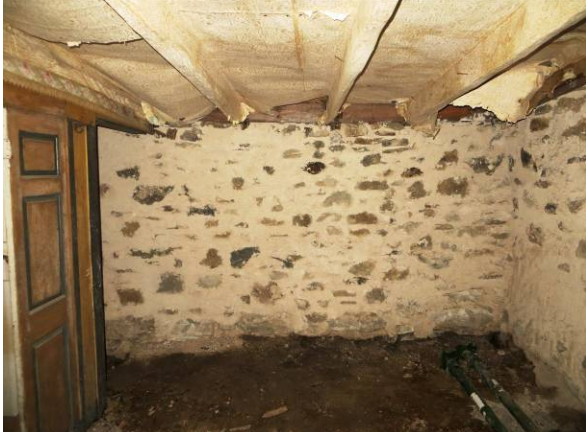
Wall – North – Window (W1) Sash & case 9-pane window; window ingoe lined in layers of wallpaper (mainly lost); roller blind; window painted white, glass missing; boarded timber cill. No existing ironmongery.	Yes with adaptation	Wallpaper removed after recording; ingo masonry consolidated and plastered – new timber cill. Remove roller blind; strip paint from window to access repair. Make necessary repair and adapt upper sash to form side hung opening casement. Refer Window Schedule and drg. no. TTL 410.	
	Wall - South – Finishes Exposed masonry repaired in 2009.	n/a	New insulated plaster finish to be applied.

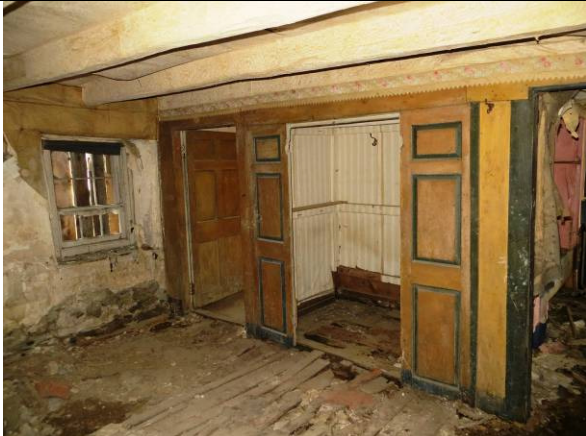
Location	Item	Retain?	Repair/adapt	Images
West room former parlour (cont)	Wall – East – Finishes Only exposed wall finishes above boxbed/ doors; decorative wallpaper.	TBC	Take samples presume wallpaper on timber boarding – possibly remove for repair with doors.

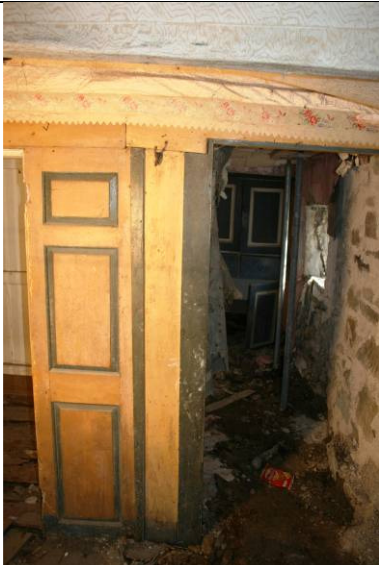
Wall – East – Door (D4) Panelled door to hallway. Finishes: timber stained to bedroom/ white painted with blue detail to hallway.	Yes	Repair & refinish to match existing; extend base to allow for new FFL (as for D3).	
	Wall – East – Box bed 2 x double fielded panelled doors (D12a-d) to box bed (1 set not insitu). Finishes: timber stain with dark blue panel detail. Note: door to rear room missing.	Yes	Repair, refit and refinish to match existing. Doors to be fixed shut to form part of wall to new bathroom. Doors to be lined on bathroom side and protected from damage. Refer drg. no. TTL 405-6.

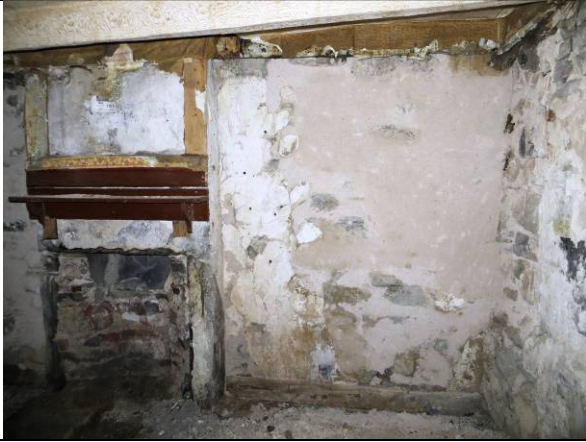
Location	Item	Retain?	Repair/adapt	Images
West room former parlour (cont)	Wall – West – Finishes LHS of fire: exposed masonry repaired in 2009. RHS of fire: exposed plaster/patched masonry.	No	All finishes to be removed to allow wall consolidation and new plaster finish.

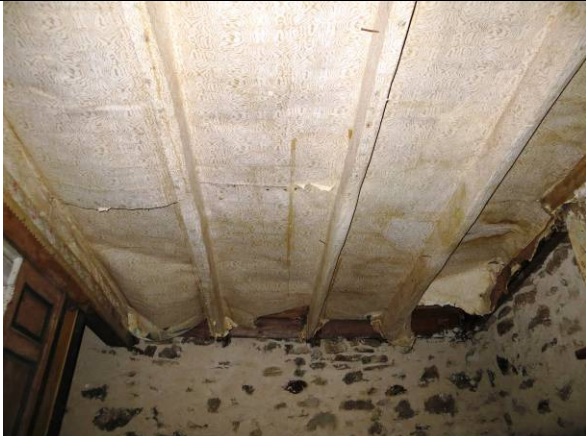
Wall – West – Fireplace stone fire surround with flagstone hearth; timber mantle shelf on timber board and timber board and wallpaper border detail to wall above,	Yes, partly	Stone fireplace repaired (tbc); flagstones lifted and relaid after new floor construction. Remove timber shelf? (tbc) Remove wallpaper detail after recording and retain sample.	
	Floor Timber boarded floor on earth (poor condition)	No	Record floor; new salvaged timber floor to match existing as close as possible (tbc) on completion of new floor construction.	Refer box bed image above.
	Floor Under box bed. Some remaining rotted timber boards on earth.	No	Record floor; area becomes part of new bathroom with new timber floor.	Refer box bed image above.

Ceiling: timber joists with multiple layers of wallpaper.	Yes	Wallpaper removed after recording; off white paint finish.

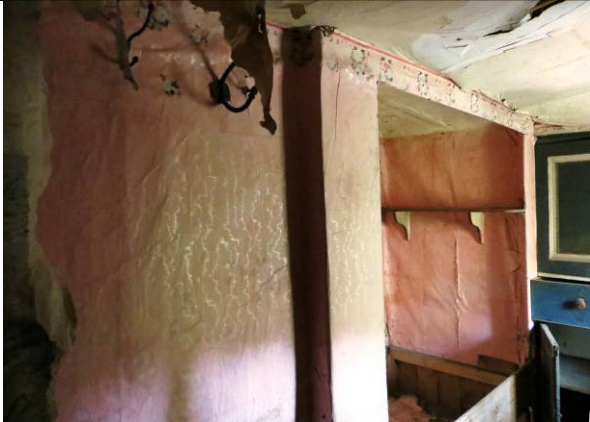
Location	Item	Retain?	Repair/adapt	Images
South room rear box bed (proposed bathroom)	Wall – North – Finishes Multiple patterned wallpaper layers on timber boards.	No	Walls removed as part of new bathroom adaptation. Wallpaper removed for recording.

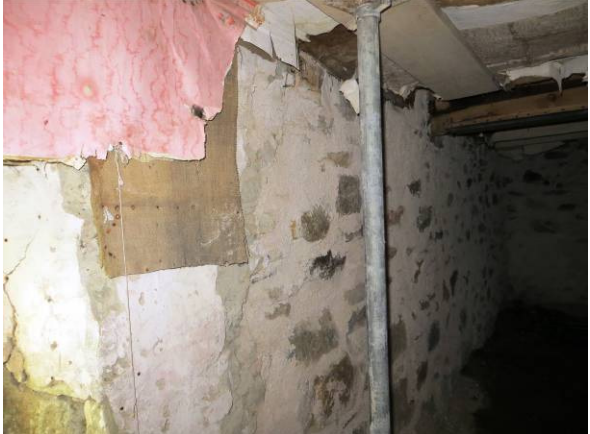
Wall – North – Box Bed Existing box bed enclosure constructed from boarded timber. Patterned wall paper finish. Timber floor. Bed not existing only front board.	No	Timber enclosure recorded and removed including wallpaper and floor. Area forms part of new bathroom.	
	Elements – Box Bed small timber shelf on brackets	No	Record only.	
	Wall – South – Finishes Multiple patterned wallpaper layers on plaster on hard. Only part of the wall retains paper.	No	All finishes to be removed to allow wall consolidation and new plaster finish. Wallpaper removed after recording and sample retained.

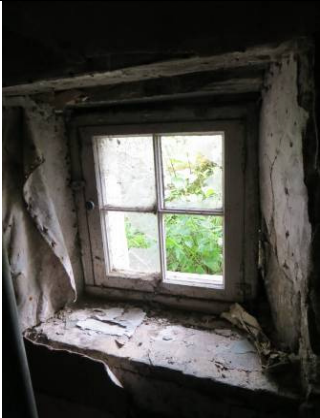
Location	Item	Retain?	Repair/adapt	Images
South room (cont)	Wall – South – Window (W4) 4 pane casement, no glass, knob, hinges and timber catch; timber cill (tbc); painted white.	Yes	Wallpaper removed after recording; ingo masonry consolidated and plastered. Timber cill detail tbc; strip paint from window to access condition, repair and repaint.

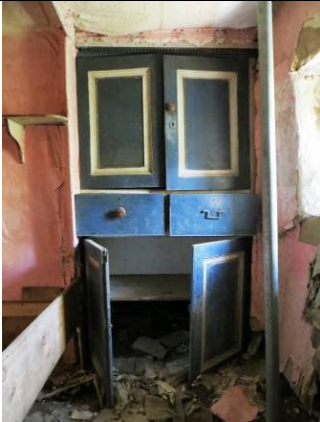
Wall – East – Dresser Timber dresser forming the rear of the cupboard in the sitting room. Double fielded panel doors to upper and lower cupboards and 2 drawers. Timber dentil detail/cornice. 3 shelves, 2 door knobs and brass handle. Finish: painted dark blue with white detailing.	No, possible reuse elsewhere.	Record and set aside.

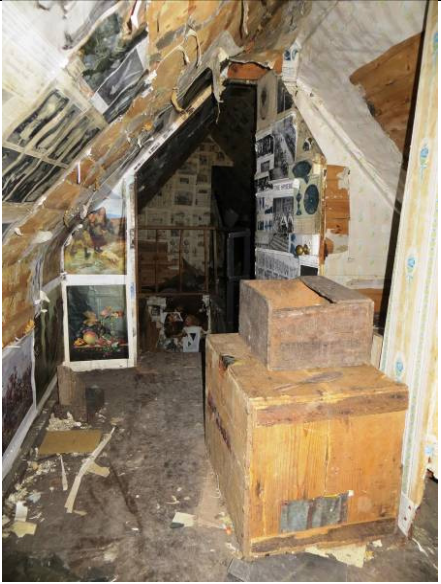
Location	Item	Retain?	Repair/adapt	Images
Attic	Wall/Soffit – North – Finishes Historic magazine papers	Yes	Only essential consolidation. Refix area of loose lining boards.

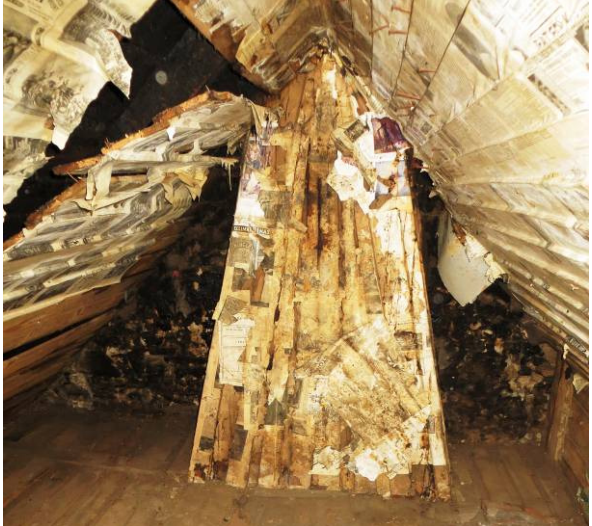
Wall / Soffit – South – Finishes Historic magazine papers	Yes	Only essential consolidation.	
	Wall – South – Box Bed 2 existing box bed enclosures constructed from boarded timber. Patterned wall paper finish (some historic magazine pages). Timber boards for bed base and front. Small timber shelf on brackets	Yes	Only essential repairs.	
	Elements - Box bed Walls & roof soffit lining in historic newsprint.	Yes	Only essential consolidation.	
	Elements – Door to Box bed area Door covered in historic newsprint	Yes	Only essential consolidation.	
	Wall – East – Finishes Masonry.	Yes	Check condition of masonry and consolidate.

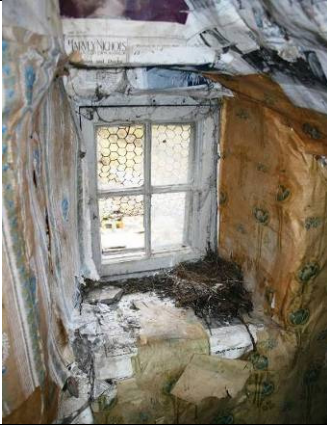
Location	Item	Retain?	Repair/adapt	Images
Attic (cont)	Wall – West – Finishes Multiple layers of wallpaper and some newspaper cut outs over masonry.	Yes	Check condition of masonry but maintain paper insitu.

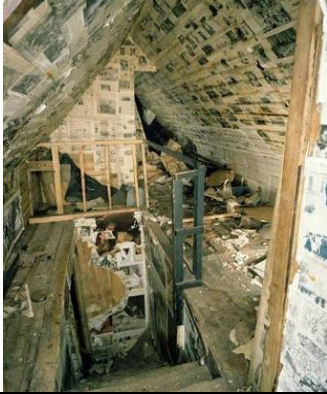
Wall – West – Window (W6) 4 pane casement painted white. No glass.	Yes	Repair and adapt to allow ventilation of the attic space; vent method tbc.	
	Element - Stair handrail	No?	Replacement tbc. New trap door to be fitted.

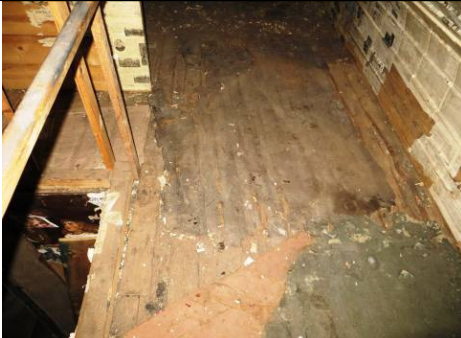
Floor Timber boarded floor with layers of mixed linoleum in poor condition.	Yes in part	Remove old linoleum. Existing timber floor to be overlaid in fibre board insulation.

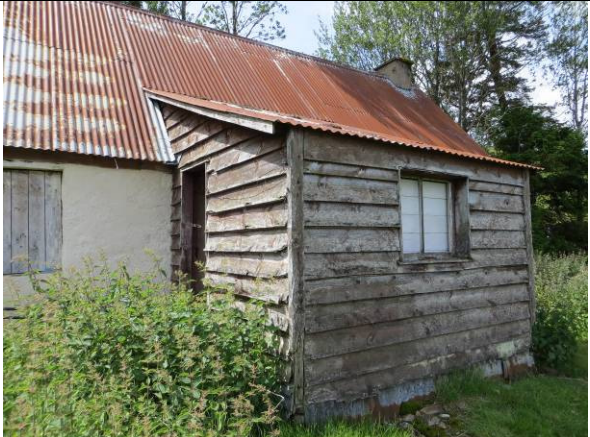
Location	Item	Retain?	Repair/adapt	Images
Porch	General Structure Timber boarded porch with external lapped weather boards	Roof only	Porch to be taken down and new build insulated construction built to replicate existing external appearance. Existing roof to be retained and propped during reconstruction. Timber framing may be retained if found to be in sound condition.

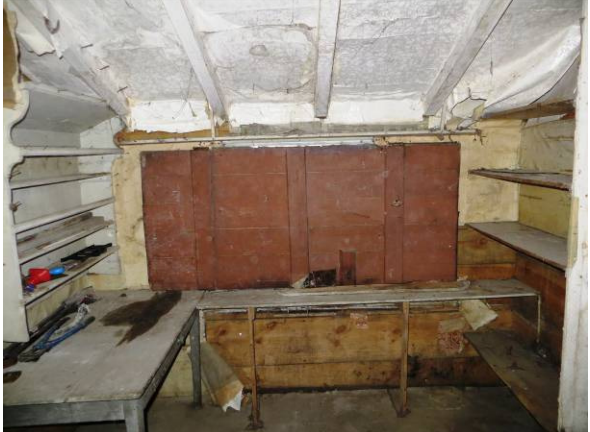
Wall – North – Finishes Timber board, some wallpapers remaining.	No	Record only.

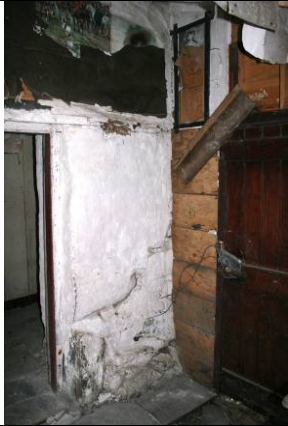
Location	Item	Retain?	Repair/adapt	Images
Porch (cont)	Wall – South – Finishes External masonry wall with painted finish; some historic newspaper cut outs above badly damaged/ removed.	Yes in part.	External wall of bothy repaired and repainted.

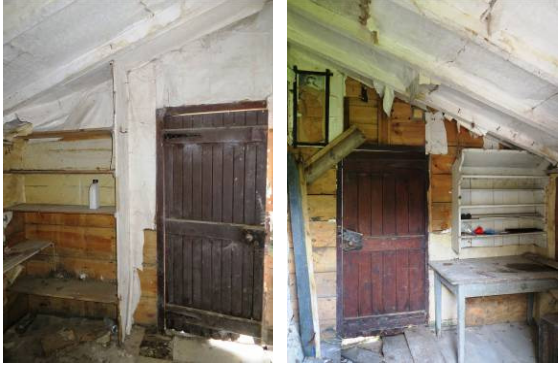
Wall – East – Finishes Multiple layers of wallpaper on timber boards. Small return to door and shelves.	No	Record only.

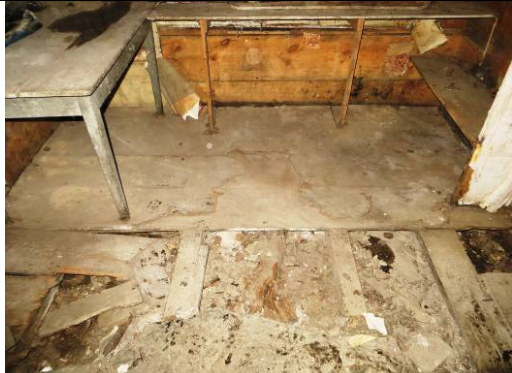
Location	Item	Retain?	Repair/adapt	Images
Porch (cont)	Floor Timber floor on earth, in poor condition.	No	Replace with granolithic floor.

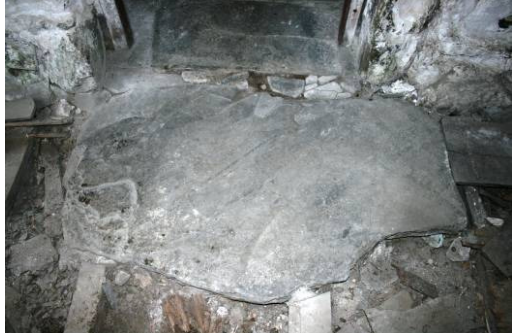
Floor Flagstone platt to main bothy entrance	Yes	Retain, may require to be lifted to accommodate new floor construction and relaid.

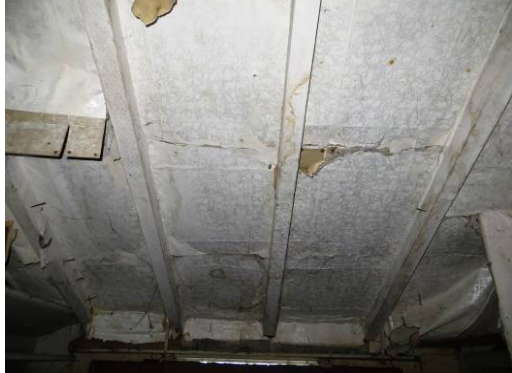
Ceiling Multiple layers of wallpaper on timber joists.	No	But roof to be retained
