Post-intervention monitoring of 11 Annat Road, Gannochy Trust Estate

Dr Paul Baker

November 2018

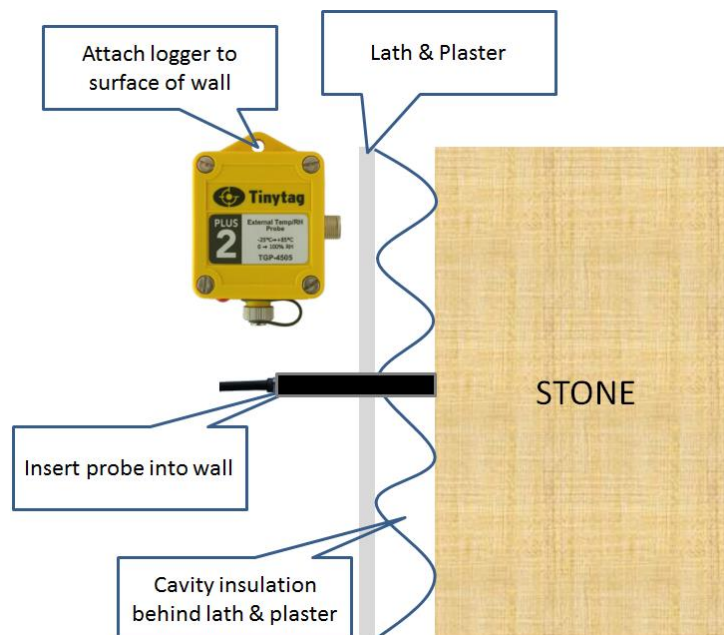
A modified Gemini Tinytag temperature and humidity probe (TGP 4505) is inserted through the lath and plaster and insulation until it reaches the masonry (Figure 1).

Figure 1: Schematic diagram showing location of Tinytag probe in wall.

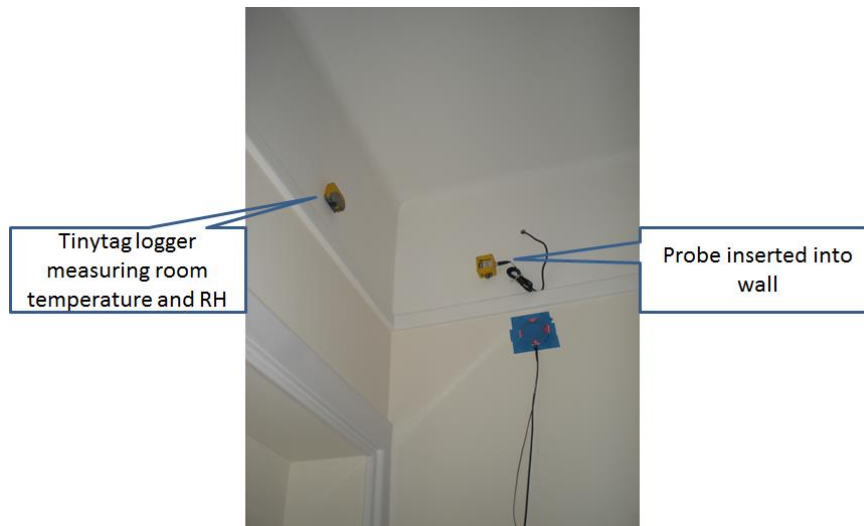
A probe was inserted into the N-W facing gable wall under the gable window in the living room whilst work was still in progress on the house on 2 February 2015. A second probe was inserted in the S-E gable wall above the picture rail in the main bedroom on 12 March 2015 (Figure 3). Tinytag loggers for measuring room conditions and the external temperature/RH sensor were also installed on 12 March.

Figure 3: To right of photograph probe inserted into wall above picture rail. To left Tinytag logger for measuring room conditions.

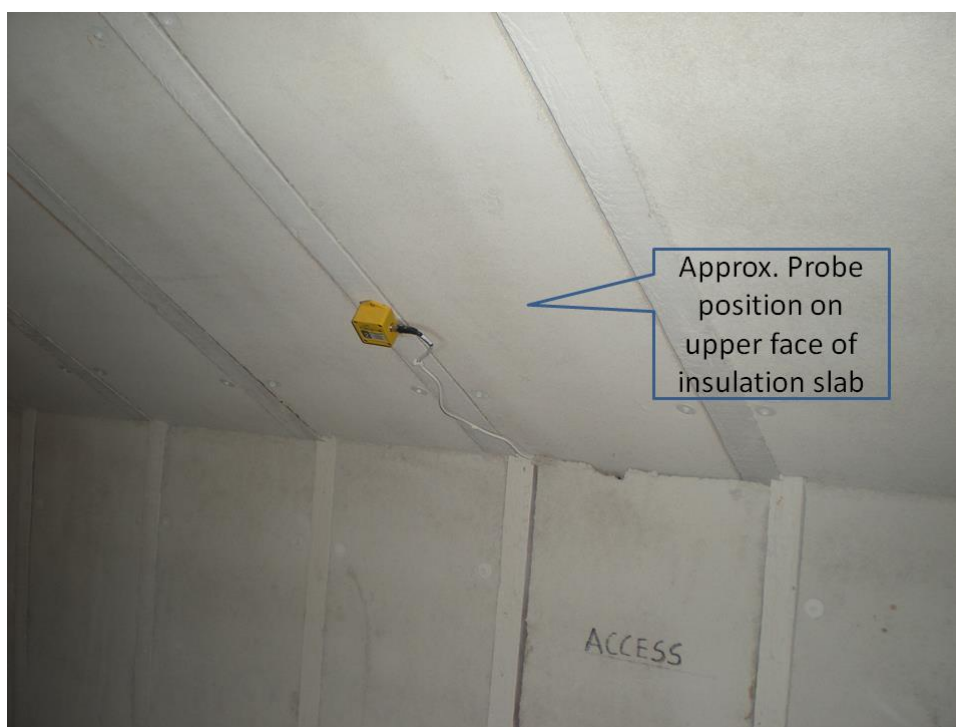
A probe was also positioned above a slab of the woodfibre insulation in the loft (Figure 4) on 2 February 2015.

Figure 4: Location of temperature/RH probe above insulation slab in attic.

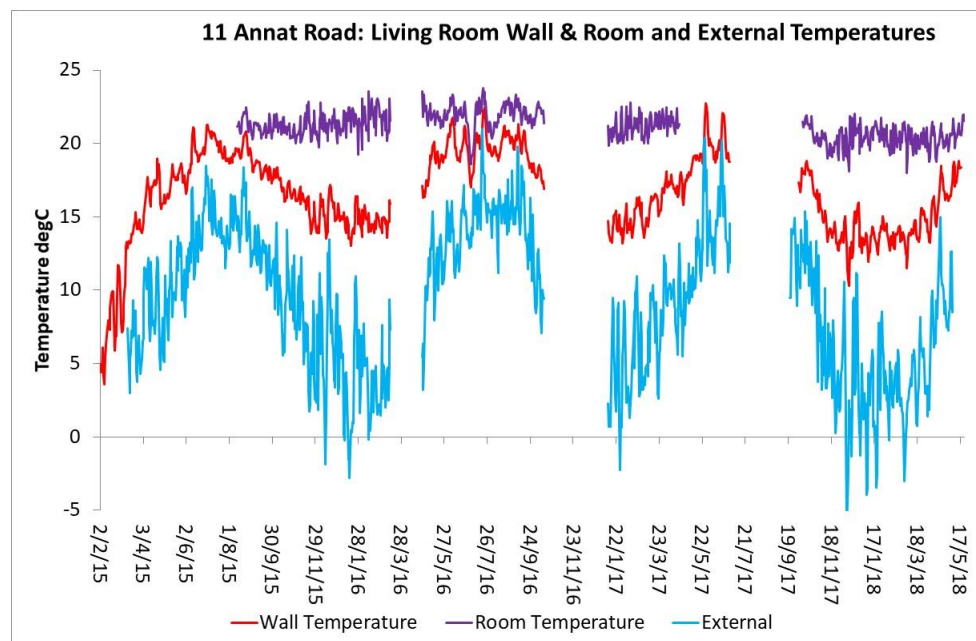
Figure 5: Living room, wall probe and external temperatures.

During the heating season, the difference between the room and wall probe temperatures confirms that the insulation installed behind the plaster is effective (Figure 5).

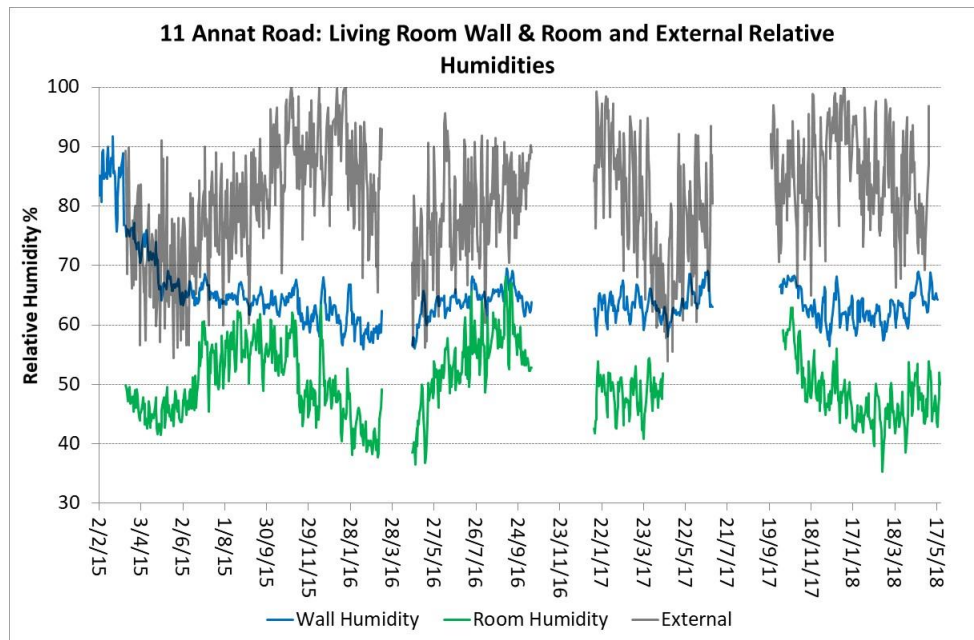
Figure 6: Living room, wall probe and external Relative Humidities.

Figure 6 indicates that after installation there is a period of high humidities, probably due to drying out of the Icynene insulation and unheated room conditions. However, after the heating system had become operational and tenants had moved in the humidities fall to safe levels below 70%RH. The critical level for interstitial RH is generally taken as 80%, above which there is potential for timber decay for long periods of exposure.

Monitoring of humidity within the walls indicate safe levels of humidity throughout the monitoring period after an initial period of high humidity following the injection of Icynene, which is applied wet.

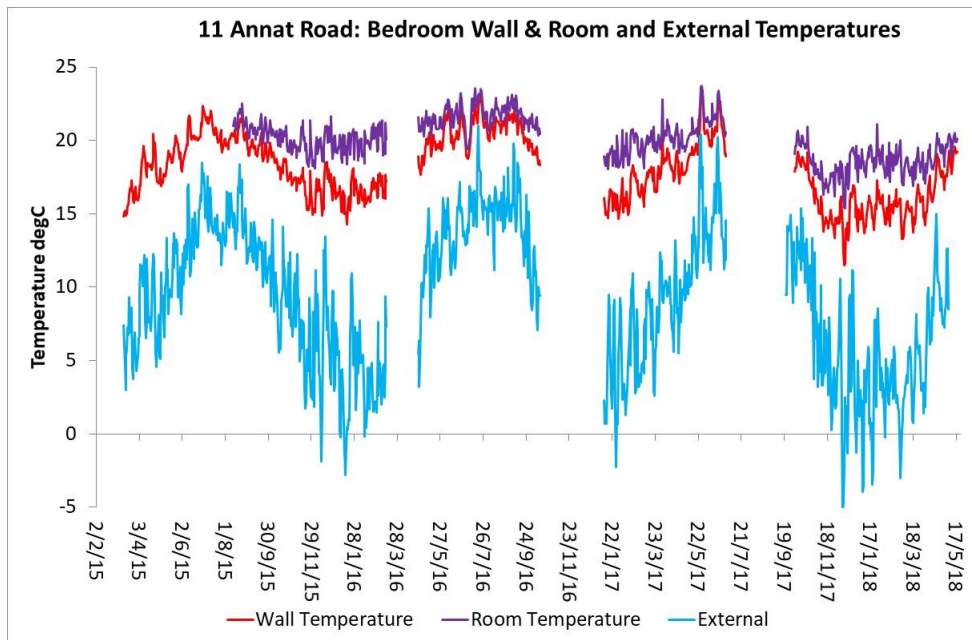
Figure 7: Bedroom, wall probe and external temperatures.

In the ground floor bedroom, where monitoring only began with heating operational, the humidity levels in the wall are safe (Figure 8). The difference between the room and wall probe temperatures during the heating season confirms that the insulation installed behind the plaster is effective (Figure 7).

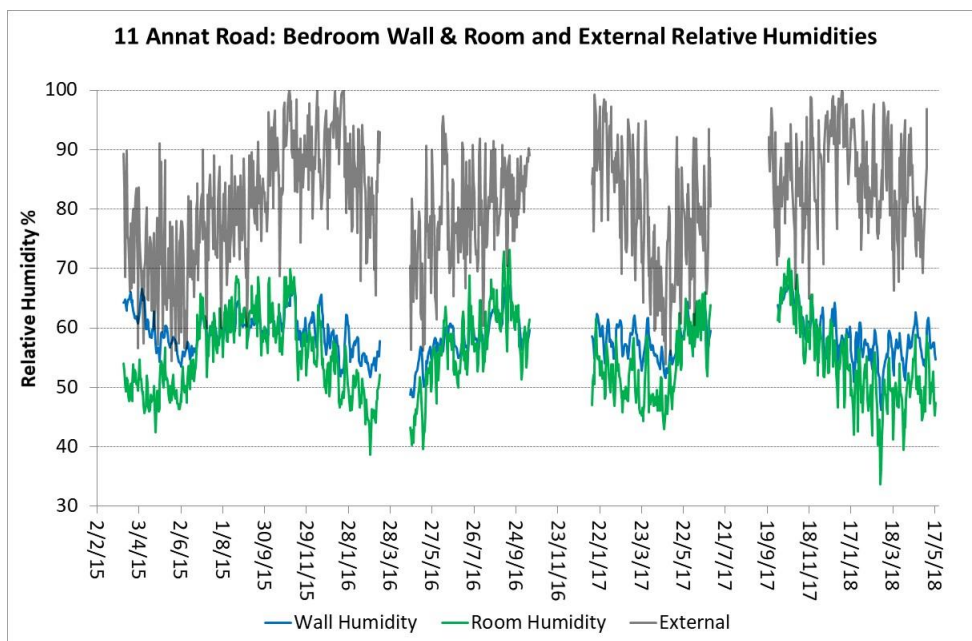
Figure 8: Bedroom, wall probe and external Relative Humidities.

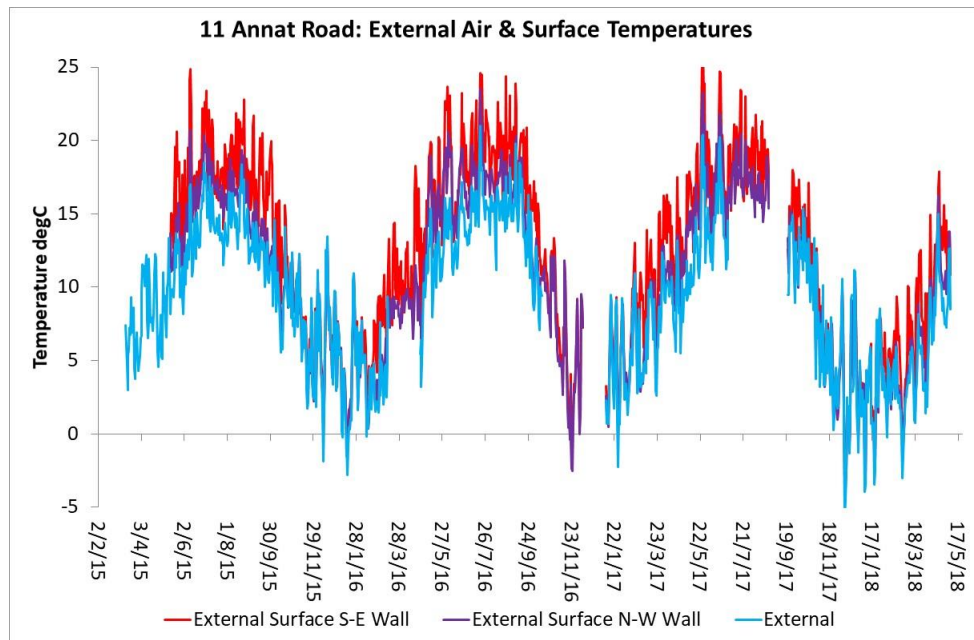
Figure 9: External surface temperatures measured on the S-E and N-W gable walls and the external air temperature.

Figure 9 indicates that the S-E gable (bedroom) benefits more from solar gains in the spring and summer periods than the N-W elevation. During winter there is little difference between the surface and external air temperatures. The increased external surface temperature on the bedroom wall may help lower the humidity at the interface between the stone and the insulation compared with the N-W gable of the living room, despite the bedroom conditions being more humid than the living room.

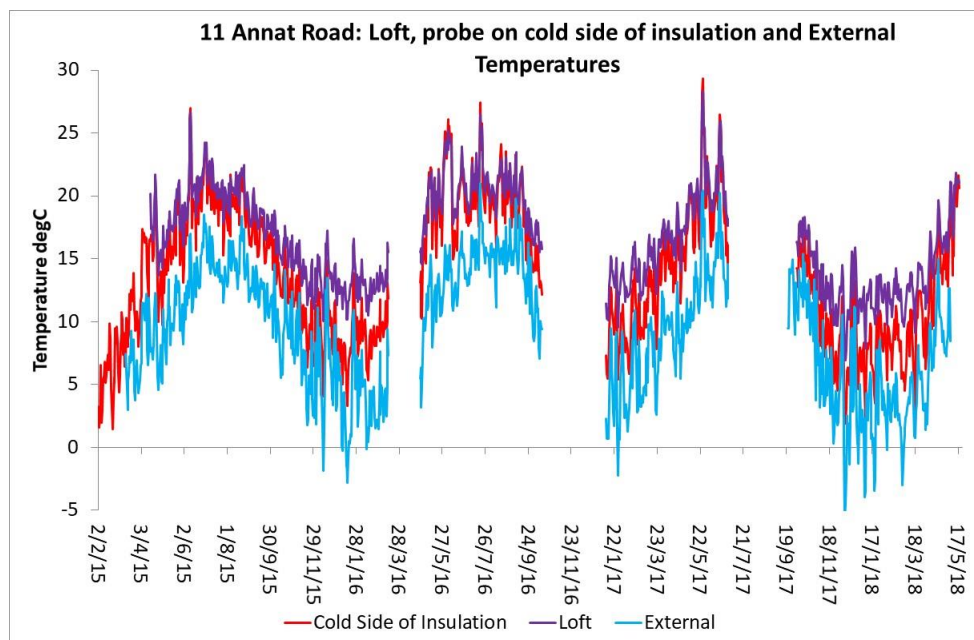
Figure 10: Loft, probe on cold face of insulation and external temperatures.

The probe temperatures and RHs tend to follow the loft conditions in spring and summer, but probe temperatures fall and humidities rise in autumn and winter. Relative humidities on the cold side of the insulation tend to peak and exceed 80% during winter for short periods. Calculating the moisture content of the air in the loft, above the insulation and the exterior (Figure 12) indicates that air moisture content above the insulation is lower than the exterior during spring and summer, however it tends to be higher than the external moisture content during autumn and winter and is closer to the loft air moisture content. These results suggest that the woodfibre tends to buffer moisture: accumulating moisture in the autumn and winter and releasing it during spring and summer.

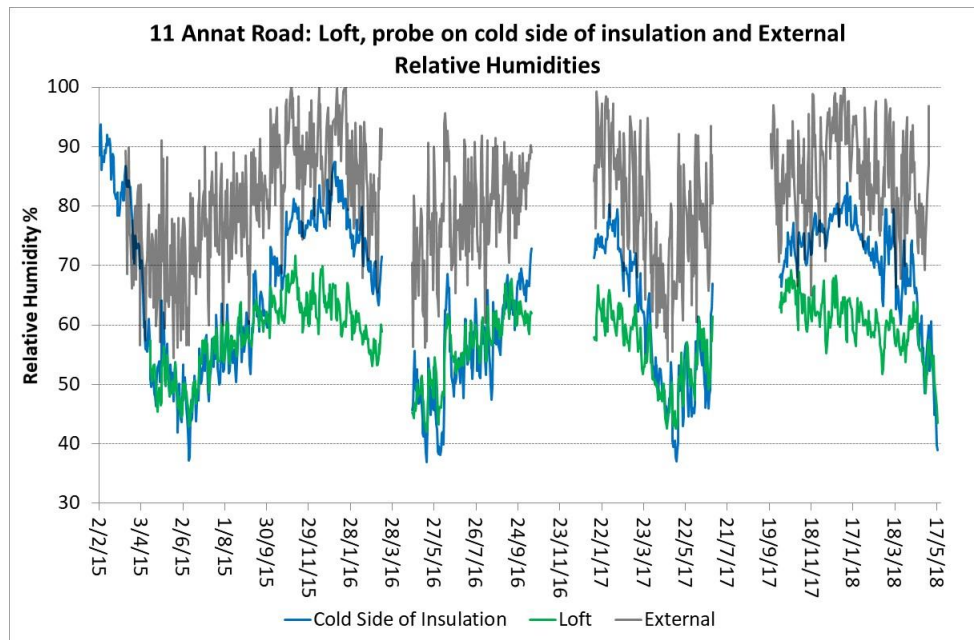
Figure 11: Loft, probe on cold face of insulation and external Relative Humidities.

Some periods of high humidity greater than 80%RH occur on the cold side of the loft woodfibre insulation mounted between the rafters, however calculations of air moisture contents indicate that the woodfibre may be acting as a moisture buffer. It is recommended that the moisture content of the woodfibre is measured seasonally and its condition assessed by visual inspection.

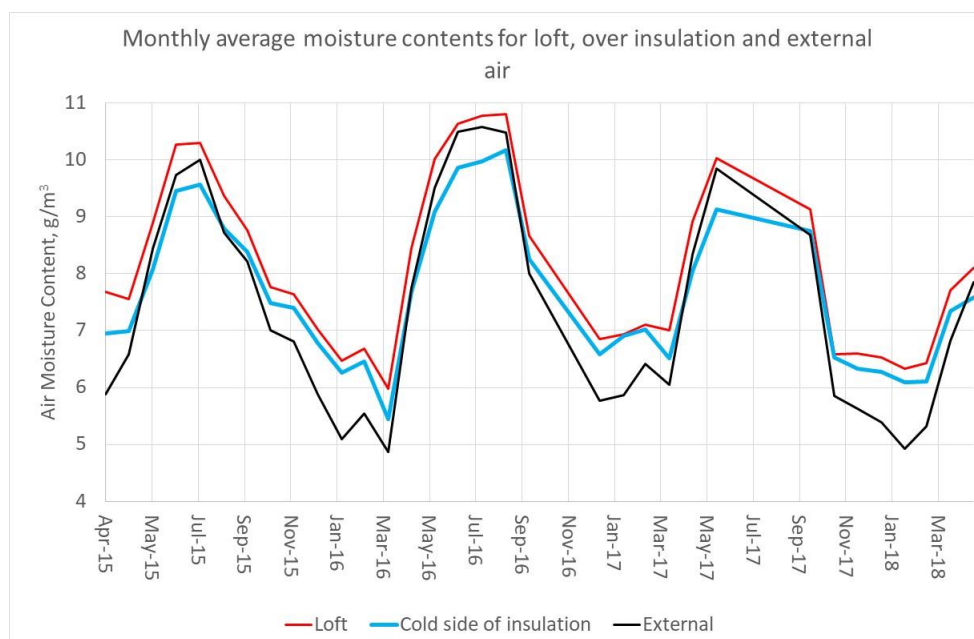
Figure 12: Monthly average air moisture contents in loft, cold side of insulation and exterior.

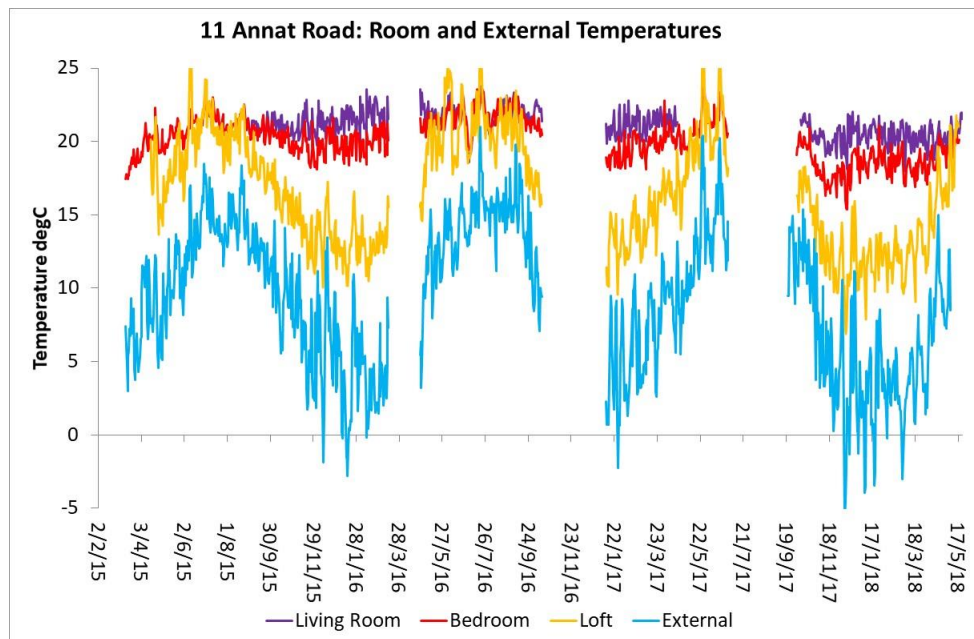
Figure 12: Comparison of loft, living room, bedroom and external temperatures

Figure 13 indicates that whilst the attic space is always warmer than outside, during the heating season it is significantly colder than the ground floor rooms. Heat is therefore lost from the ground floor to the loft space; however, the roof insulation will reduce the heat loss compared to the previous situation with no insulation. It could be argued that insulation at the ceiling level of the ground floor would be a better option than the roof insulation; however, the warmer and drier attic conditions are more suitable for storage.

The roof insulation will reduce the heat loss compared to the previous situation with no insulation. Insulation at the ceiling level of the ground floor would be a better option to reduce overall heat loss from the dwelling; however, the warmer and drier attic conditions resulting from the woodfibre between rafters are more suitable for storage.

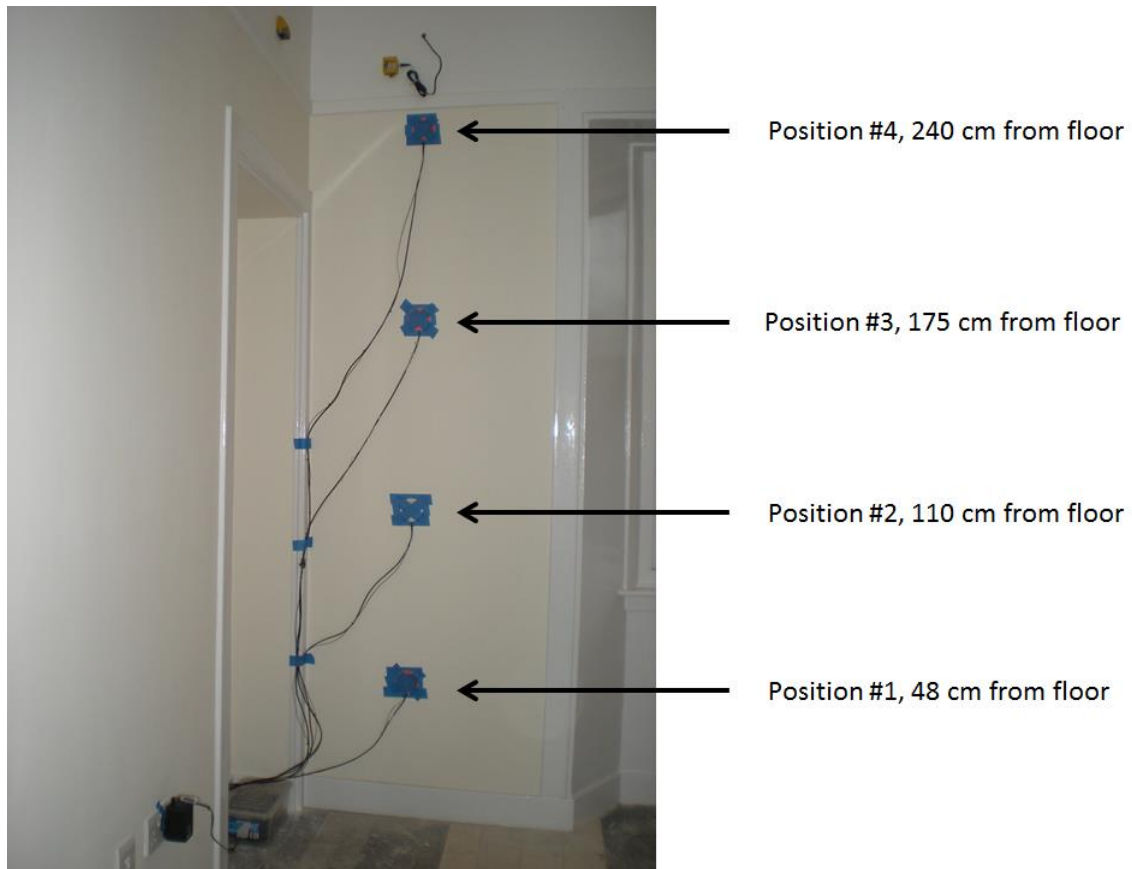
Figure 3: Position of sensors on gable wall of bedroom - locations on the gable wall of the ground floor bedroom were chosen to enable a profile to be measured up the wall.

U-value (W/m ² K)
Position#1	0.43
Position#2	0.35
Position#3	0.39
Position#4	0.48
Average	0.41

Whilst there is a variation in the U-values in the profile with a standard deviation of 0.05 W/m²K (i.e. about $\pm 13\%$ about the average value of 0.41 W/m²K, the U-values represent a significant improvement compared to the uninsulated property.

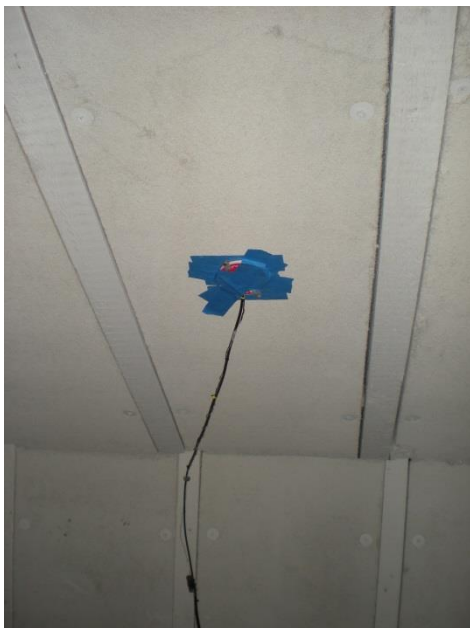
Figure 15: Loft Coombe

U-value (W/m ² K)
Loft Coombe	0.13
Loft Wall	0.15

U-value (W/m ² K)
Loft Coombe (insulation only)	0.42
Loft Wall (insulation only)	0.50
