## **Ansitz Kofler in Bolzano/Italy: Energy retrofit to near passive house standard and towards zero emission for heating and cooling.**

Alexandra Troi\*, Hannes Mahlkecht, Margherita Rametta, Roberto Lollini  
Institute for Renewable Energy, EURAC research, Bolzano/Italy  
e-mail: Alexandra.troi@eurac.edu

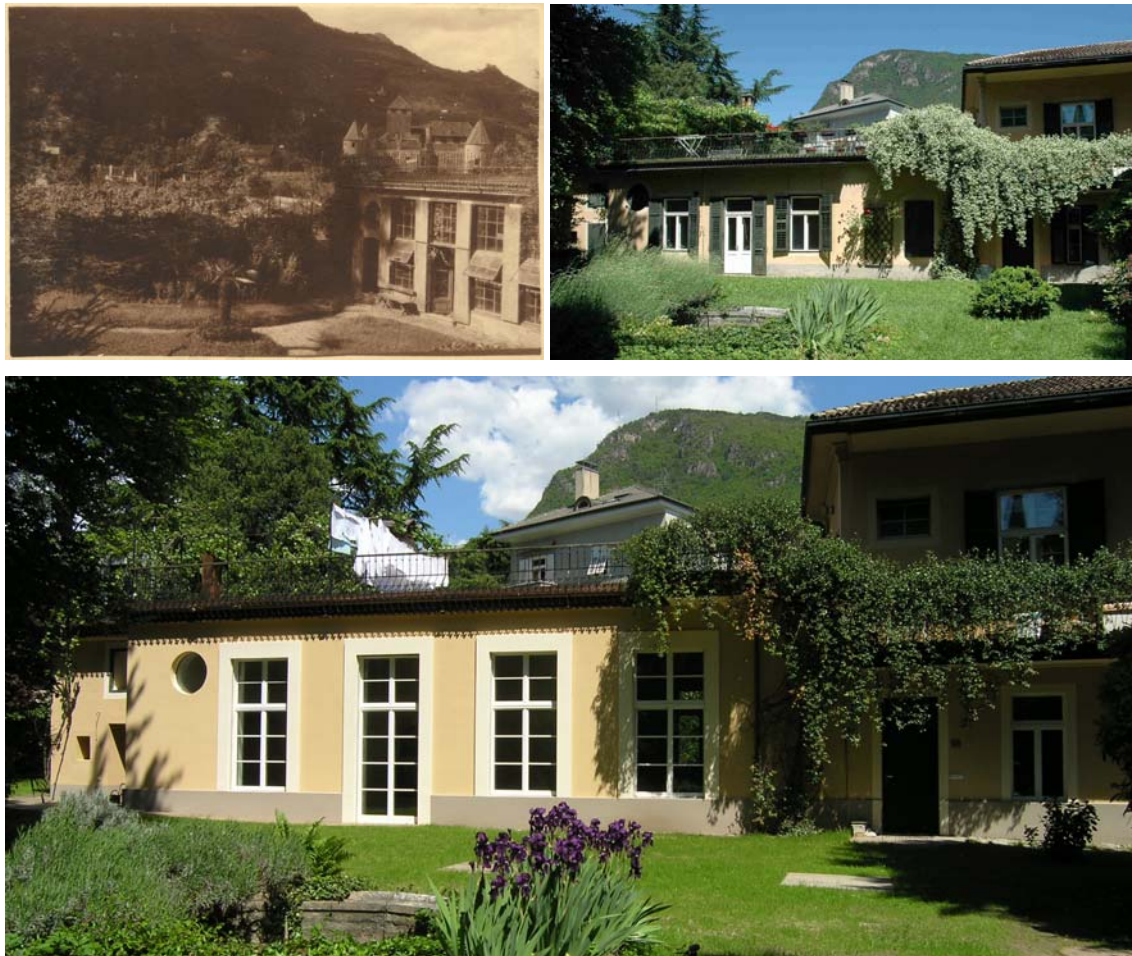
Figure 1. The Orangery of Ansitz Kofler, (a) status from an old photograph before the transformation into housing unit in 1925 (b) before and (c) after the refurbishment in 2007/2008. It was explicit wish of the owner to preserve also the ancient Jasmin.

Ansitz Kofler in Bozen (Italy) was built in 1749 – and had Wolfgang Amadeus Mozart as guest in 1969. The Orangery (see Figure 1.a), which was erected a little after the main building, was transformed into a housing unit in 1925. Before the energetic refurbishment the energy demand for heating was about 450 kWh/m<sup>2</sup>a. The reason for the high energy demand was on one hand the low thermal performance of the massive stone walls with an U-value of 2.1 up to 2.6 W/(m<sup>2</sup>K) and the with large windows on the East and Westside with an U-value of 3.0 W/(m<sup>2</sup>K) and on the other hand the unfavourable form of the building with its A/V-ratio of 0,8 1/m.

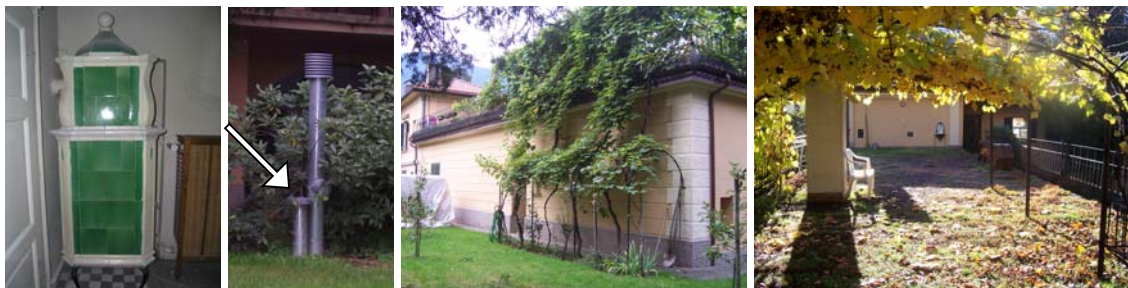
Figure 4. The ancient tiled stove was preserved and got a separate air supply. Also preserved should be the ancient vine at the eastern facade

termination of the construction works the blower door test attested  $n_{50}=0,66$  1/h. Special conservation related aspect here: Since the existing tiled stove was stated as listed object, a new insulated chimney pipe had to be foreseen, which provides fresh air supply independently from the ambient air.

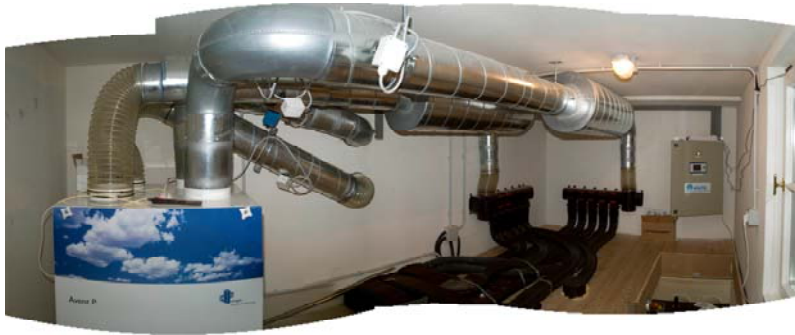
Figure 7. Technical installation (e.g. the ventilation system) were positioned in a new “plant room” above the kitchen, taking advantage of the amply height of the rooms
