# Monitoring Results

## Observations Report 6: Roof Conditions

Document Status: **Final**  
Document Date: 10/01/20  
Monitoring Period: 01/11/18 to 31/10/19  
Report by: ArchiMetrics Limited

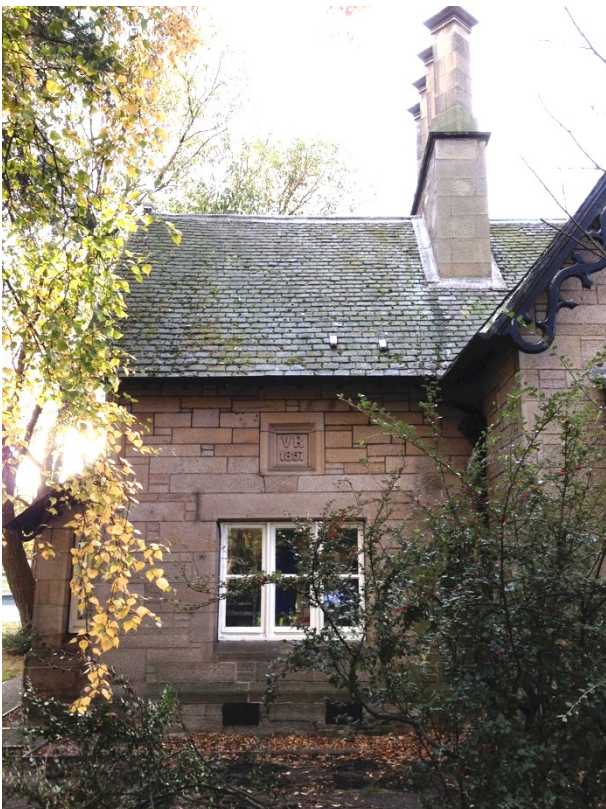
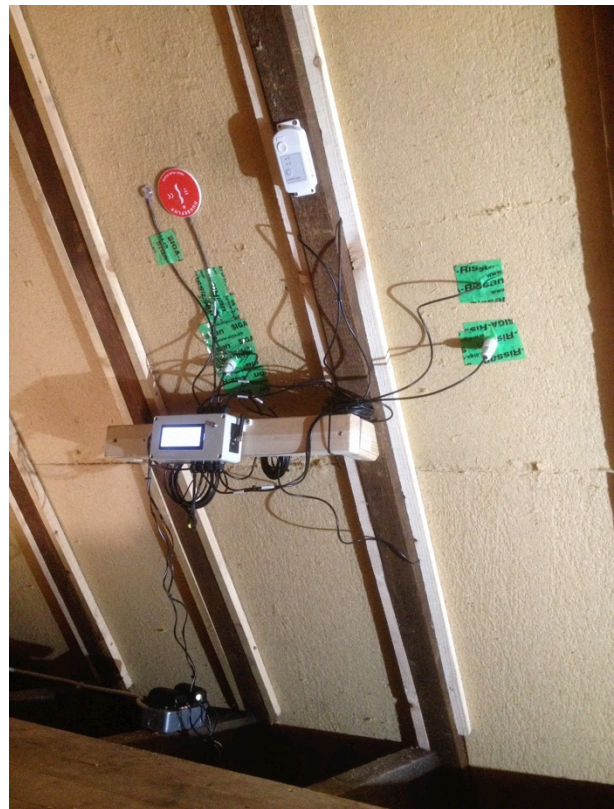
Figures 1 & 2. South-facing gable, Holyrood Park Lodge, East-facing roof slope, external and internal views 2018

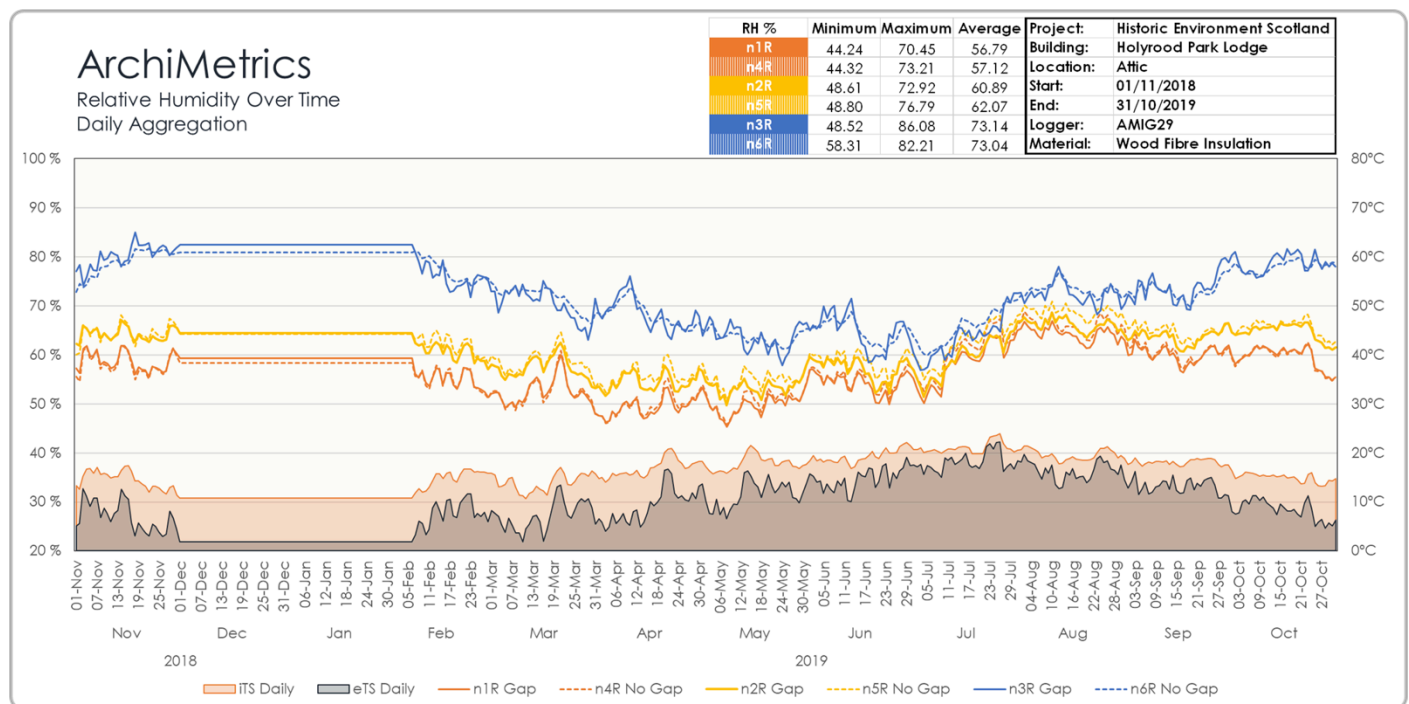
Figure 4. RH Over Time, Daily Aggregation, South Gable Roof, Holyrood Park Lodge, November 2018 – October 2019.

As can be seen in Figures 4 and 5, RH increases in proximity to external conditions and is highest throughout the year at measurement nodes 3 and 6, being on average 73%. RH is seen to decrease at these outer nodes during the first half of the year to the end of May 2019 and in July starts to increase again. RH measured within the woodfibre insulation averages 57% at n1 and n4 and 61% and 62% respectively at n2 and n5. It also falls through February to April 2019 but starts to increase from May onwards. This results in a closer alignment of RH values, roughly between 60 – 70%, across all measurement nodes through both sections in July 2019. This annual pattern of RH distribution, with more similar sectional RH through the summer, is perhaps to be expected. It is like the arrangement we typically see through measured wall sections, where RH is higher towards the external side of the building envelope and RH values become more closely aligned through the fabric section over the spring and summer months. Within the woodfibre insulation RH is at it's highest in August. The smallest maximum value of the four sensors during this month within the insulation is 70% measured at n1, the 25 mm deep sensor closest to internal conditions in the 'normal' arrangement, which includes an air gap. The highest value for August being 77% measured at n5, the 75mm deep sensor in the insulated section with no air gap.

If RH measurements are used to provide an indication of risk to fabric (when this is defined as the risk of mould growth in/on organic materials at humidities above 80%) it can be seen that this threshold is likely to be exceeded over the winter months on the cold side of the insulation beneath the sarking board at n3 and n6 (data for December and January is missing but the overall trend would indicate this is probable). However, RH also declines here during the spring and summer falling to lows of 49% (n3 – gap) and 58% (n6 – no gap) and is, on average, below 80% at both locations. The inclusion of December and January measurements, absent from this analysis, would likely result in a slight increase in overall average RH at these two locations? Measurements are continuing to be made over this current winter period, 2019 - 2020, and will be reported on next year.
