# Osram Culture Centre – Copenhagen, Denmark

Valhalsgade 4, 2200 Copenhagen N

IEA - SHC Task 47

Renovation of Non-Residential Buildings towards Sustainable Standards

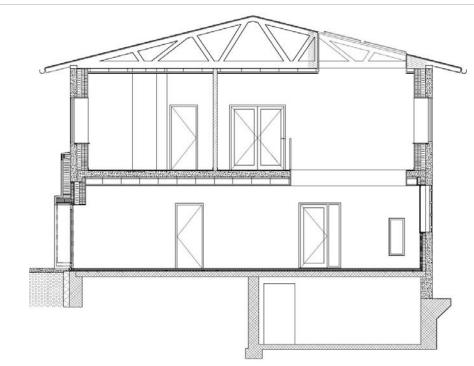
Cross section of the energy-renovated building.

Construction U-values [W/m²K]	U-value before	U-value after
Roof	0.20 - 0.30	0.20 - 0.30
Deck above the gate	3.90	0.09
Walls	1.65 – 3.73	0.09
Windows	2.70 – 5.90	1.20
Doors	1.00 - 5.20	1.00 – 1.50
Slab floor and basement deck	0.57 – 2.37	0.57 – 2.37

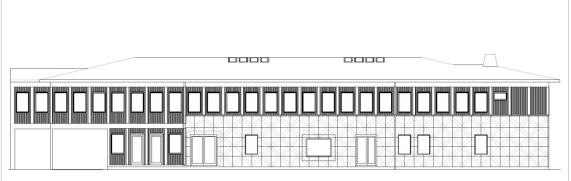
Façade of the renovated building

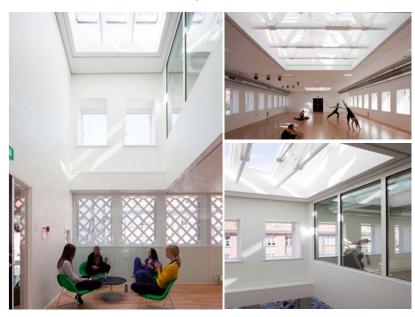
The roof windows have a significant and positive influence on the daylighting level in the building.

In addition to the existing windows the renovated building has an added  $24 \, m^2$  of roof windows. 16 roof windows of 0.66 m x 1.40 m and 12 roof windows 0.66 m x 1.18 m, to increase the amount of daylighting in the building.
