Project no.:	637268
Project full title:	Robust Internal Thermal Insulation of Historic Buildings
Project Acronym:	RIBuild
Deliverable no.:	D3.2 (not yet approved by the European Union)
Title of the deliverable:	Monitoring Data Basis of European Case Studies for Sound Performance Evaluation of Internal Insulation Systems Under Different Realistic Boundary Conditions

Contractual Date of Delivery to the EC	31.01.2019 (M49)
Actual Date of Delivery to the EC	29.04.2019 (M52)
Organisation name of lead contractor for this deliverable	TUD
Author(s)	Peggy Freudenberg (TUD)
Participants(s)	DTU, RTU, AAU, UNIVPM, HES-SO
Internal reviewers	Morten Ørsager (EMA), Sébastien Lasvaux (HES-SO), Ernst Jan de Place Hansen (AAU)
Work package contributing to the deliverable	WP3
Nature	R
Version	1.0
Total number of pages	103
Start date of project	01.01.2015
Duration of project	31.12.2019

The present report summarized the outcomes of case studies developed within the RIBuild project. These case study buildings were evaluated regarding the documented damages and damage indicators, the location characteristics (weather conditions), the usage (indoor climate, type), historic constructions and retrofit cons

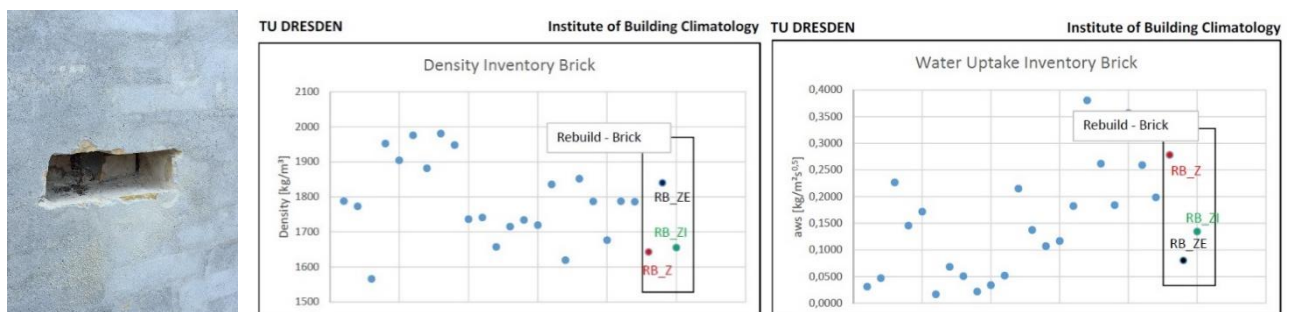
Figure 1: Sample extraction (left picture) from the case study building in Klütgaarden, Denmark. Diagrams in the middle and on the right show results of the laboratory measurements. Named dots in the frame are three different bricks extracted from Klütgaarden building, showing a huge variety of values.

Beside these utilization characteristics, unknown material or construction properties, and local weather conditions are further uncertainty aspects to be mentioned. Although wall thickness and material of the walls are often known, the exact material properties are normally not known. The variety of brick types is huge, concerning not only the density and thermal conductivity but also the vapour diffusion resistance and liquid water conductivity. This is shown in Figure 1.

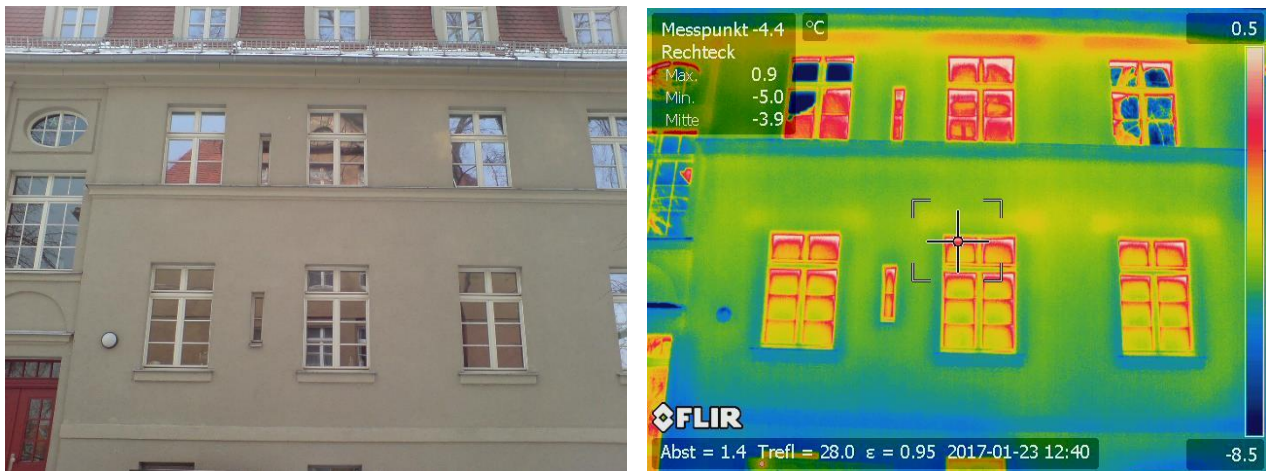
Figure 2: Photography and infrared image of the building façade taken from the case study building in Weimar, Germany. Thermal bridge areas around windows, ceiling, roof and inhomogeneity in the wall can be seen in the distribution of surface temperatures.

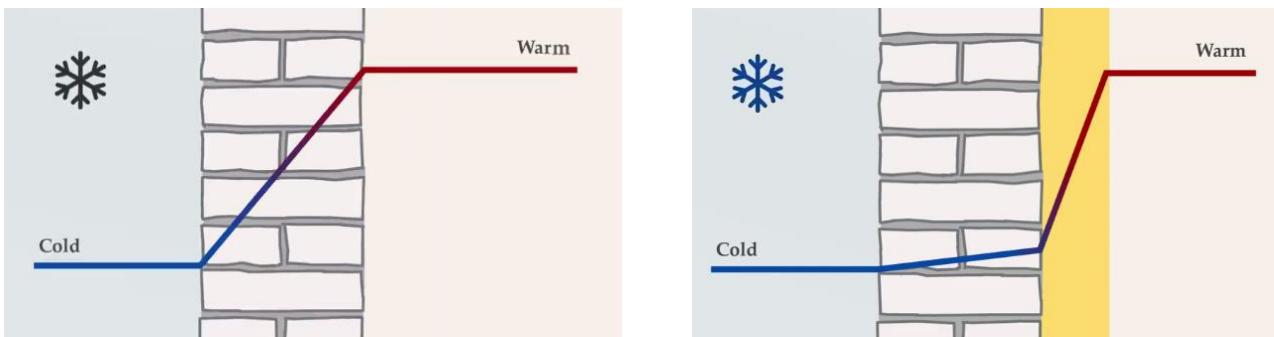
Figure 5: Comparison between the temperature profile of the uninsulated wall (left) and the internally insulated wall (right) (Figures from the RIBuild-video: <https://www.ribuild.eu/news/video-internal-insulation-historic-buildings-desirable-risky>)

Some risk factors for internal insulation are given by the construction itself. The condensation risk within the wall increases with decreasing thermal resistance of the existing wall (small thickness or high thermal conductivity of the wall material) and increasing thermal resistance of the insulation system. This can be directly concluded from the impact of the insulation layer on the temperature conditions within the wall as shown in Figure 5 (left and right).

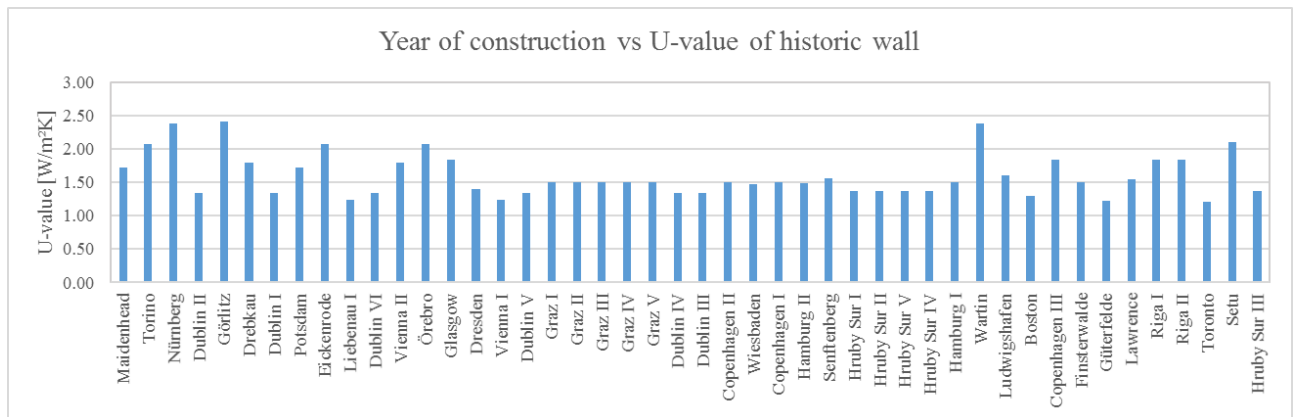
Figure 6: U-value (original historic construction) of published case study buildings ranked by their year of construction (starting with the oldest building from 1550).

A first comparison shows the relationship between the year of construction of the published case study buildings and their heat transmission coefficients (U-value) (Figure 6). There is obviously no relationship between these parameters. The same statement is valid for the relationship between wall thickness, ranged between 260 and 800 mm, and building age as shown in Figure 7.

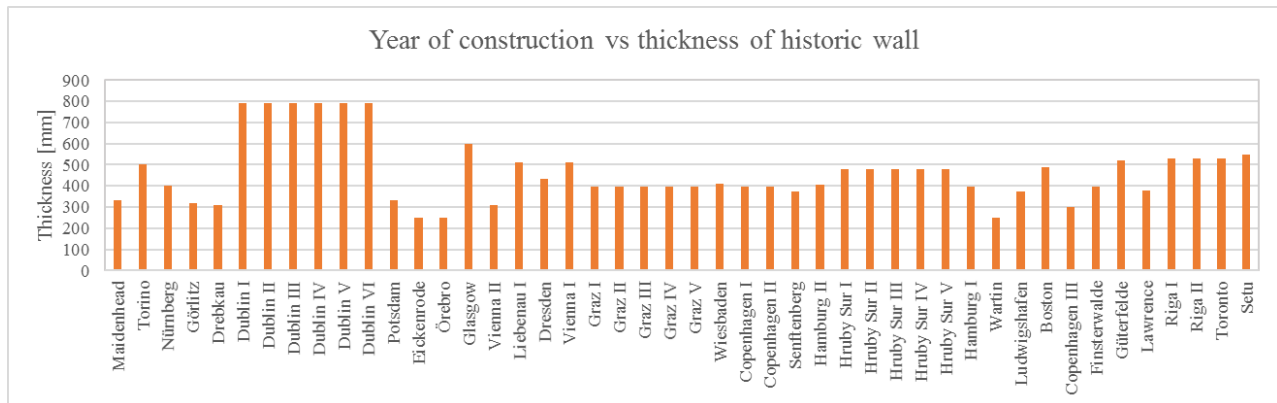
Figure 7: Wall thickness (original historic construction) of published case study buildings ranked by their year of construction (starting with the oldest building from 1550).

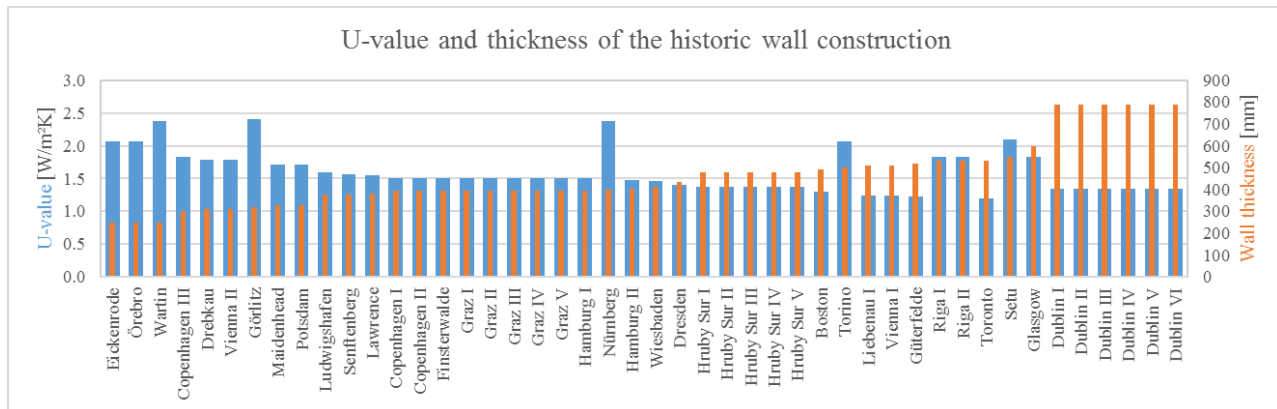
Figure 8: U-value of historic wall construction (blue bars) in published case study buildings compared with thickness of the historic wall construction (orange bars). Buildings are ranked by the wall thickness.

The majority of buildings shows varying thicknesses for the floors. Most of the buildings were built of bricks in local standard format and at least plastered from inside. Thermal conductivity is mostly not mentioned in the articles but in many cases indirectly given with heat flux or U-value prior retrofit respectively after retrofit. The results of the estimated U-values of the historic construction in comparison with the thickness is presented in Figure 8.

The U-value prior retrofit ranges between 1.2 and 2.4 W/m²K. There is a dependency of this U-value on the thickness of the masonry, as the masonry properties did not vary that much in case of brick buildings. Exceptions are given for constructions made of natural stone, e.g. sandstone for the building in Nürnberg or rubble stone for the building in Torino.

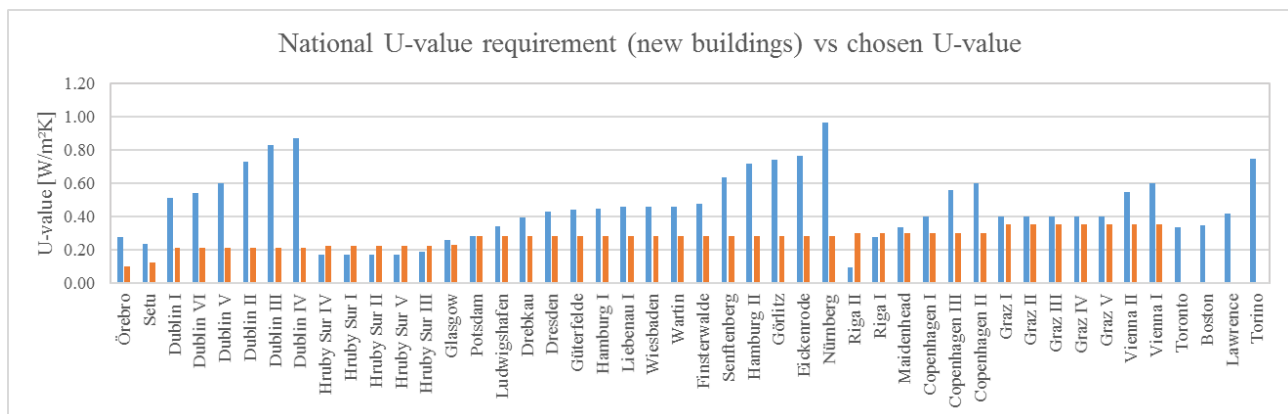
Figure 9: U-values required for newly erected buildings according to the national building regulations (orange bars) compared with U-values of the external walls after renovation of published case study buildings (blue bars). Buildings are ranked by the required U-values.

The chosen insulation system (products and thicknesses) is supposed to depend on the local requirements about heat transmission coefficients in historic buildings. This assumption is checked in Figure 9 for the European published case studies and for the thresholds defined for new buildings in each national regulation. This is a consequence of some unclear national regulations resp. missing regulations for existing buildings.

Apparently, there is also no dependency between these factors. This might be a consequence of the energy regulation diversity and could therefore not be analysed with these values. Firstly, the required values are based on the current standards while the buildings were erected several years ago (first articles from 2003). Secondly, the regulations include many specific determinations whose conditions cannot be validated for the published buildings with their rough descriptions. One example for this diversity could be given with the Swedish regulation (Swedish Regulation for Building Works 2014), which allow a higher U-value for small buildings (0.18 W/m²K) than for bigger ones (0.10 W/m²K). Another exception is provided in the Estonian regulation (Building Act of the Republic of Estonia 2002) according to the intended building usage (non-residential

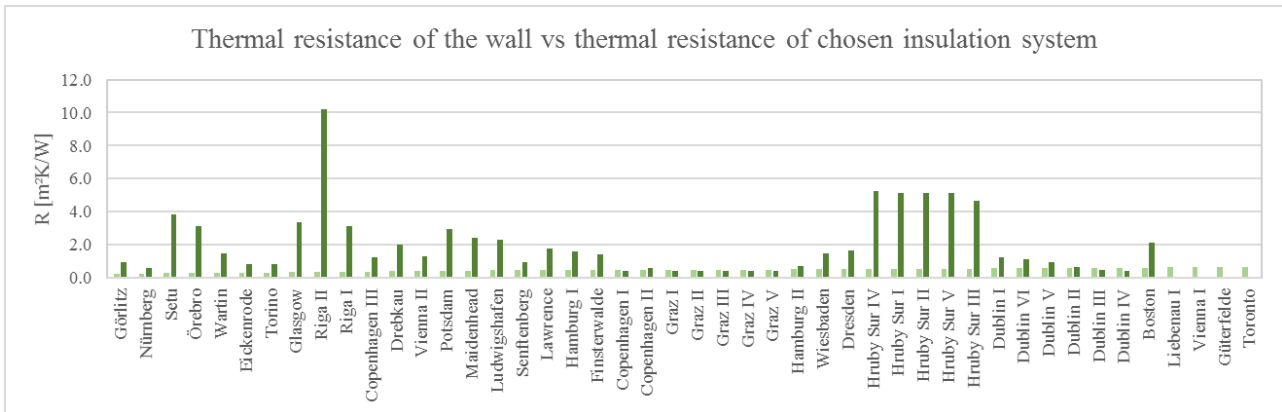
Figure 10: Thermal resistance (R-value) of the existing wall (light green bars) in published case study buildings compared with thermal resistance of the insulation system (green bars). Buildings are ranked by R-value of the existing wall.

The variety in the chosen insulation systems is great and results in U-values for the renovated constructions between 0.1 (VIP, Riga) and 1.0 (calcium silicate: Nürnberg) W/m²K. The planners might have chosen these U-values according to the quality of the existing building in order to limit the impact on thermal conditions within the wall. This assumption was checked in the following graph Figure 10 where the thermal resistance of the existing construction (R-value) is compared with the thermal resistance of the insulation system in the specific case.

There is obviously no relationship between these factors, although a cautious choice of insulation system resistance would be beneficial for a damage-free performance. The variety of chosen insulation products and thicknesses is huge for the analysed buildings. This is shown in Figure 11.

Figure 16 shows a comparison between the thermal resistance of the existing wall and the chosen thermal resistance of the insulation material. Again, as in Figure 10 on page 16, there is no relationship between both parameters. This could be different in building projects from the practice, where the variety of chosen materials and the caution of the building owners and planners is higher. In these research cases, where high-performance insulation systems were applied (e.g. Spikeri: VIP) and huge thicknesses were chosen (e.g. Brüttelen: > 10 cm mineral wool), the thermal resistance of the existing wall was not an important factor for the choice of the insulation standard.

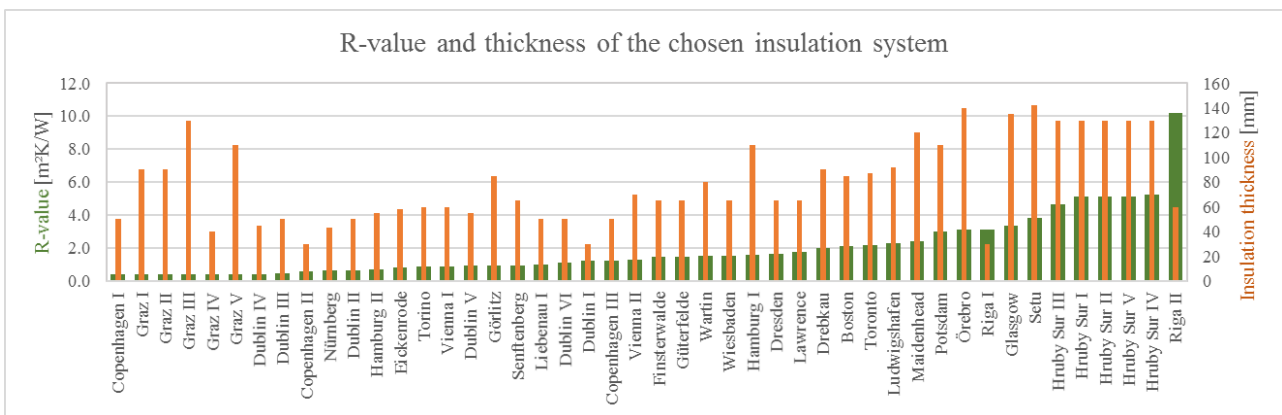
Figure 11: Thermal resistance (R-value) (green bars) compared with thickness (orange bars) of the chosen insulation system in published case study buildings. Buildings are ranked by R-value.

This comparison shows a basic dependency between both factors, although there are some outliers in form of well-performing insulation systems (e.g. Riga I: VIP) and some worse performing systems (Graz: natural materials like reed, cellulose).

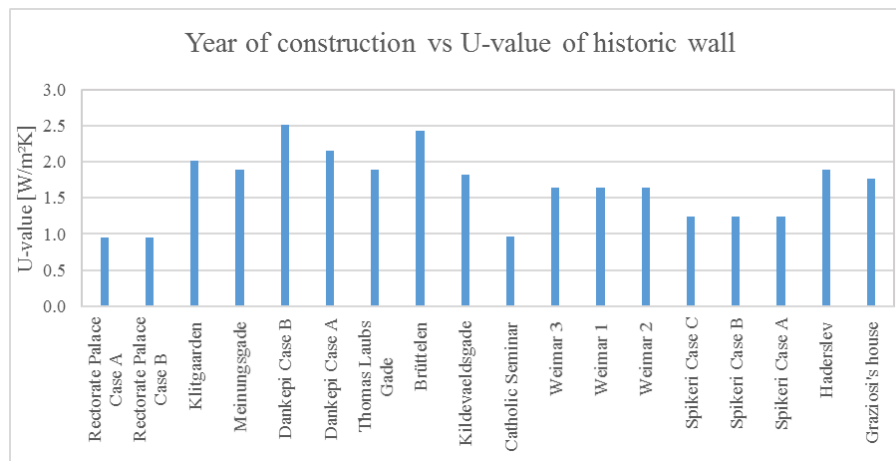
Figure 12: U-value (original historic construction) of RIBuild case study buildings ranked by their year of construction (starting with the oldest building from 1866).

Figure 12 shows the thermal quality of the historic constructions for all RIBuild cases in form of the heat transmission coefficients. The starting value ranges from 0.94 W/m²K for the Rectorate building in Ancona, Italy (770 mm of brick) to 2.52 W/m²K for the Dankepi building in Sece Parish, Latvia (600 mm of dolomite masonry). Most of the buildings show, in accordance to the published cases, a brick masonry with varying thickness from 250 over 360 to 770 mm. In the majority of RIBuild case study buildings, the thermal conductivity was measured in the laboratory and yielded values from 0.64 W/mK to 0.86 W/mK. There is no dependency of the existing wall U-value on the year of construction as Figure 12 shows.

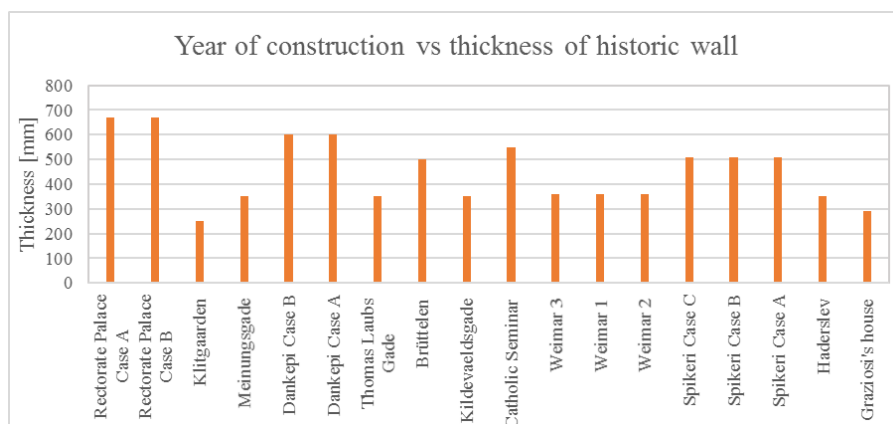
Figure 13: Wall thickness (original historic construction) of the RIBuild case study buildings ranked by their year of construction (starting with the oldest building from 1866).

There is no relationship between thickness of the construction and the year of construction as depicted in Figure 13. There might be a relationship between the location latitude and the construction thickness. Nevertheless, the number of analysed cases is too small for an approval of this statement. Further, the wall thickness often is decreasing, so that e.g. fifth floor has a thinner wall than second floor. In addition, not all buildings involved had the same number of storeys.

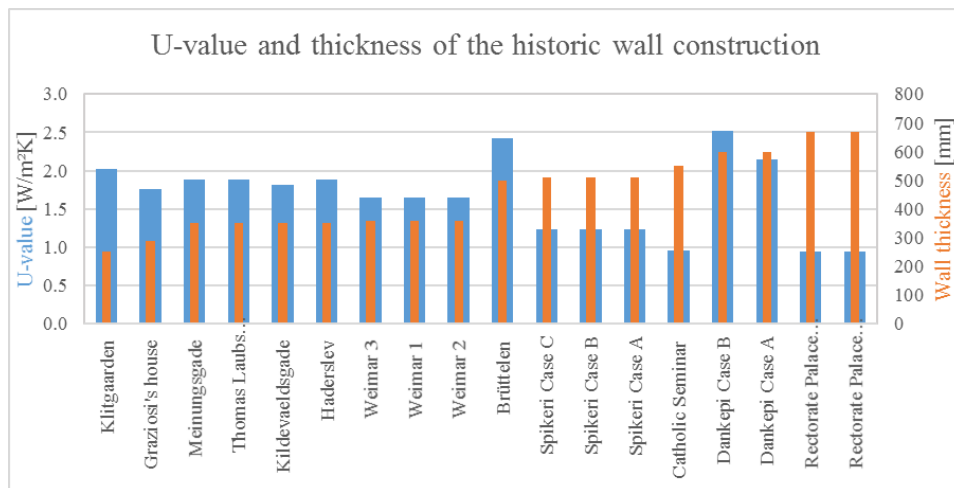
Figure 14: U-value of historic wall construction (blue bars) in RIBuild case study buildings compared with wall thickness (orange bars). Buildings are ranked by the wall thickness.

As for the published case study buildings, Figure 14 shows that there is a relationship between masonry thickness and U-value of the historic construction because most of the buildings are made of masonry with a limited variation of thermal conductivity. Exceptions from this dependency are the building in Brüttelen (rubble stone) and the Dankepi project in Sece Parish (dolomite). Both constructions are made of a natural stone that has a high thermal conductivity compared to brick.

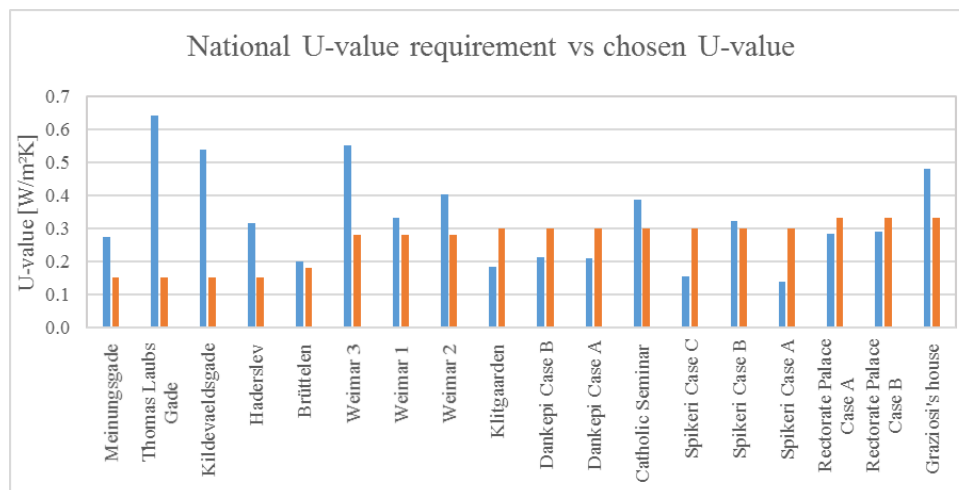
Figure 15: : U-values required for newly erected buildings according to national building regulations (orange bars) compared with U-values of the external walls after renovation of RIBuild case study buildings (blue bars). Buildings are ranked by the chosen U-values.

The chosen U-values in RIBuild case studies show, similar to the published cases, no dependency on the required national U-value for newly erected buildings. It was assumed that the relationship between the U-value thresholds for new buildings in the European countries equals the relationship of these values for building retrofit. However, as stated in the previous comparison for published case studies, these values underlay some exceptions according to the size of the building, the foreseen usage, the protection status etc.

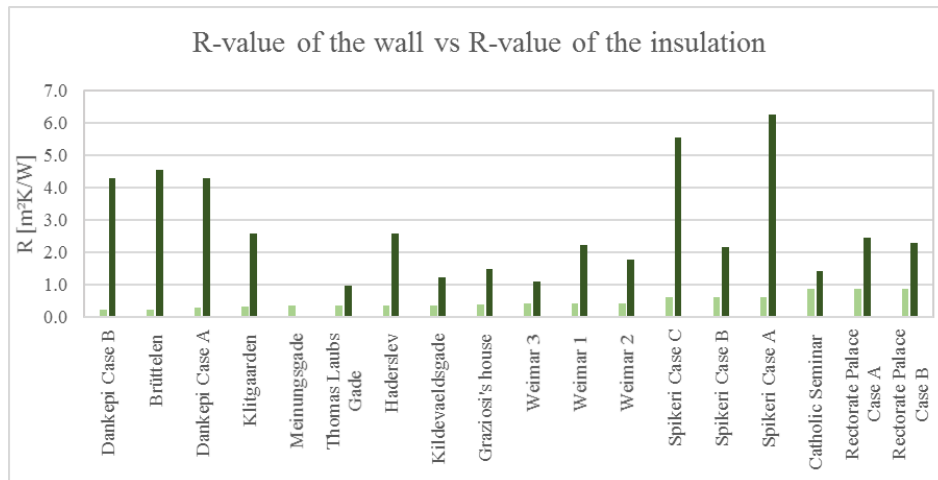
Figure 16: Thermal resistance (R-value) of the existing wall (light green bars) in RIBuild case study buildings compared with thermal resistances of the insulation system (green bars). Buildings are ranked by R-value of the existing wall.

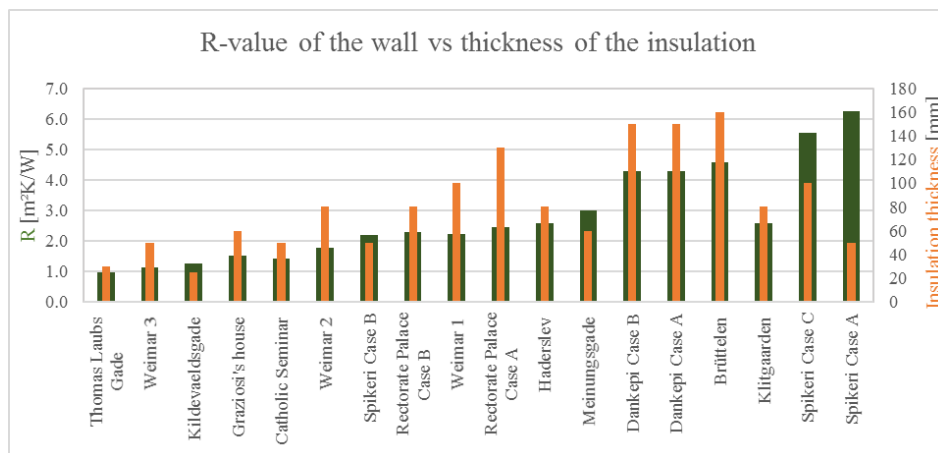
The last comparison addresses the variability of insulation materials as it compares the chosen insulation thickness with the achieved thermal resistance. This comparison in Figure 17 shows the strong dependency of both properties. The bigger the length difference between both bars, the better (green bar much longer than orange bar) respectively worse (green bar much shorter than orange bar) the insulation system is. Despite some exceptions with comparatively low thermal conductivity (e.g. VIP, PIR in Spikeri, TecTem in Meinungsgade) and comparatively high thermal conductivity (e.g. calcium silicate in Rectorate Palace), the thermal conductivity shows a relatively low variation of around 0.033 W/mK from about 0.31 to 0.45 W/mK.

Figure 17: Thermal resistance (R-value) (green bars) compared with thickness (orange bars) of the chosen insulation system in RIBuild base study buildings. Buildings are ranked by R-value.

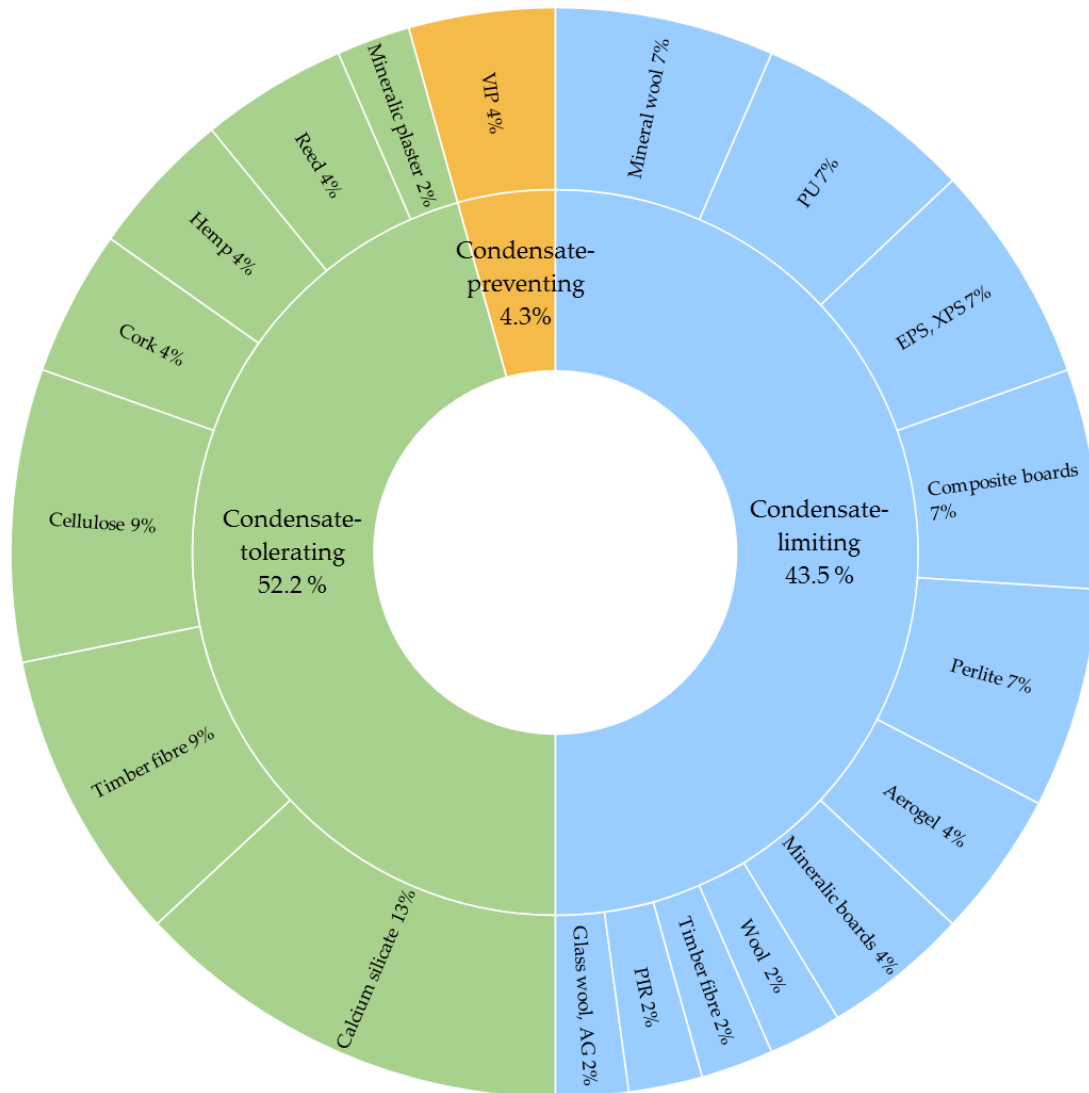
The majority (52.2% resp. 24 out of 46 constructions) of evaluated published case studies represents the group of condensate-tolerating insulation systems (Figure 18). Within this group, mainly calcium silicate, timber fibre and cellulose are applied. With the exception of mineral plaster and calcium silicate, insulation material of this group contain organic, natural ingredients. Some of them consist of a base rendering material, which is supplemented with insulating entrappings. This is true for reed, hemp, cork and cellulose. The other insulation products (timber fibre, calcium silicate) are boards.

Figure 18: Sunburst diagram showing the share of different insulation systems in published case studies grouped by their insulation system class: condensate-tolerating (green), condensate-limiting (blue) and condensate-preventing (orange).

The group of condensate-limiting systems (share of 43.5%) shows a huge variety of products compared to the group of condensate-tolerating systems. There are eleven different products out of 20 cases in this group compared to seven different products out of 24 cases for the group of condensate-tolerating resp. capillary active materials. Mostly used products are mineral wool, polyurethane, extruded polystyrene. The group of composite boards includes systems that combine different products and partially different principles (e.g. iQ-Therm with a combination of Polyurethane with capillary active cores).

Among the group of condensate-preventing systems, only vacuum insulation panels were applied in two cases out of 46 constructions, representing a share of 4.3%.

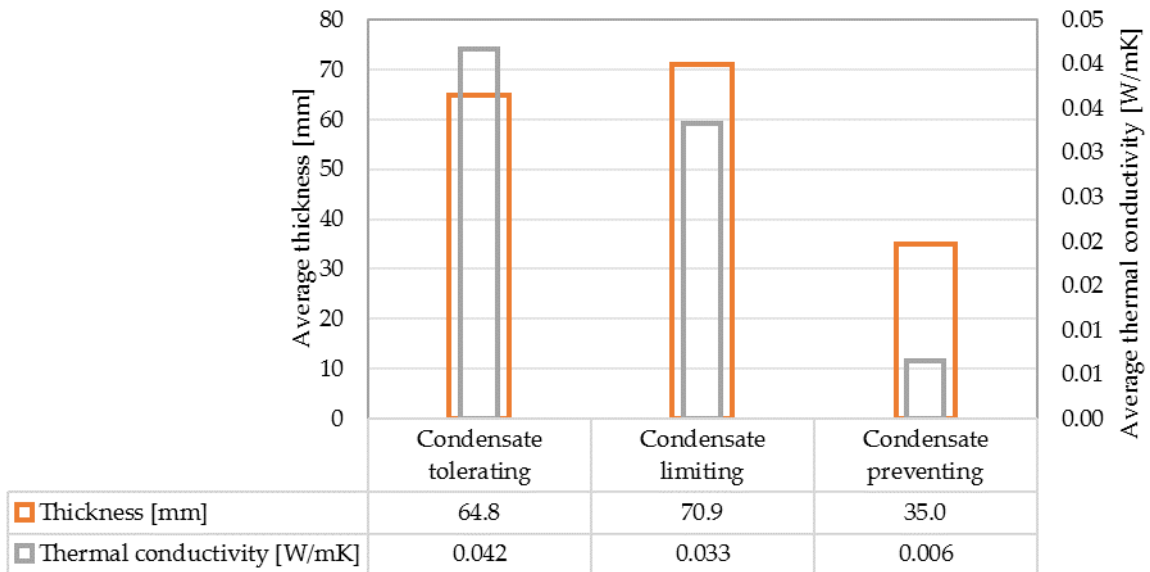
A comparison of average thickness and average thermal conductivity in the published case study buildings show the smallest dimension (35 mm) and lowest thermal conductivity (0.006 W/mK) for the group of condensate-preventing systems, in this case the two VIP constructions (Figure 19). Condensate-tolerating systems show in comparison, a smaller thickness (65 mm) of the insulation layer and paradoxically also a higher thermal conductivity (0.042 W/mK). This leads to the conclusion that the lower thermal performance of these condensate-tolerating systems is not balanced with an increased thickness. The fact that many of these capillary active insulation systems are rendering systems with a limited possible thickness might play a role in this context. Condensate-limiting systems used in the published case study buildings did have an average thickness of 71 mm and shows an average thermal conductivity of 0.033 W/mK.

Figure 19: Average thickness and average thermal conductivity for published case studies sorted by insulation group.

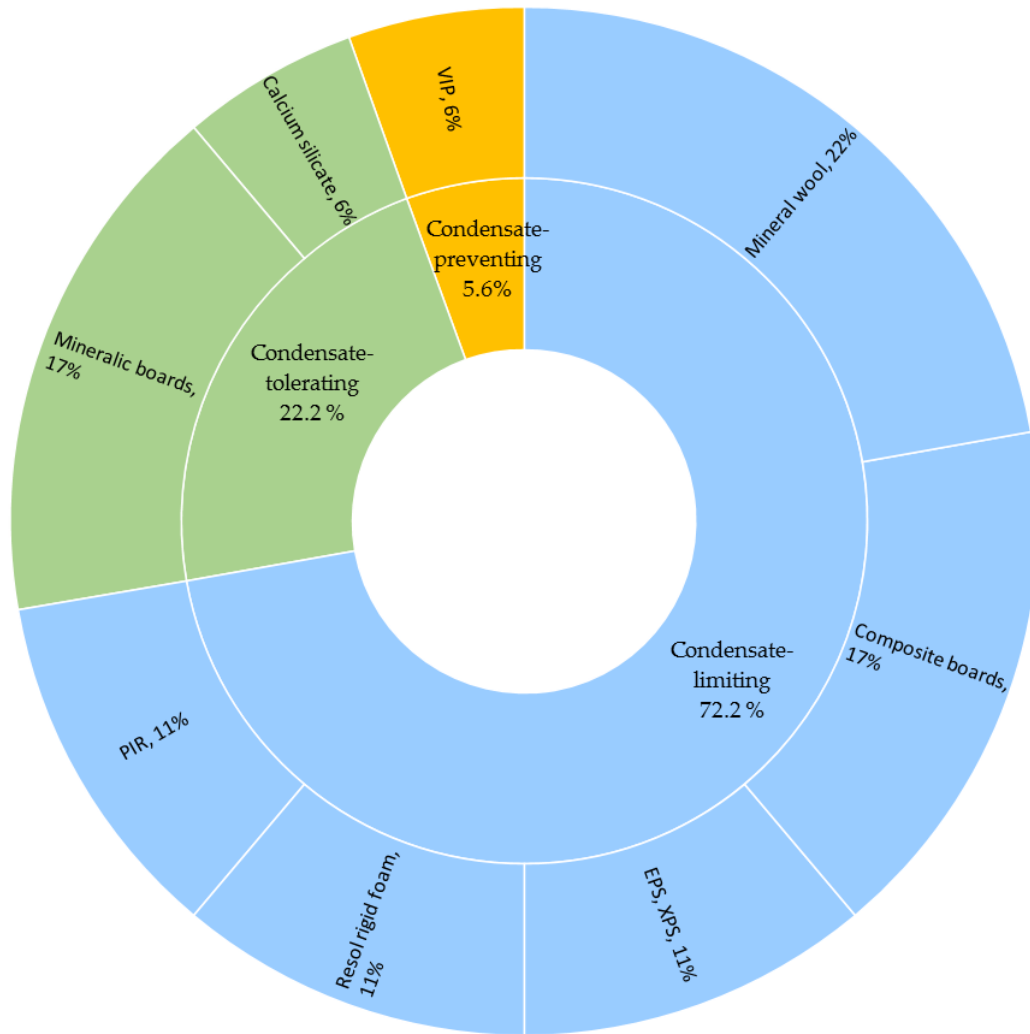
RIBuild case studies show a majority (72.2%) of condensate-limiting insulation systems in contrast to the published case studies. Again, the product variety among this group is high (Figure 20). In addition to the published case studies, two projects applied resol rigid foam insulation boards (Kingspan, Denmark). These boards are made of Bakelite and provide a low thermal conductivity of about 0.021 W/mK. The other products, composite boards (Mineral wool, iQ-Therm, EPS, PIR) were already applied in published cases. Again, mineral wool is the most frequently used (22%). Among the condensate-tolerating products, calcium silicate and mineral boards (products Multipor and TecTem) were used. However, the share of capillary active materials in RIBuild projects is less than one quarter (22.2%).

Figure 20: Sunburst diagram showing the share of different insulation systems in RIBuild case studies grouped by their insulation system class: condensate-tolerating (green), condensate-limiting (blue) and condensate-preventing (orange).

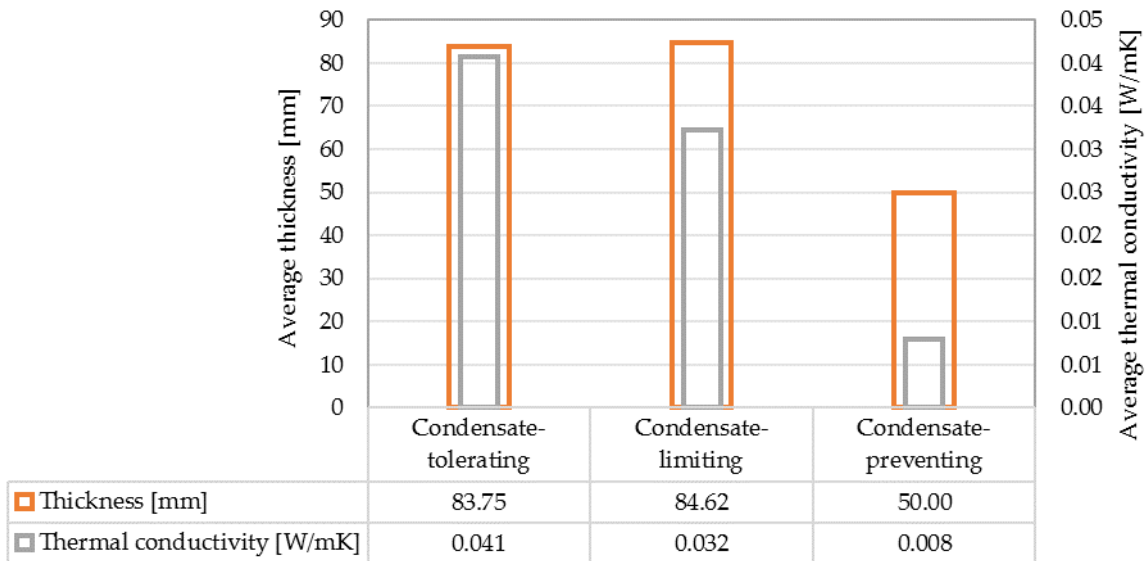
The comparison of thickness and thermal conductivity for each insulation group shows the same relationship as for the published case studies. The lowest thermal conductivity and thickness is given by the condensate-preventing products (Figure 21). Again, this group is solely represented by vacuum insulation panels of a thickness 50 mm and a thermal conductivity of less than 0.01 W/mK. In contrast to the published cases, the thickness difference between condensate-tolerating and condensate-limiting systems is neglectable and ranges around 84 mm. This is much more than for the published cases with an average thickness of 66 mm. Eventually, this can be attributed to the retrofit year, as the RIBuild cases are younger and definitely following the tendency of an increasing insulation standard. Nevertheless, the average thermal conductivity among the condensate-limiting systems (0.032 W/mK) is definitely lower than for the condensate-tolerating systems (0.041 W/mK). Both values are slightly lower than for the published case studies (0.033 and 0.042 W/mK) and show the same relationship as for these cases.

Figure 21: Average thickness and average thermal conductivity for RIBuild case studies sorted by insulation group.

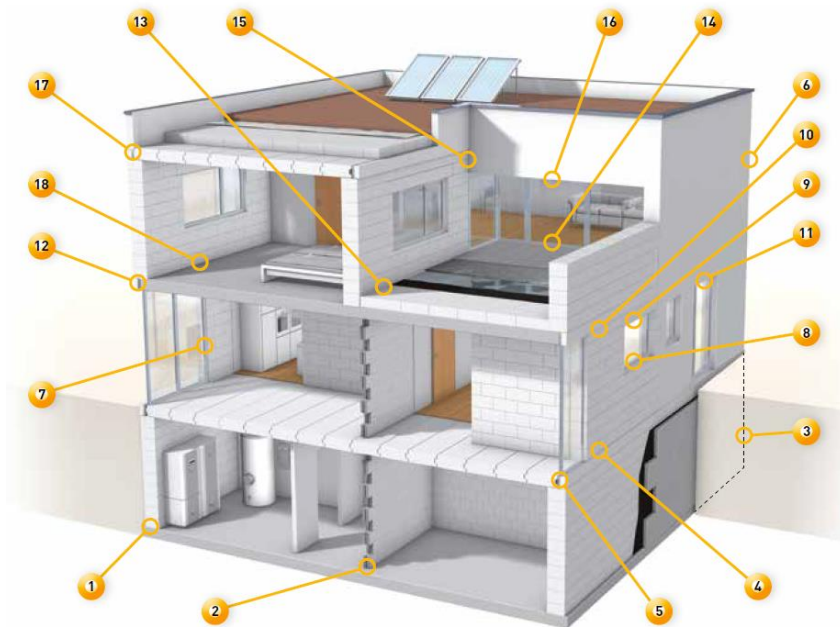
A ruling risk in the application of internal insulation is the interruption of the insulation layer by all embedded constructive details like ceilings, windows, partitions, roof etc., exemplified in Figure 22.

Figure 22: Overview of possible thermal bridges resp. constructive joints in (internally insulated) buildings, e.g. residential buildings (Griebel, et al., 2015)

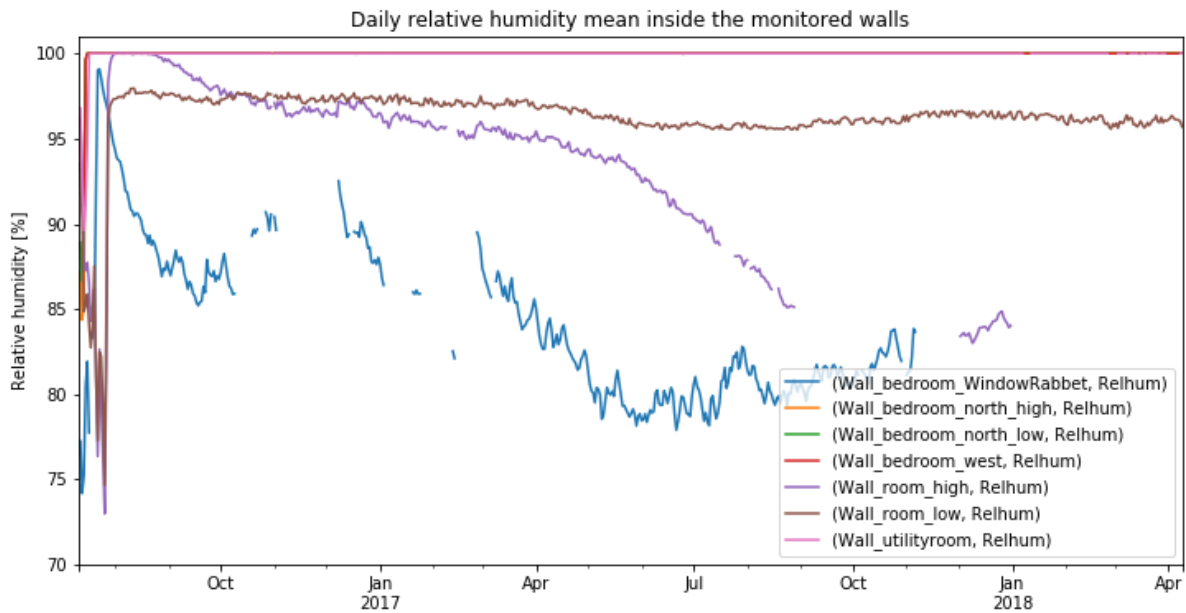
Drying process of the captured built-in moisture was confined in the winter period for the Klitgaarden project, as the heating system was partially inactive for the first year after the retrofit (winter 2016/2017) and for the following winter season (2017/2018). Indoor conditions for the Haderslev-building were rather typical with consistent heating and indoor relative humidity of less than 65%. In this case, the driving rain protection of the façade was completely missing (exposed brickwork, no additional measures). This was also the case for the “Thomas Laubs Gade” project, the last entry in the table with critical conditions as well but a visible drying process. These factors might be the reasons for the drying time prolongation for the critical cases. This argument is supported by the stable high-moisture-level characteristics (Figure 23).

Figure 23: Extract of the measurement results for the building in Klitgaarden, Denmark for the winter period 2017-2018. The majority of the sensors (four out of seven) record a permanent moisture level of 100% (it was questioned where some of these had defects as single-point measurements showed lower values). Three sensors show a drying tendency towards summer.

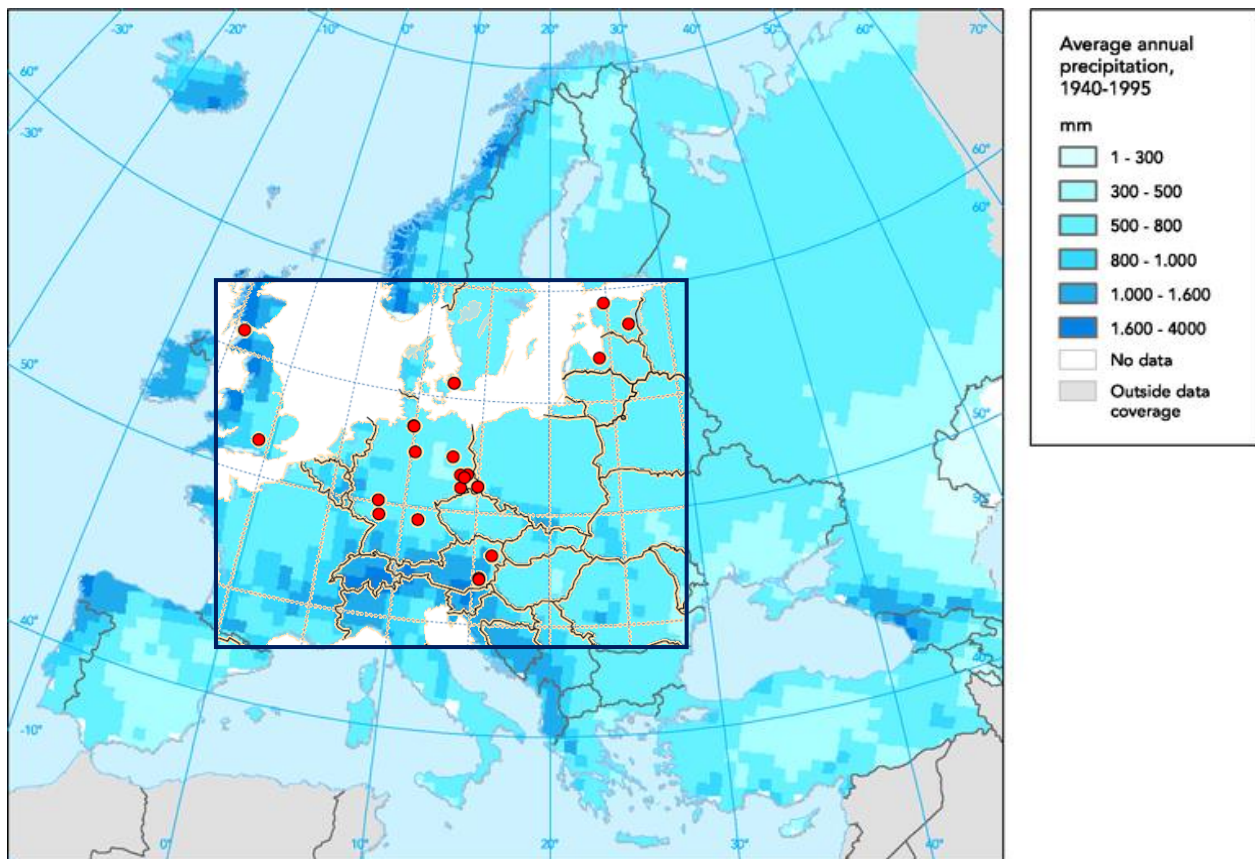
The driving rain load is generally dependent on the amount of horizontal precipitation (rain load) and the local wind conditions. Figure 25 show that the annual rain load is varies a lot in Europe, e.g. being less than 500 mm per year in some areas of eastern Germany and in central parts of Spain, while the rain load is more than twice as high in the Alpine region, West England, and the Western part of Norway. However, precipitation is to be evaluated in conjunction with wind speed. In contrast to the precipitation level, which is mainly depending on the altitude of the location, wind conditions are stronger ruled by the closeness to the sea.

Figure 25: European precipitation map complemented with selected locations of published cases studies, Owner: University of East Anglia, Climate Research Unit, Processor: European Environment Agency (EEA), Permalink: http://www.eea.europa.eu/data-and-maps/figures/ds_resolveuid/872B55F3-B1F7-4277-8668-891AF213B314

Figure 26 shows the average wind speed for the period of 2000-2005. It gives a reason for the accumulation of critical constructions around the sea as these areas show the highest wind speeds of more than 7 m/s. A more obvious visualization of the weather conditions impact is given by combining Figure 26 with Figure 25. Four of the five northernmost locations reported critical conditions for the case study buildings. Most of these locations (Estonia, Latvia, Sweden, England) show average annual wind speeds of more than 6 m/sec and an annual precipitation level of about 500 to 800 mm. An exception is Glasgow, which is characterized by a very high rain load of more than 1000 mm. Initially critical conditions were furthermore given in the buildings in Maidenhead (England), located in an area with high wind speed of more than 6 m/sec and moderate precipitation level, Liebenau and Vienna (both Austria), located in a region with high precipitation load of more than 1000 mm per year.

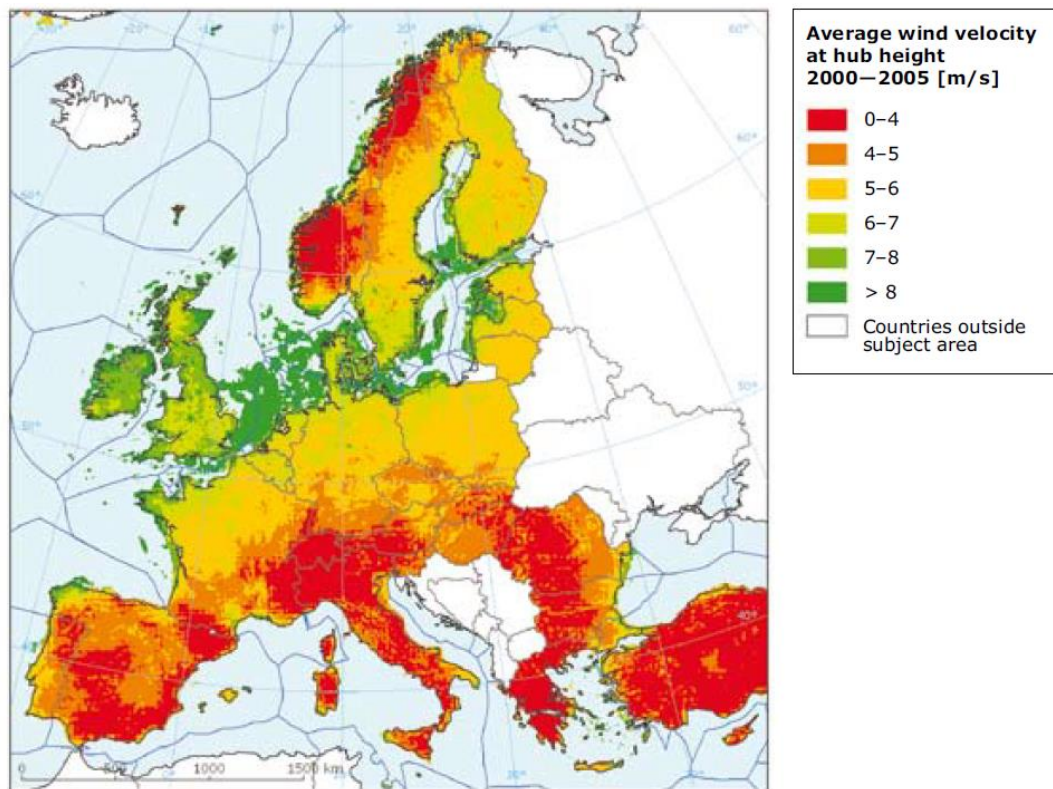
Figure 26: European average wind speed map for the period 2000-2005. Owner: University of East Anglia, Climate Research Unit, Processor: European Environment Agency (EEA)

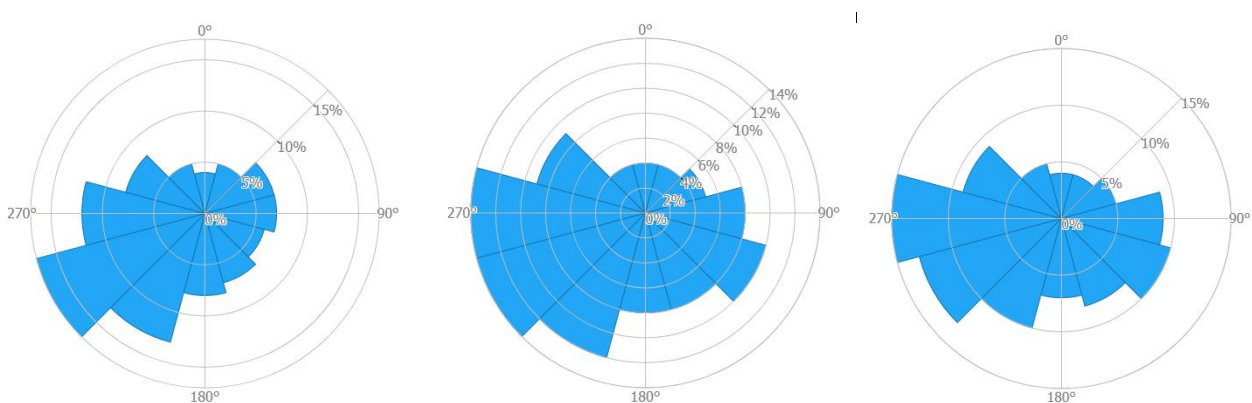
The direction of the monitored walls could influence the damage risk as well, as the distribution of wind directions over the year differs. This is briefly evaluated for the risky buildings by the help of the local wind roses in Figure 27 for the three locations of Weimar, Haderslev and Copenhagen. The graph for Weimar shows a very small precipitation level for the northern sector, although this is the direction of the critical wall in this project. Of course, not only the wind and precipitation levels indicate risky conditions. The drying potential of the solar radiation is also important and nearly absent for the northern sector. The same direction is also rated as risky in the Klitgaarden project that featured an exterior rendering as well. Indeed, all other wall directions are moist in this building (Klitgaarden) as well, despite the intact (renewed) exterior rendering of that building.

Wind roses for the three locations show a small variability of main wind directions among the locations. This is also the case for the remaining locations of RIBuild case study buildings. Most of them show a main wind direction from west respectively South-West and a slightly increased wind load from the opposite direction. There is only a fundamentally different characteristic for locations in the alpine region.

Figure 27: Wind roses for the critical cases in Weimar (left), Haderslev, Denmark (center) and Copenhagen, Denmark (right) according to the data provided by DTU in 2018 on <https://globalwindatlas.info>.

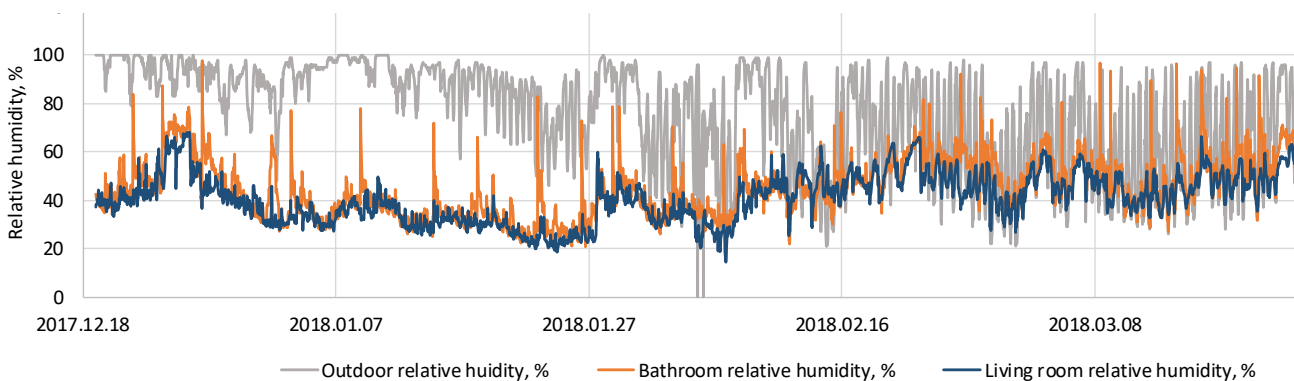
The course of relative humidity for a winter period for one case study building is illustrated in Figure 28 for the example of Dankepi in Latvia. Obviously, the relative humidity level of indoor air is low and ranges around 50%. All longer usage periods of the bathroom cause short-time-peaks in this curve and a slightly increased level of the indoor air in the living room during non-occupied hours. These peaks are not affecting the damage risk of the construction behind in a significant way and can be balanced by the construction.

Figure 28: Outdoor and indoor relative humidity for two rooms in the test case building in Dankepi, Latvia. The values for the bathroom are on the average on a typical level but show regular peaks due to the usage
