Project no.:	637268
Project full title:	Robust Internal Thermal Insulation of Historic Buildings
Project Acronym:	RIBuild
Deliverable no.:	D3.2 (not yet approved by the European Union)
Title of the deliverable:	Monitoring Data Basis of European Case Studies for Sound Performance Evaluation of Internal Insulation Systems Under Different Realistic Boundary Conditions

Contractual Date of Delivery to the EC	31.01.2019 (M49)
Actual Date of Delivery to the EC	29.04.2019 (M52)
Organisation name of lead contractor for this deliverable	TUD
Author(s)	Peggy Freudenberg (TUD)
Participants(s)	DTU, RTU, AAU, UNIVPM, HES-SO
Internal reviewers	Morten Ørsager (EMA), Sébastien Lasvaux (HES-SO), Ernst Jan de Place Hansen (AAU)
Work package contributing to the deliverable	WP3
Nature	R
Version	1.0
Total number of pages	103
Start date of project	01.01.2015
Duration of project	31.12.2019

The present report summarized the outcomes of case studies developed within the RIBuild project. These case study buildings were evaluated regarding the documented damages and damage indicators, the location characteristics (weather conditions), the usage (indoor climate, type), historic constructions and retrofit cons

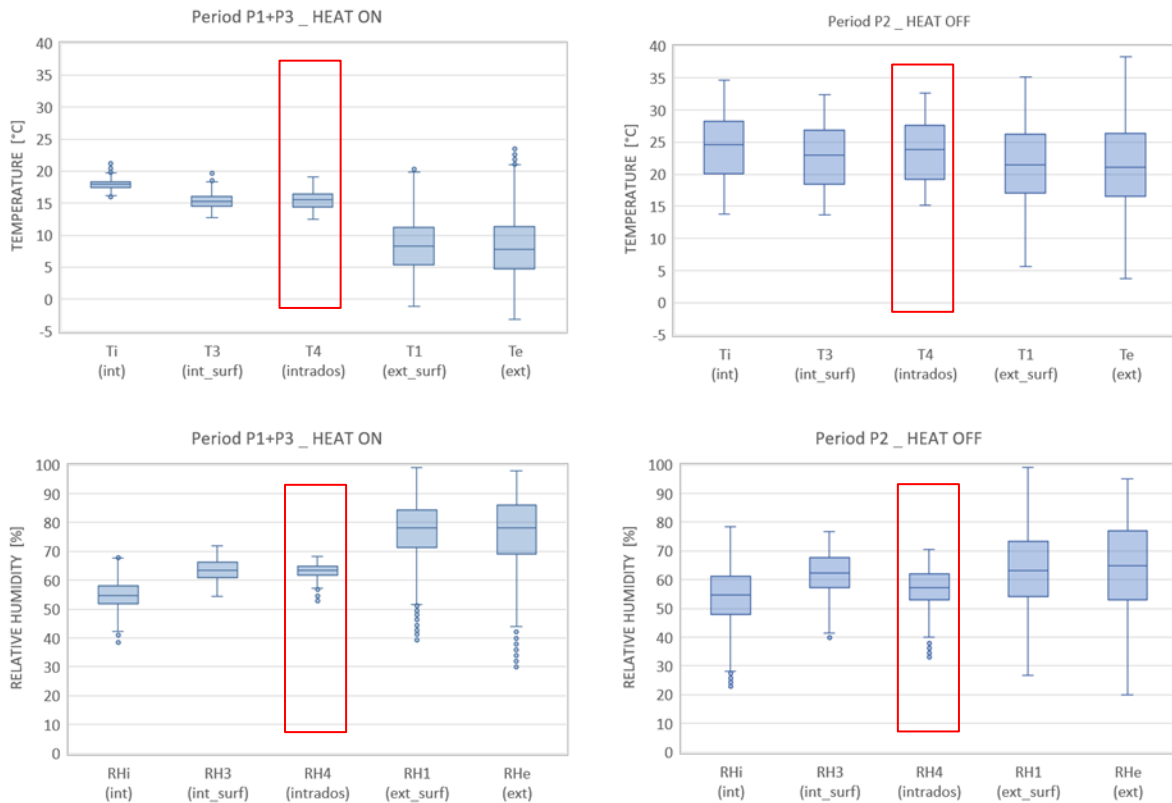
The seasonal variations and their impact on the temperature conditions is shown in Figure 29 for the Villa Graciosi. Three phases were chosen for the comparison, two cold seasons with activated heating system (Periods P1 and P3) and one phase in the summer (Period 2), where the heating system was inactive. The temperature box plots in Figure 29 show already a huge range of measured indoor air temperature in the warm season and a remarkably higher temperature level within the construction (red boxes in Figure 29). The corresponding moisture level in the wall is consequently much lower.

Figure 29: Temperature (upper graphs) and relative humidity (lower graphs) conditions for the heating season (left graphs) and for the free-running season (right graphs) in the RIBuild case study building Villa Graciosi in Ancona.

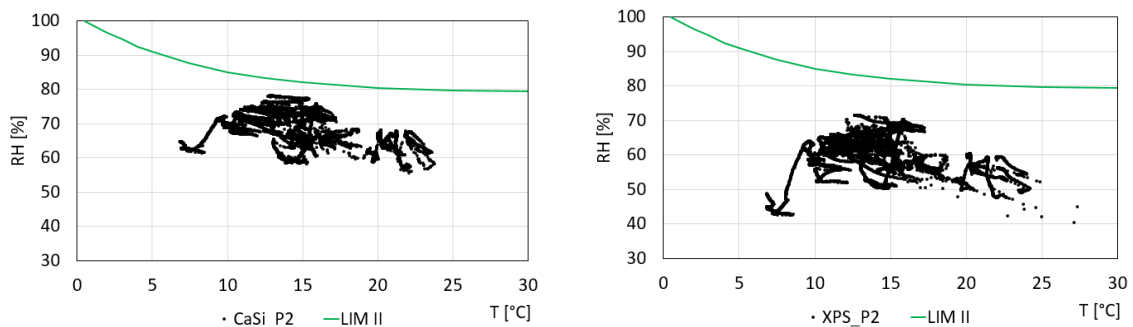
The heating settings resp. the level of heating during the cold season is decisive for the damage risk potential of internally insulated buildings. This was analysed for the Rectorate building in Italy (Figure 30 and Figure 31). The building was not directly in use during monitoring but instead heated in an experimental way with heating-on and heating-off phases. The comparison between the free-running phase with an inactive heating system (period 2) with a constantly heated phase (period 3) shows a remarkably higher indoor moisture level for the first phase. The resulting measurement points in the graph are compared with a mould growth risk indicator, the isopleths (Sedlbauer, Krus, & Zillig, 2003). The unheated phase dot cloud (upper and lower left graph) is much closer to that risky line than the heated phase (upper and lower right graph) values, especially for the calcium silicate construction, which is more vapour permeable and thus stronger linked to the indoor climate.

Figure 30: Mould risk evaluation with Sedlbauer isopleths (LIM II: common building materials) for CaSi (left) and XPS (right) insulation systems in period 2 (unheated phase). RIBuild case building Rectorate (Italy)

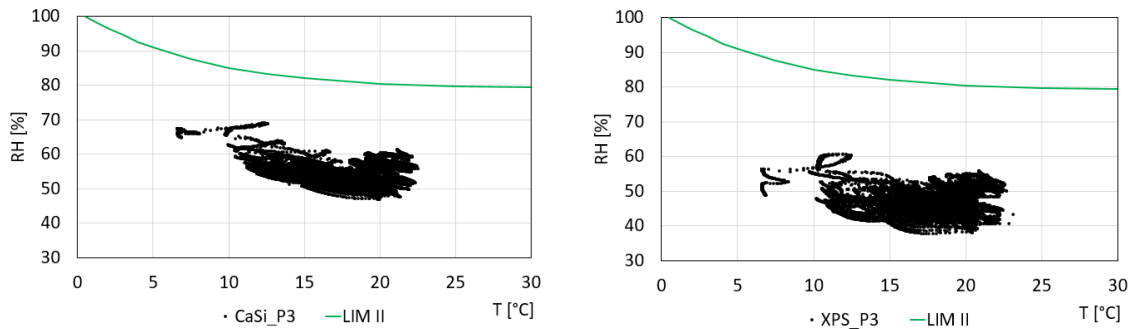
Figure 31: Mould risk evaluation with Sedlbauer isopleths (LIM II: common building materials) for CaSi (left) and XPS (right) insulation systems in period 3 (heated phase). RIBuild case building Rectorate (Italy)

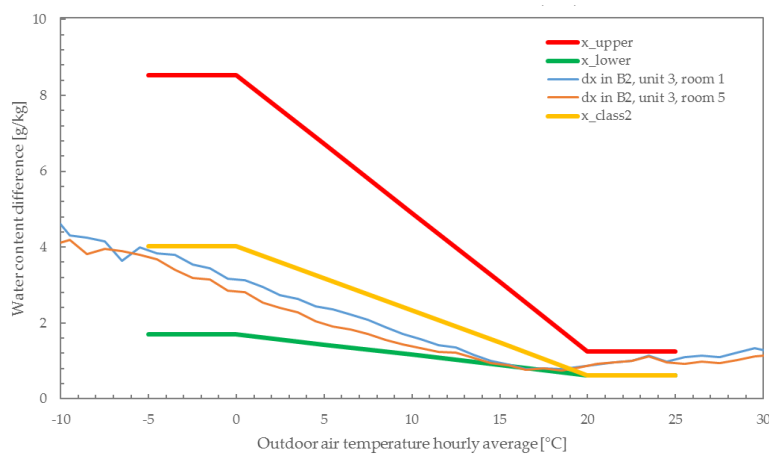
A proper estimation of the resulting indoor climate in hygrothermal simulations is still a challenge. The case study results for Italy have shown that both summer and winter conditions influence the wall behaviour essentially. During a year, the moisture content of indoor air is assumed to depend on the outdoor air temperature as the moisture content depends on the temperature level. Furthermore, the ventilation behaviour of building occupants is dependent on the season. EN ISO 13788 describes both aspects by means of humidity classes. In order to give a recommendation for the practical assessment of these constructions, the existing model has been compared with measurement results for the case study building 3 in Weimar. Figure 32 shows that measured indoor air values for this building are within the limit of humidity class 2.

Figure 32: Measured indoor air values in case study building Weimar 3, Germany compared with upper limit curves for humidity class 1 (green), class 2 (yellow) and class 4 (red) according to (EN ISO 13788: 2013). Indoor air value is represented by water content difference (g/kg) between indoor and outdoor air.

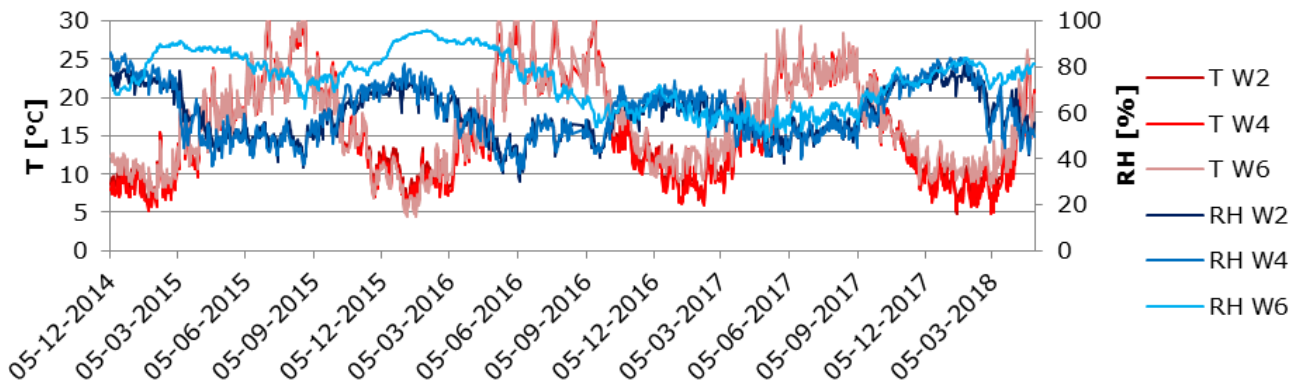
Figure 33: Relative humidity and temperature between insulation and historic wall construction measured in the case study building in Meinungsgade, Copenhagen. Relative humidity shows strong fluctuations, which are untypical for a construction with a vapour barrier.

for the case study building Meinungsgade in Denmark. The measured fluctuations of relative humidity behind the 60 mm insulation layer is very high. This is untypical for such an insulation system. Compared to another building with similar construction properties in Kildevaeldsgade, the amplitude of the relative humidity seems exceptionally high. This is shown in the comparison below. As this construction is also a facebrick wall, fluctuations might also be promoted by the driving rain load through the masonry and eventually cracks in the joints. This is not evaluated for the given construction.

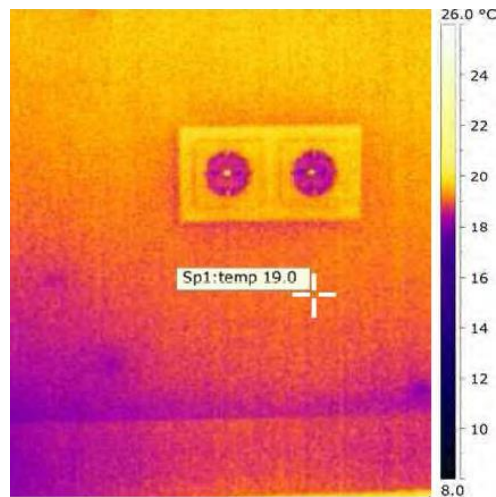
Figure 35: Impact of insulation system perforations on the temperature field. The wall was supplemented with power sockets that degrade the insulation layer. Dark areas in this infrared image show areas of lower temperature and give a hint to thermal bridges resp. leakages (Oswald, Zöllner, Liebert, & Sous, 2011).

Consequences of vapour transport through gaps, cracks, connections etc. might be condensation, mould growth and increased energy consumption. The latter is especially relevant for cases in which openings in the masonry are given in addition to the connection between interstitial condensation plane and room air. In this worst case, airflow through the whole construction occurs (Oswald & Zöllner, 2010). Locating these untight points or areas is possible with infrared imaging as shown below for the example of power sockets perforation.

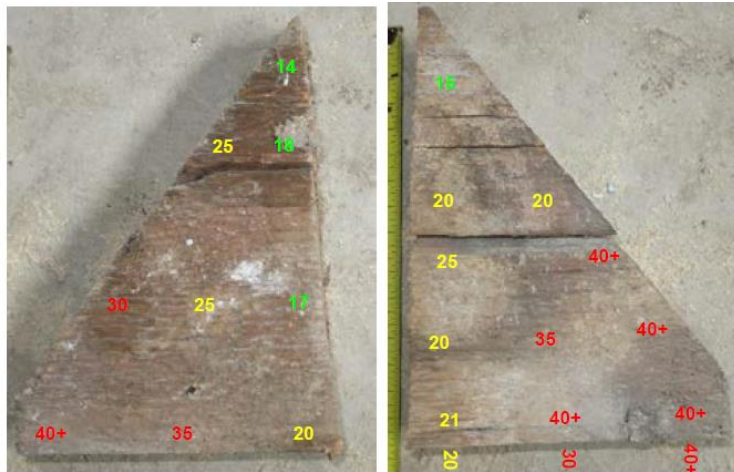
Figure 36: Moisture content in southeast oriented joist end faces in a case study building located in Ottawa, Canada. IDs represent measurement points with a colour-decoded moisture content (red= high, yellow= moderate, green= low). The bottom side of the samples was the horizontal bearing surface. The samples show left and right side of the beam end. The beam ends were bevelled cut off at an angle of 45° and the long side was placed on the masonry, thus the long sloped side is was the front face (in contact with cavity air) of the beams in the masonry. All red (critical) points are located outwards (closest to the outer surface of the wall).

There are not only measurements, which evaluate the damage risk approaches but also measurement that analyse the spatial distribution of damage risk within the building and within the beam end itself. Measurements showed that the critical situation for wooden joist ends varied among different azimuth directions of the facades and between different positions within the beam end. A remarkably higher risk was given for beam-ends that suffer a reduced solar radiation (local shading, north direction etc.). Small-scale spatial distribution within the joist end is shown in Figure 36, where two samples from a southeast façade were extracted from a case study building. Higher moisture contents (red IDs) are given for the lower measurement points close to contact face with the masonry. Less critical is the upper area of the beam end and the front face.

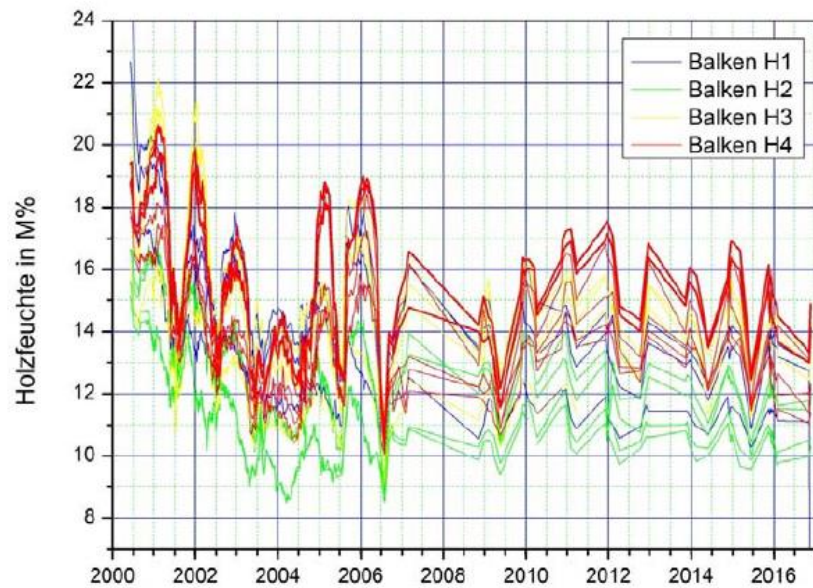
Figure 37: Moisture content (weight-% in wood) in joist ends in a case study building located in Senftenberg, Germany. Different graphs represent different measurement points at the North-West-Façade within four different joist ends. All joist ends were equipped with a heat source in form of different heating pipe solutions that provided different levels of permanent heat inlet over the cold period of the year. (Stopp, Strangfeld, Toepel, & Anlauff, 2010)

Some authors suggest raising the joist end temperature level by use of direct or indirect heating. A solution is given with flow line pipes or heat pipes placed at the joist ends. This should be combined with the removal of insulation around the joist ends. The expected drying process could be initiated with the placement of heating pipes beside the beam end. The disadvantage of this method is an estimated additional heat loss of 10% (Stopp, Strangfeld, Toepel, & Anlauff, 2010). The resulting long-time behaviour is shown in Figure 37.

The estimated increased energy demand using direct/indirect heating in this case compared with a completely insulated and non-heated wall is about 10%. Another solution makes use of heat conducting elements, connecting flow line pipes to the joist end. Alternatively, well-conducting materials could be used to replace the insulation material around the wooden beam end. Further solutions without heating include insertion of thermal insulation behind the front face of the beam end (between beam end and exterior masonry), combined with moisture absorbing materials in cavity around the beam end (side areas of the beam end in the masonry). (Stopp, Strangfeld, Toepel, & Anlauff, 2010) (Strangfeld, Staar, & Stopp, 2012).

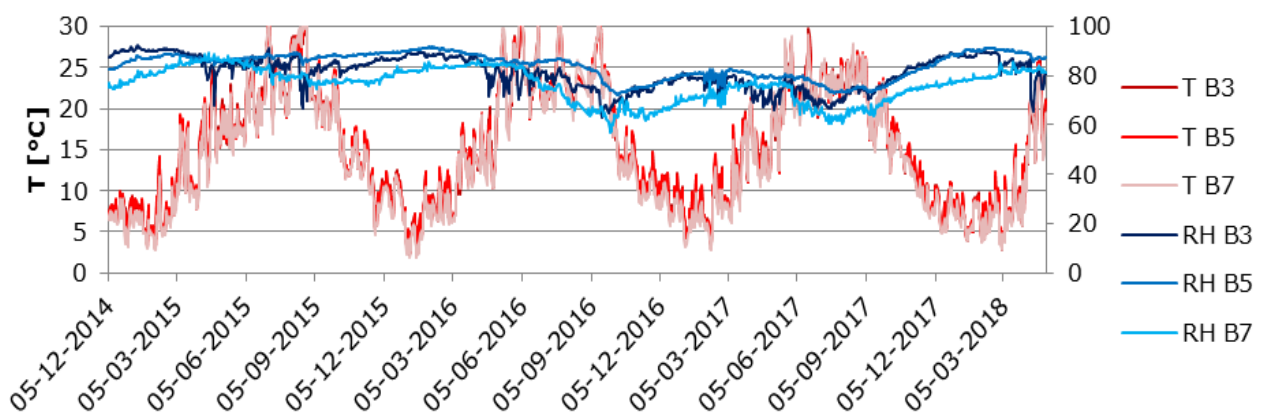
Figure 38: Joist end temperature (T) and relative humidity (RH) in the case study building in Meinungsgade, Copenhagen. Despite an initial drying process, the moisture content exceeds the 80% level in the third measurement year (2018).

Another approach of indirect heating was evaluated in Danish test houses (Morelli & Svendsen, 2012), (Hansen, Bjarlov, Peuhkuri, Harrestrup 2018). The authors left an air gap around the beam end of about 30 cm without insulation but covered by boards, to increase the local temperature around the joist end. These cases did not combine the omitted insulation with local heating. A similar strategy was also realized in Danish RIBuild cases, e.g the case study building in Meinungsgade, Copenhagen (Figure 38).

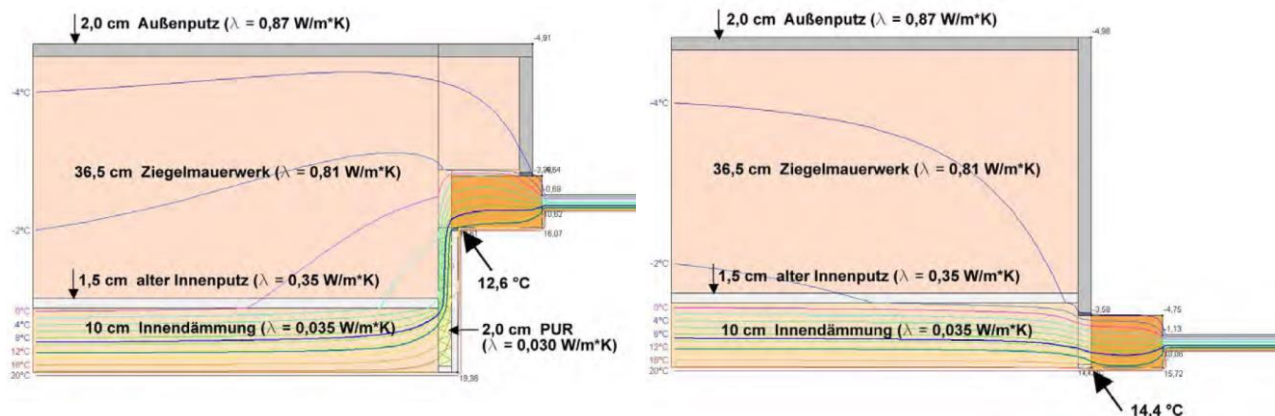
Figure 39: Comparison of the window placement impact on resulting interior surface temperatures. Left detail shows very low surface temperatures (about 12.6°C) for the middle-placement, right detail shows more balanced conditions for the inner placement of the window level (about 14.4°C) (Oswald, Zöllner, Liebert, & Sous, 2011).

Generally, the location of the window should be as close as possible at the insulation layer of the surrounding wall and there should be a continuously insulated area around the problematic joints to reduce the thermal bridge effects. The impact of the window placement level within the window reveal is shown in Figure 39. The detail at left shows a placement in the middle of the window reveal with very low surface temperatures close to condensation level (about 12.6°C), while the detail at right shows a placement close to the insulation layer with resulting balanced temperature conditions (minimum surface temperature is about 14.4°C).

Problematic thermal points around the window could be diminished with a placement of the window close to the insulation layer (see Figure 39), a continuation of the insulation layer behind the window reveal, punctual heating, highly insulating materials or a second fenestration layer. These measures are also applicable for floor-to-ceiling windows. In this case, the absence of a radiator (local heating) could be compensated with a floor heating system.

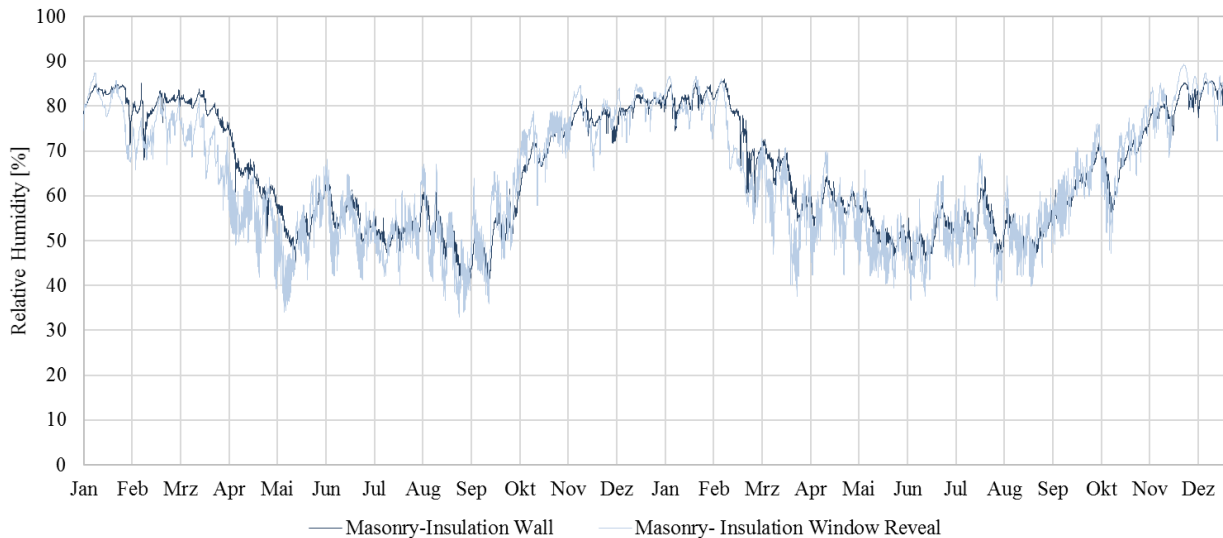
Figure 40: Conditions in the wall between insulation layer and 240 mm masonry (dark blue) compared to the condition in the window reveal area (light blue). The fluctuations of the relative humidity are higher and the moisture level is slightly higher at the window reveal area.

Among the case study buildings, two cases, the building in Weimar, Germany and the building in Klitgaarden included measurements around the window. Outcomes for one of these measurement points are illustrated in Figure 40. The condition in the window reveal area showed only a marginally increased relative humidity level compared to the undisturbed wall area.

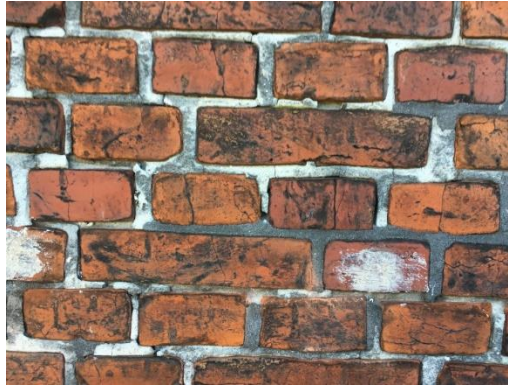
Figure 41: Face brickwork from RIBuild case study building Meinungsgade, Denmark.

Face brick walls suffer remarkably from driving rain events with a relatively long lasting impact on the overall moisture load of the exterior wall. Risky walls show an immediate response of brick moisture content on rain events. Supporting factors for the driving rain sensitivity are, among others, high precipitation amounts, weather exposed façade orientations, reduced solar incidence, not-existing or incomplete hydrophobization, inappropriate brick types and improper, cracked or weathered joints. The irregularities of these brickworks, including irregularities in the stones and joints, cracks etc. are illustrated in the following picture Figure 41 for the example of the case study on Meinungsgade in Copenhagen.

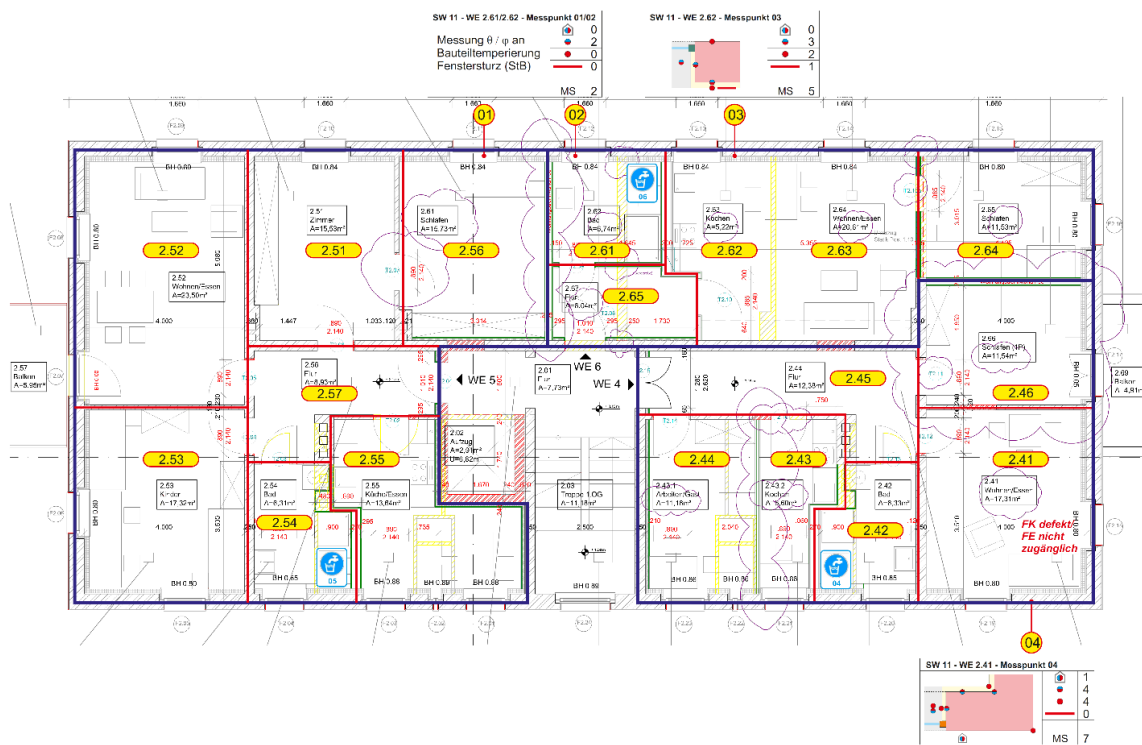
Figure 42: Selection of measurement track position in the floor plan of the building in Weimar, Germany. Each track is defined with an ID and with the type and locations of sensors.

Depending on the monitoring concept in the case study building, e.g. hygrothermal evaluation of selected details or different wall directions, different sensor types are installed at different positions in the building. In most cases, temperature and relative humidity sensors are placed to record the indoor and outdoor conditions, the situation at critical points like wall edges or other thermal bridges and at reference points, which are supposed to show a typical hygrothermal behaviour. A measurement of heat flux is often supplemented at the inner surface, a measurement of wood moisture content often performed in joist ends or other wooden construction elements. The development of a hygrothermal measurement concept is shown below for the case study building no. 1 in Weimar, Germany. First, the floor plan was analysed in order to define critical points for the measurement track locations in the building. Four points were identified, all of them included critical areas, some also undisturbed reference points (Figure 42). The selection of critical points was done under consideration of the building geometry (thermal bridges), the wall orientation and the usage of the rooms (e.g. bathrooms, sleeping rooms with higher moisture levels).

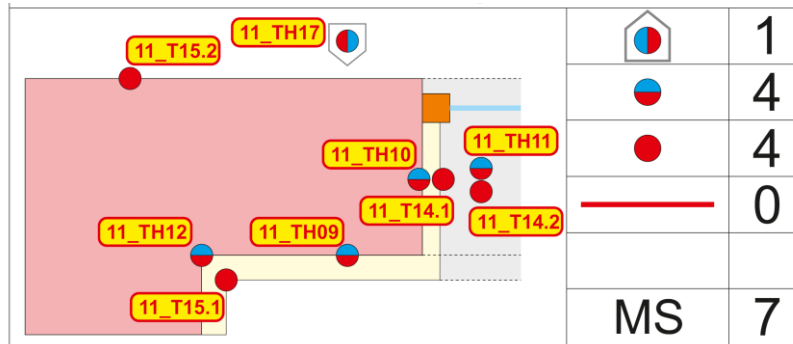
Figure 43: Selection of measurement track position in the floor plan of the building in Weimar, Germany. Each track is defined with an ID and with the type and locations of sensors.

The second step in the definition of the measurement concept is the design of each measurement track itself. Each zone or room requires at least the measurement of indoor air condition. Furthermore, combined temperature and humidity sensors are applied at critical, condensation-relevant points (Figure 43). Additional sensors are placed for special cases, e.g. the calculation of the transient U-value.

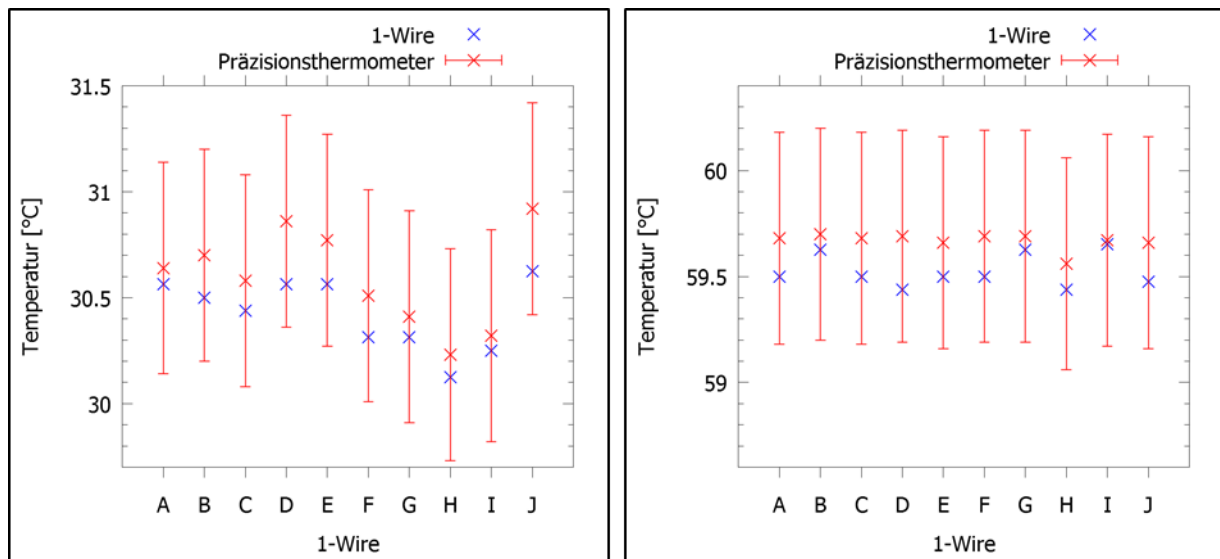
Figure 44: Calibration of temperature sensors with a producer-given accuracy of 0.5 K for the building in Weimar. Sensors to be calibrated are listed on the x-axis (characters A to J, blue crosses), temperature scale is given on the y-axis. Sensors show an average deviation of 0.3 K from the reference sensor (red crosses) and are within the allowed value range (red whiskers) for a low (left graph) and a high (right graph) temperature range.

Prior to installation of monitoring sensors, sensor quality should be calibrated. This is done with high-precision reference sensors. Calibration ensures the producer-defined precision of chosen sensors and thus the value range that defines the limits of results interpretation. Each sensor is exposed to the same condition as the reference sensor. The deviations of each sensor to the reference sensor are then analysed over different value ranges. This procedure is shown in Figure 44 for the case study building in Weimar.

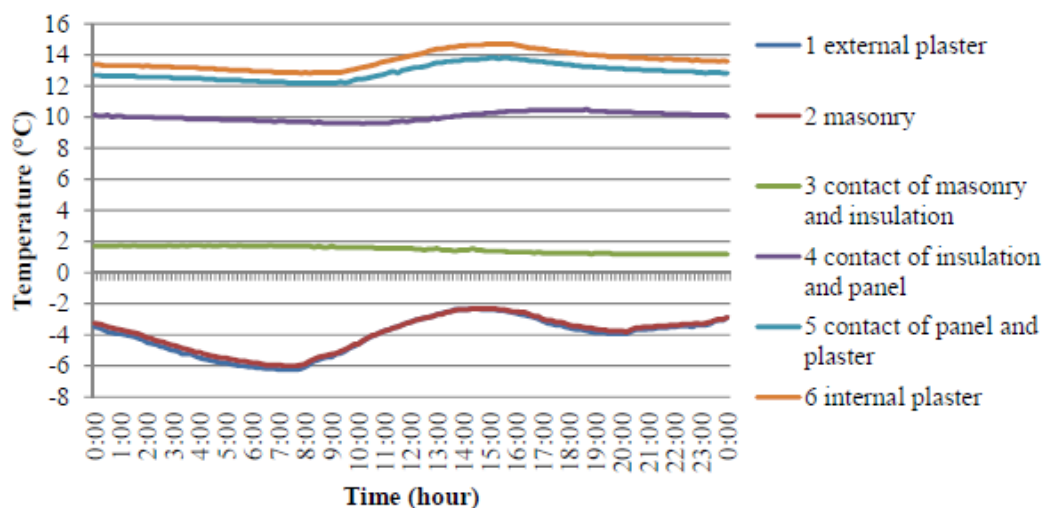
Figure 45: Temperature measurement in different depths of the wall construction: shows fluctuations close to surfaces and stable conditions inside, allows identification of risky positions (Baďurová, Jošt, Bahleda, & Ďud'ák, 2016)

After choosing representative locations of measurement tracks, the extent of measurements in form of sensor location within the construction, sensor type (precision, robustness, etc.) and number of sensors are to be defined. A set of additional sensors for the most important points is recommended, as some of the sensors could fall out in the course of the measurement period. A dense grid of sensors is also recommended, as this allows more options for the interpretation of results. One example for such a high-resolution measurement track is given below for the published case study building in Slovakia. The focus of this project was a thermal analysis of the construction. The wall track comprised one temperature sensor at each material interface as well as at the interior and exterior surface. Measurement results for one day are illustrated in Figure 45.

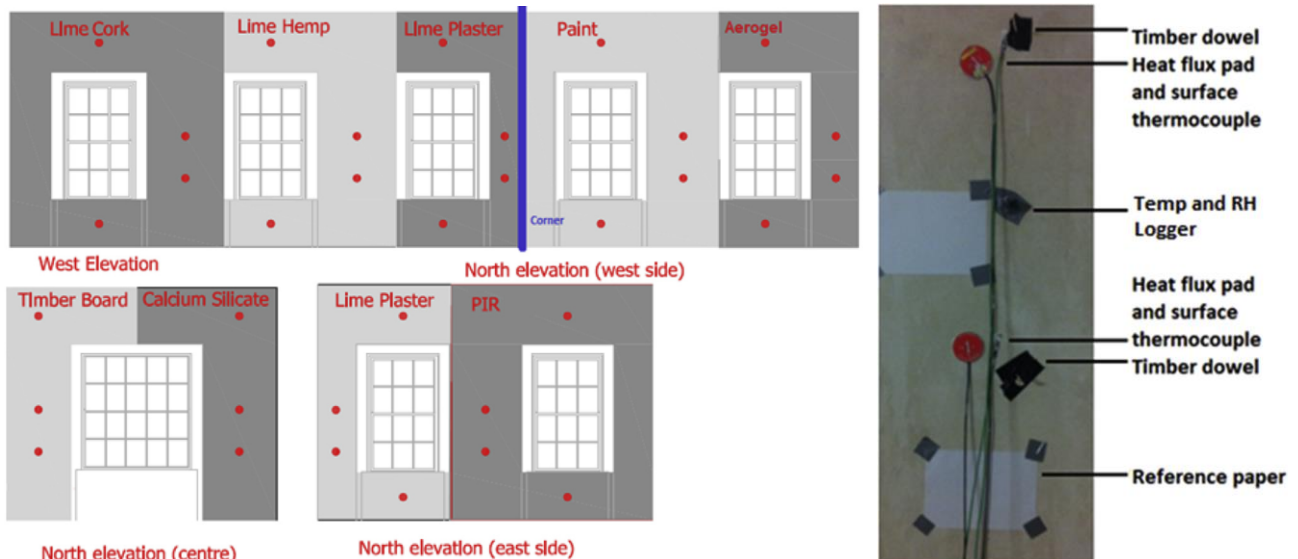
Figure 46: Temperature measurement in different heights and positions of the wall. Left graph shows the distribution of measurement tracks, right graph shows a single measurement track. (Walker & Pavia, 2015)

The spatial distribution of sensors is decided for the construction section and for the construction dimension. Besides the measurement of different depths, a measurement in different heights or distances from critical details might be reasonable, e.g. if different initial states are given over the room height because of rising damp prior retrofit. Another reason might be the placement of heaters and their impact on the spatial distribution of wall temperatures. An example for such a track over several heights is given below for the published case study building in Dublin, Ireland. Sensors are placed in the window breast area (reduced wall dimension) and over several heights around the window.

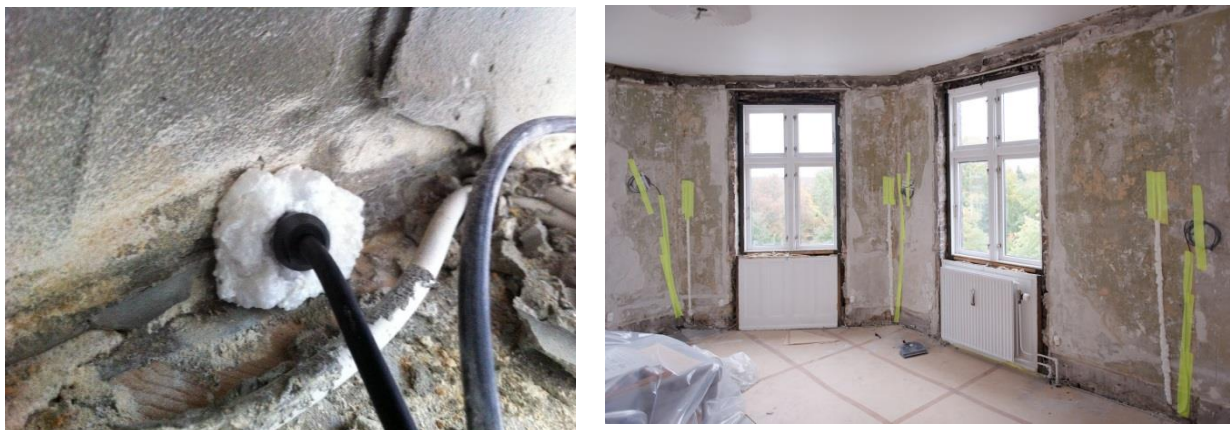
Another example is illustrated below for the RIBuild case study building in Meinungsgade, Copenhagen. Sensors are all placed in the same height but in two different directions (corner living room) and at the bridge area (exterior wall edge). Furthermore, sensors are placed in the joist ends. In this case, drilled and sensor-filled holes are filled with foam.

Figure 47: Placements of sensors behind beam-ends (left), drilled and sealed with foam, and in notches in the interior render (right), notches for the wire sealed with foam

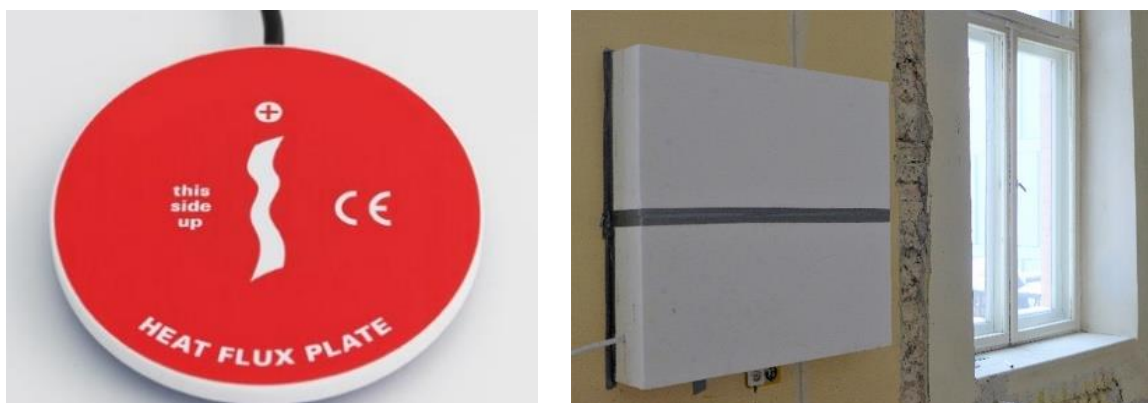
An example for this procedure was conducted for the RIBuild case study building in Riga (Catholic Seminar). U-value measurements were done for North and West facades over period of two weeks. Two heat flow measurements on the inside and three temperature measurements (indoor air, indoor surface and outdoor air) were logged. Measurements were carried out in the non-heated parts of the building. Therefore, a temperature difference was provided by a heating box at the inside of the wall.

Figure 48: Heat flux sensor and heated box setup used on the west facade of the RIBuild case study building Catholic Seminar in Riga.

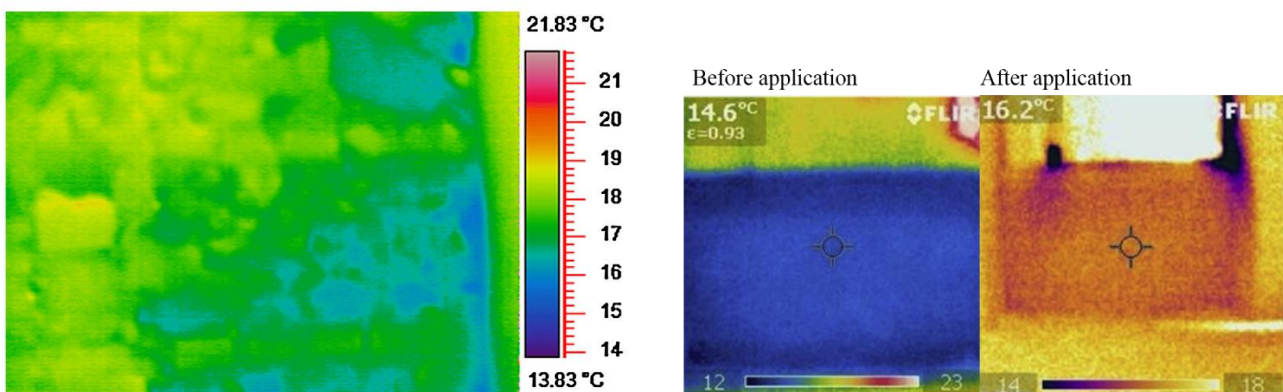
Examples of IR-images are given in Figure 49. In both cases, IR-imaging was used to identify the spatial distribution of the materials and identify typical wall areas for the sensor placement (qualitative thermography). In the Irish project (Walker & Pavia, 2015), it was furthermore used to evaluate the difference between pre and post intervention situation (comparative thermography). The requirements for this comparison are the selection of equal views and similar days with nearly identical temperature conditions in the hours before the measurement for the shots to be compared. The impact of solar radiation and rain should be excluded for this comparison by an appropriate selection of the measurement period, e.g. in a dry phase (rain) and in the morning hours or at overcast sky days (solar radiation). Naturally, the best days for an IR-imaging campaign are during the coldest time of the year, when the highest heat fluxes resp. temperature differences between indoor and outdoor conditions are given.

Figure 49: IR-image of a historic irregular wall made of brick and natural stone located in Turin, Italy (left figure) (Bianco, Serra, Fantucci, Dutto, & Massolino, 2015, S. 90, Fig. 6) and IR-imaging of the window sill before and after the application of hemp lime plaster for a building located in Dublin, Ireland (right figure) (Walker & Pavia, 2015, S. 163, Fig. 9).

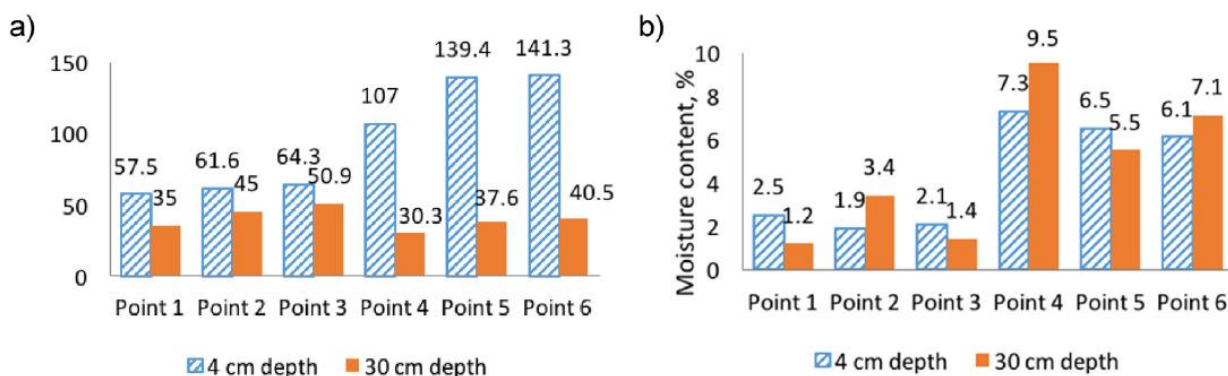
Dielectric moisture indicators were used in a project in Latvia (Biseniece, Zogla, Kamenders, Purvins, & Kass, 2017). The outcomes were compared with a destructive measurement technique and yielded both, quantitative and qualitative differences as shown in Figure 50. Quantitative differences were attributed to the measurement accuracy itself, e.g. the evaporation of moisture due to the drilling of samples. Quantitative differences for the deeper measurements were unexpected and not directly justifiable. It demonstrates that an interpretation of such measurements should be taken with caution. The authors suggest the removal of whole bricks resp. masonry parts for the identification of moisture contents. This is done in other projects, e.g. (Söhnchen & Schoch, 2017).

Figure 50: Comparison between a) non-destructive moisture content measurements via dielectric moisture indicators and b) destructive measurements via drill-cores and drying. Blue bars give the results for a depth of 30 cm, orange bars for a depth of 4 cm. Both measurements were done at identical positions (points 1-6) in the wall. (Biseniece, Zogla, Kamenders, Purvins, & Kass, 2017, S. 579, Fig. 2)

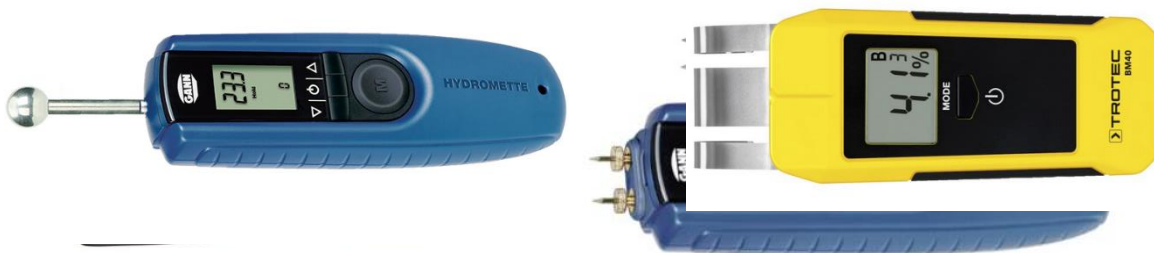
In the resistance measurement, current is passed through the material to be measured by means of two electrodes that are hit, rammed or drilled into the material. The electrical resistance is measured as a function of the electrical conductivity. In dry building materials, the resistance is very high, as dry building materials conduct the power poorly. Thus, a low reading is displayed on the meter. As the moisture content of the material increases, so does the conductivity, as the water contained in the material conducts the stream well. This displays a higher reading. With the measuring method, the moisture content at the material surface, but also in deeper component layers can be measured. However, drilling is required to allow longer electrodes to be inserted. The displayed measurement results can be converted into moisture percentages taking into account different building materials. Falsifications of the measurement results are possible due to unequal moisture distribution and inhomogeneity in the material, due to other conductive materials in the wall, e.g. Cables, lines or cleaning rails, salts in the building material, surface treatment or poor contact of the electrodes to the material. By several measurements, however, such incorrect measurements can be corrected somewhat.

Figure 51: Examples of a resistance humidity measuring device (Source: left: testo.com, right: www.gann.de)

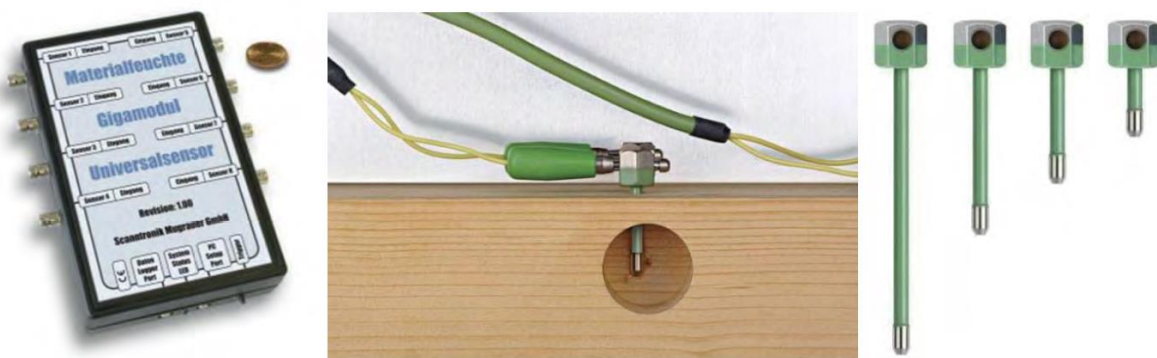
This type of moisture measurement was conducted in the case study building in Brüttelen, Switzerland. The chosen equipment is shown below in Figure 52.

Figure 52: 8-fold extension module, measuring cables and electrodes to measure moisture content in masonry and rendering.

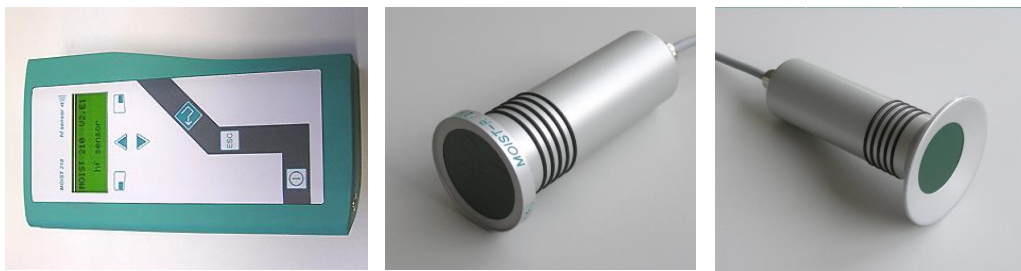
This measurement method is also a non-destructive method. The measuring principle is the radar reflection method, which allows a one-sided application of the applicators to the material to be measured. The waves are reflected as they pass through the material and detected by a meter. The method belongs to the dielectric measuring methods, i.e. the measurement is based on the determination of the permittivity of a medium to be examined. Since the dielectric constant of water is significantly higher than the usual building materials, the moisture penetration of the examined building materials causes a significantly increased measured value.

Figure 53: Example of a microwave moisture analyser with different measuring heads (Source: hf-sensor.de)

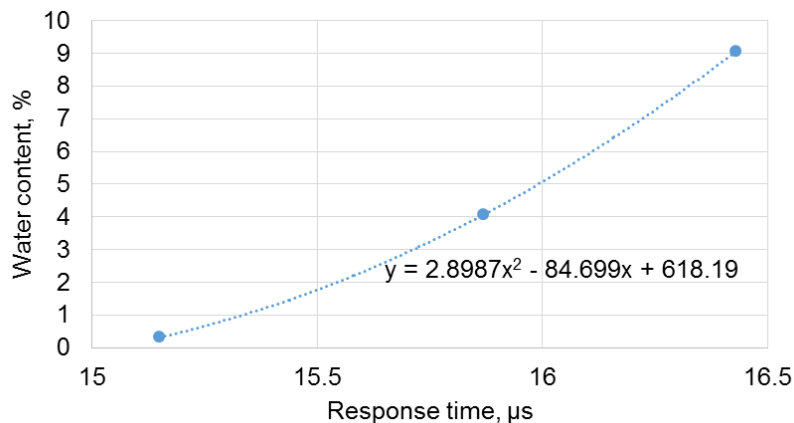
For the case study building in Dankepi, Latvia, Time domain reflectometry (TDR) measurements were used. The measurement shows an accuracy of $\pm 2.5\%$ for the volumetric water content (VWC). An operational temperature from 0 to 70 °C was used in external walls of living room and bathroom. Prior to installation, the sensor rods have been shortened to 100 mm length (due to restriction in drilling depth) and calibrated in laboratory by using sample dolomite stone from the case study building. Water content graph was obtained for sample dolomite stone. Full saturation of the stone was at 22.5%.

Figure 54: Calibration graph for TDR sensors in Dankepi, Latvia.

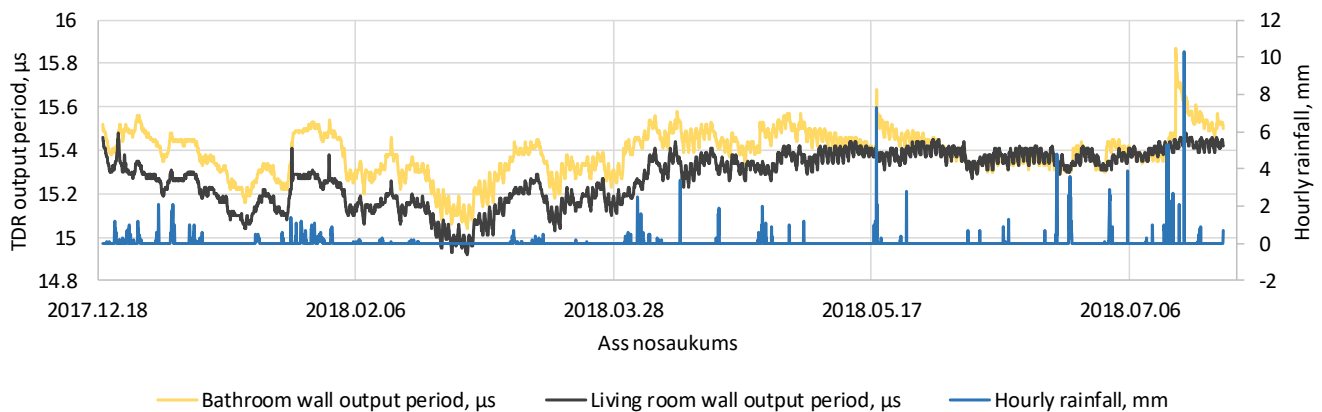
Water content measurements are shown in Figure 55. The building's dolomite stones showed a density from 2060 to 2340 kg/m³ and an average water content per volume of 11% (7-14%), determined by immersion in water. Monitoring results showed that water content mostly stayed below 8% in both measurement points.

Figure 55: Output period of TDR probes.

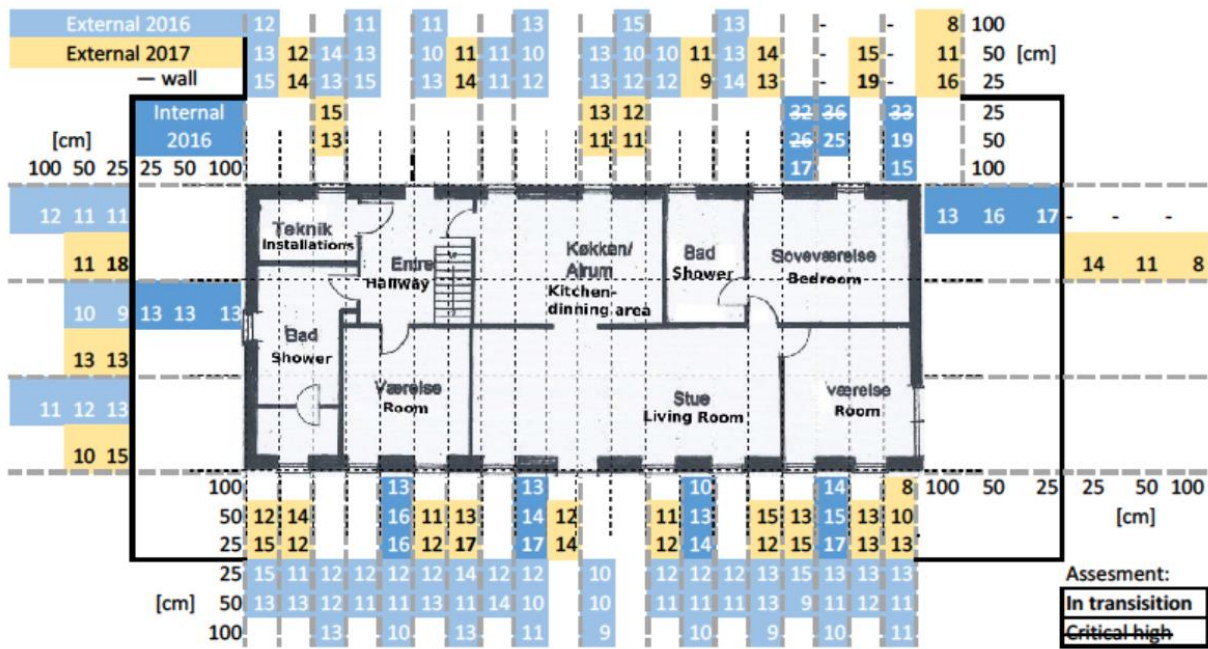
- External measurements from first visit, light blue.
- In addition external measurements from second visit, sand yellow.
- In addition interior measurements from first visit, dark blue.

Height increases away from the thick line, e.g. the nearer the thick line the lower height a value is measured. The thick line is an offset of the wall in the plan, numbers between the two are from interior measurements (possible before insulating). Yellow boxes are frequent exception from this.

Figure 56: Troxler measurements before insulating and again after insulating. The first values in a double column (shown with faded and thick dashed line) contain 2016 and 2017 measurements (e.g. upper left:12, 13, 15 & 12, 14) measured in the middle of the covered wall length while the following single column include 2016 and 2017 measurements (e.g. upper left: 14, 13 & 15, 13) below the window. The third column only include measurements from 2016. Heights stated are measured from the foundation. Yellow boxes are placed where possible due to space limitations. Values from 17 to 25 are assessed as in transition between non-critical and critical moisture content for bricks while above 25 is critical.

Another measurement principle was conducted in the case study building in Klitgaarden, Denmark, The Troxler measurement. Troxler equipment measure an equivalent to moisture content and do this with the uses of a radioactive source. A neutron source within the Troxler emit neutrons and with a selective measuring of the returning neutrons the moisture content can be assessed. This method requires reference measurements for each material to calibrate the Troxler results. Measurements with the Troxler were carried out at two separate building visits. Once before application of the interior insulation, with access to the walls' interior side and another visit after application with access from only the outside. The researchers completed measurements in two or three heights and at many positions.

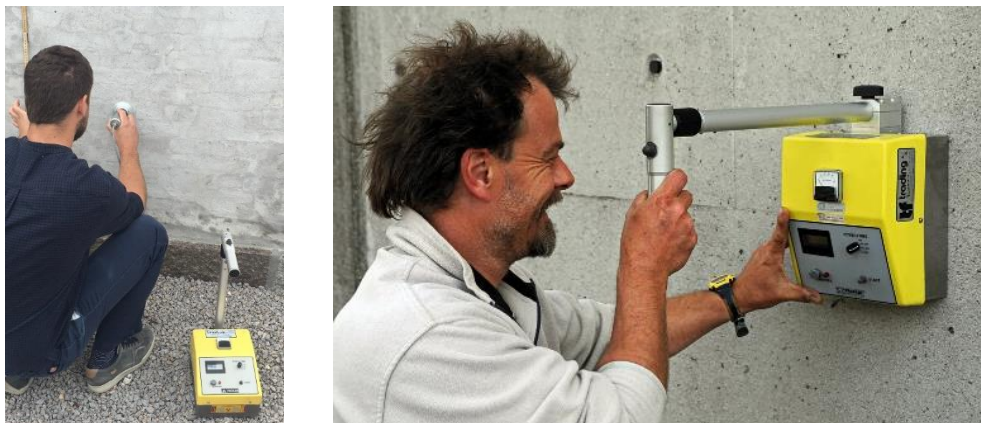
Figure 57: Troxler measurement tool standby while other measurements are carried out (left). Troxler equipment in use (right) (Brandt & et al., 2013).

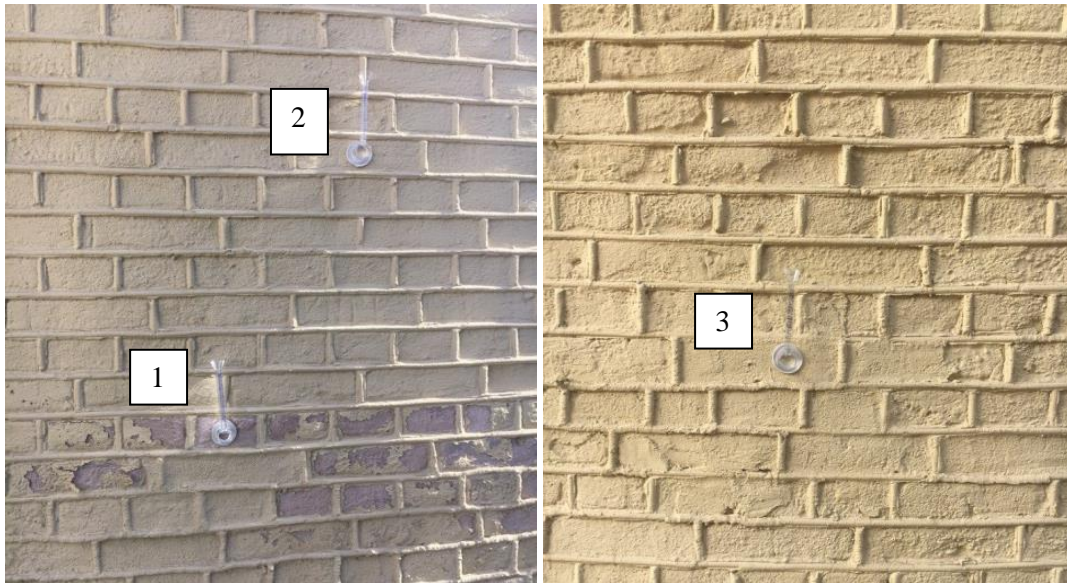
Karsten tube measurements were conducted in several RIBuild case study buildings, for example in Spikeri building in Riga, Latvia. Water uptake tests were carried out with the Karsten tube on the external surface covered with water repellent hydrophobic paint Lotusan. Three measurement points of undisturbed wall were selected. At the first point the paint has peeled off due to humidity influence (rain water pipes are not cleaned and water was falling on the wall). The second point was a plain layer of paint, one meter above the point with peeled paint. The last point was a plain layer of paint.

Figure 58: Three measurement points of undisturbed wall in Dankepi, Riga (Latvia): (1) the paint has peeled off due to humidity influence, (2) plain layer of paint 1 m above the point with peeled paint and (3) plain layer of paint.
