Project no.:	637268
Project full title:	Robust Internal Thermal Insulation of Historic Buildings
Project Acronym:	RIBuild
Deliverable no.:	D3.2 (not yet approved by the European Union)
Title of the deliverable:	Monitoring Data Basis of European Case Studies for Sound Performance Evaluation of Internal Insulation Systems Under Different Realistic Boundary Conditions

Contractual Date of Delivery to the EC	31.01.2019 (M49)
Actual Date of Delivery to the EC	29.04.2019 (M52)
Organisation name of lead contractor for this deliverable	TUD
Author(s)	Peggy Freudenberg (TUD)
Participants(s)	DTU, RTU, AAU, UNIVPM, HES-SO
Internal reviewers	Morten Ørsager (EMA), Sébastien Lasvaux (HES-SO), Ernst Jan de Place Hansen (AAU)
Work package contributing to the deliverable	WP3
Nature	R
Version	1.0
Total number of pages	103
Start date of project	01.01.2015
Duration of project	31.12.2019

The present report summarized the outcomes of case studies developed within the RIBuild project. These case study buildings were evaluated regarding the documented damages and damage indicators, the location characteristics (weather conditions), the usage (indoor climate, type), historic constructions and retrofit cons

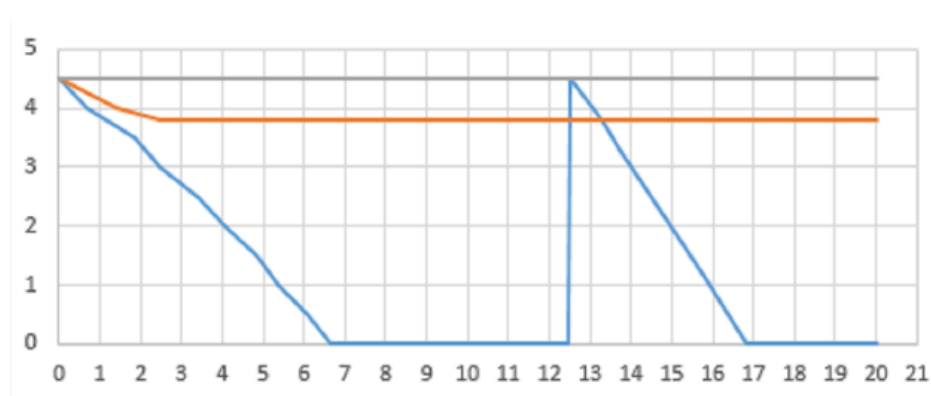
Results of the Karsten tube measurement are presented in Figure 59. The grey curve represents the painted area of the masonry. The water column height did not drop within the 20 minutes of measurements. The water absorption of the stone with slightly peeled-off paint (orange line) showed only a small reduction during this measurement time. In contrast, the stone with completely peeled-off paint shows a very high absorption (blue curve). The water column of 5 cm was sucked by the stone during less than seven minutes. The second water column was even absorbed within five minutes by the wetted and uncoated stone.

Figure 59: Water uptake test results (Karsten tube) from RIBuild case study building Spikeri, Riga (Latvia): the paint has peeled off due to humidity influence (blue line), plain layer of paint 1 m above the point with peeled paint (orange line) and plain layer of paint (grey line). Y-scale gives the scale of the Karsten tube water column, X-scale gives the time in minutes.

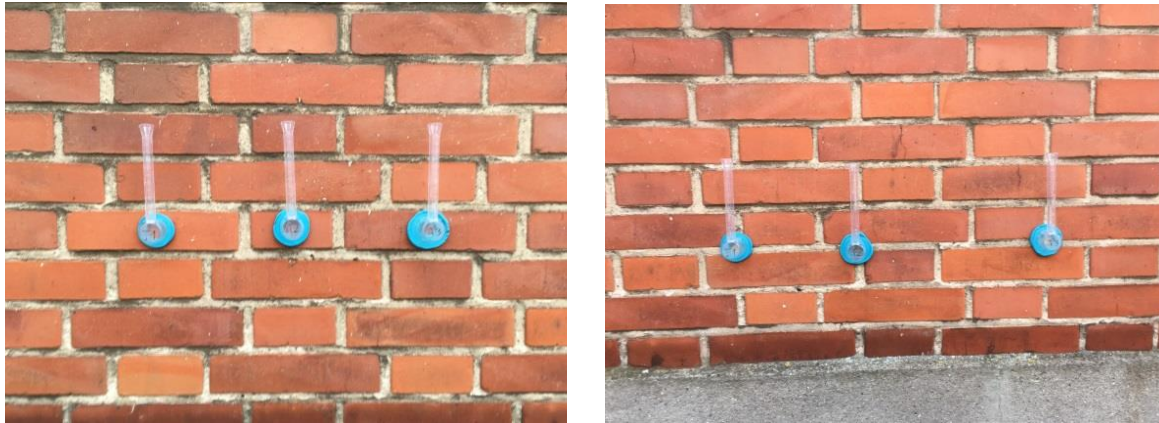
Similar measurements were performed in the case study building in Haderslev (Denmark) (Figure 60). In this case, a comparison between different measurement points within the brick-joint pattern was made. It illustrates how influential a representative measurement position is. Visual inspection of the façade revealed no major cracks or damage. Karsten tube experiments have been carried out on brick and mortar joints. Results are shown as average and standard deviation of three tests on both brick and mortar (Table 11).

Figure 60: Karsten tube measurements on Bricks (left) and joints (right) for RIBuild case study building in Haderslev (Denmark).

The comparison shows that the mortar joints have a much larger sorptivity than the bricks.

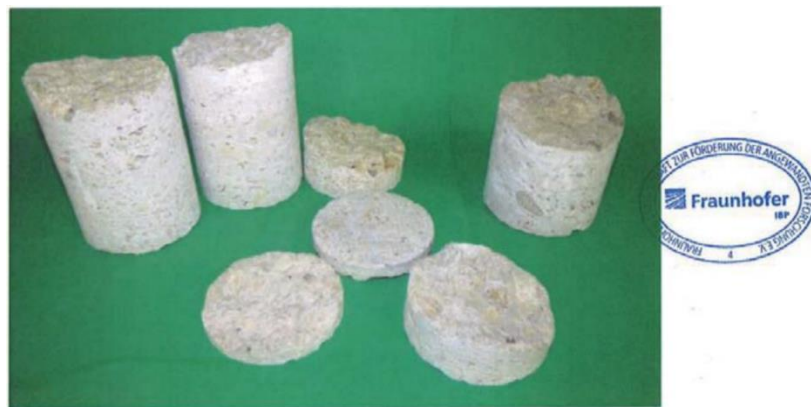
The first example is the measurement of hygrothermal properties for the case study building in Brüttelen, Switzerland (Figure 61, Table 12). As the shell limestone material in this residential building was not known, basic characteristics were measured in order to find a matching material in the database of the software tool that was used for the prediction of retrofitted construction's hygrothermal behaviour.

Figure 61: Samples from Brüttelen quarry of shell limestone probably used for the construction of the monitored building. Picture taken by IBP.

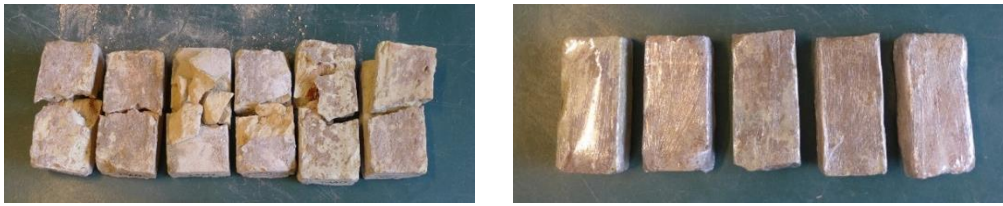
In the frame of the tests performed in Catholic Seminar building in Riga, Latvia, frost resistance of the bricks was measured. Eleven brick samples were subjected to fifteen freezing-thawing cycles. Six brick samples were tested at full water saturation. Five were tested with the maximum predicted winter saturation level determined in a hygrothermal simulation. This was achieved by soaking samples to maximum, then drying to the desired moisture content and covering with evaporation-proof film before starting the cycles. Test results are presented in Figure 62. Fully saturated samples split or formed critical cracks between 2 to 6 cycles. Samples saturated to 20% of total volume have no visible damage after 15 cycles.

Figure 62: Bricks after 15 frost-thaw test cycles. Left: Fully saturated samples (~36%). Right: Samples saturated to 20%.
